M. E. Williams and Associates, Inc.

Case Study: Dump Trailer Kingpin Assembly Failure

Merlin E. Williams, P.E.

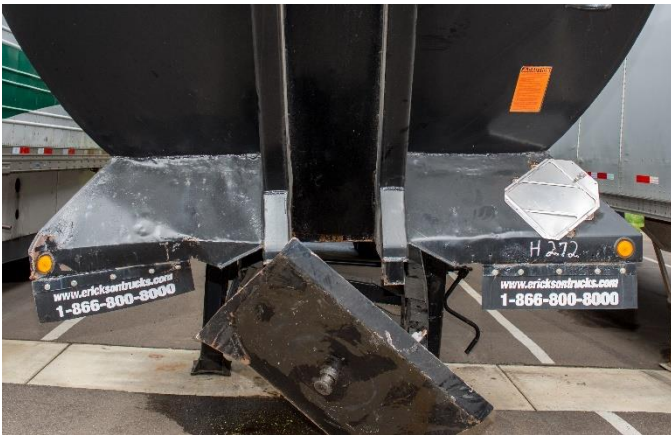
Figure 1 – Front End of Trailer

Figure 1 shows the damage on the front end of the trailer. The kingpin plate and frame were significantly damaged in the trailer roll-over. The hoist was missing and was found in the bed of the trailer.

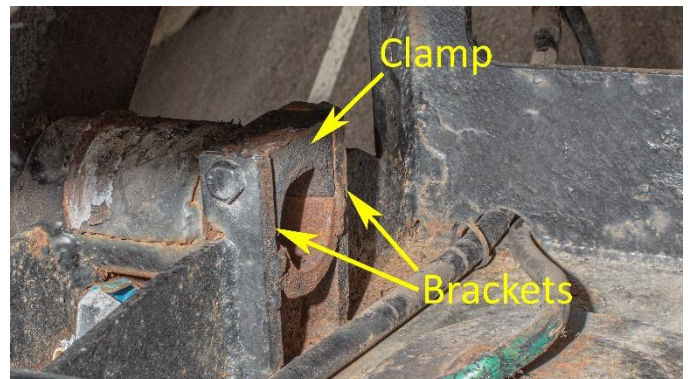
Figure 2 – Left Side Hoist Kingpin Pivot Bracket Assembly

The left side of the hoist kingpin pivot bracket used to secure the hoist to the trailer frame is shown in Figure 2. The left hand assembly was intact at the time of examination. The kingpin pivot assembly consisted of four parts: two brackets, one clamp, and a nut and bolt to hold the clamp in place. There were significant amounts of wear and rust associated with the assembly. There was no visual evidence that the left side of the hoist assembly had ever been repaired. A section of the frame in this area may have been repaired.

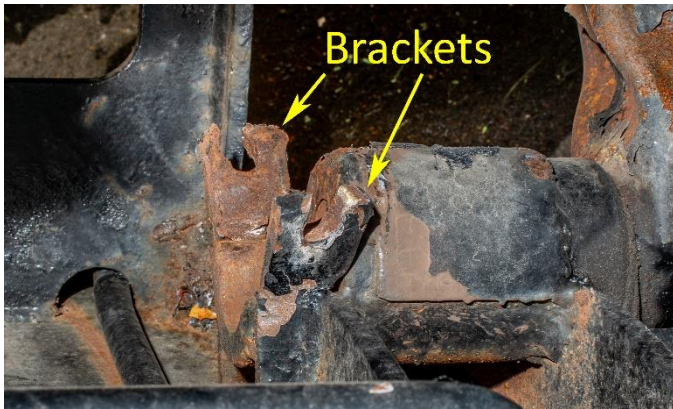
Figure 3 – Right Side Hoist Kingpin Assembly

The right side of the hoist kingpin assembly is shown in Figure 3. The assembly that held the kingpin in place was broken, and the nut and bolt and clamp were missing. This side of the trailer frame had been repaired at least once. The weld quality was extremely poor, indicating that the repairs were done by an unqualified welder. Figure 4 shows the defective repair weld. All welding standards and specifications require welds to pass visual inspection as a minimum. The repair weld was substandard and would not have passed a visual inspection.

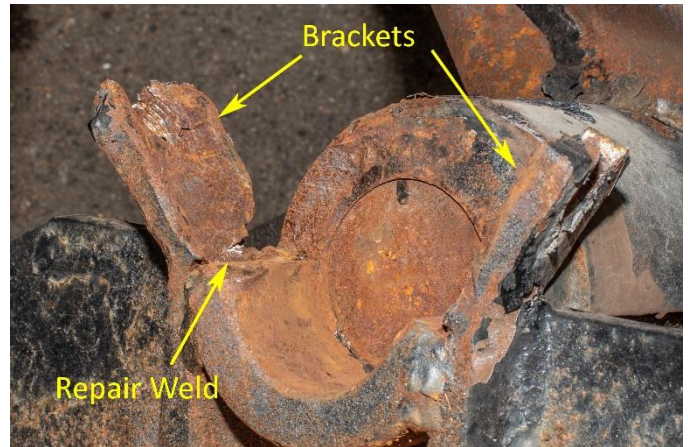
Figure 4 – Right Side Hoist Kingpin Assembly and Failure Location

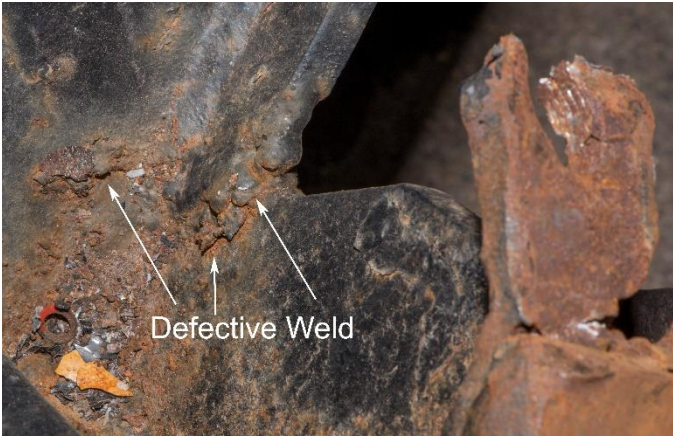
Figure 5 shows another defective weld; having excessive reinforcement with weld filler metal as shown is not acceptable by any standards. Unfortunately, the standards for welding of on-road equipment are specified by the original equipment manufacturer, and many manufacturers do not have any standards. The repair welds in this case were not, even visually, comparable to the quality of the manufacturer's welds.

Figure 5 – Defective Welds Right Side

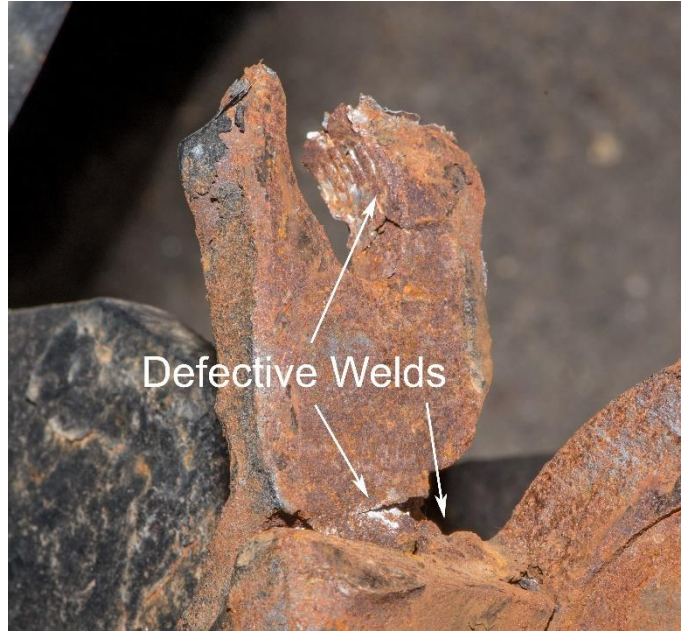
Figure 6 shows a bracket that broke, resulting in the trailer tipping over. This bracket had broken at least once before, and likely had broken several times, based on the conditions present. The upper arrow shows where the bolt hole in the bracket had pulled out and was then welded to repair it. The bracket had been repaired by welding in a small piece of steel, instead of replacing it with a solid piece, as on the front bracket and the front and rear brackets on the left side assembly. The bracket repair was removed in my presence by sawing.

Figure 6 – Defective Welds Right Side - Rear Connection Bracket

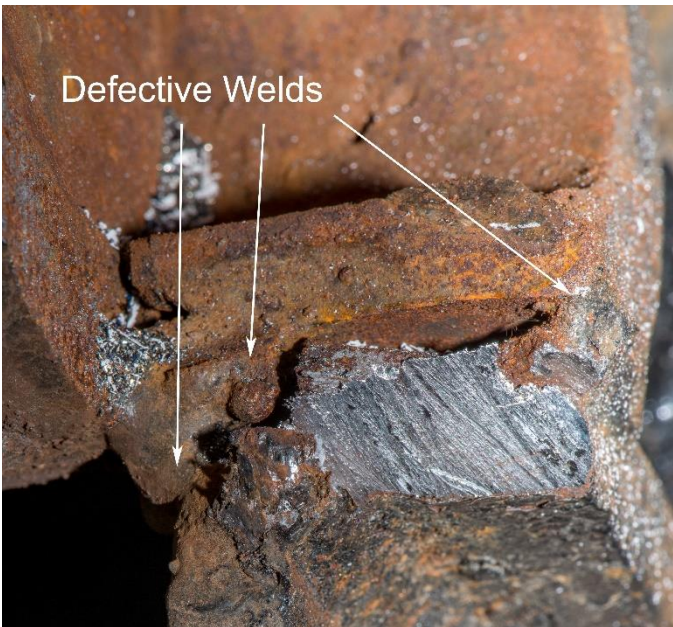
Figure 7 shows the area after the bracket repair had been cut off. The welds holding the bracket to the trailer assembly were also defective.

Figure 7 – Defective Welds Right Side - Rear Connection after Bracket Removal

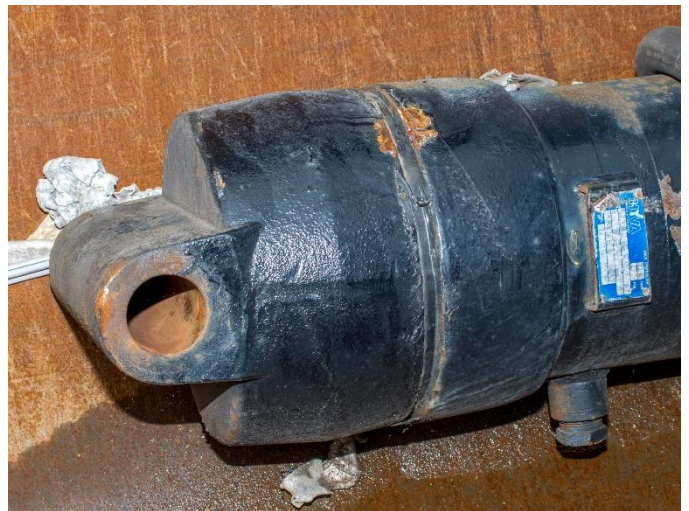
Figure 8 – Hoist Base

The base of the hoist looked to be in good condition, Figure 8. It did not appear that the hoist contributed to the bracket failure.

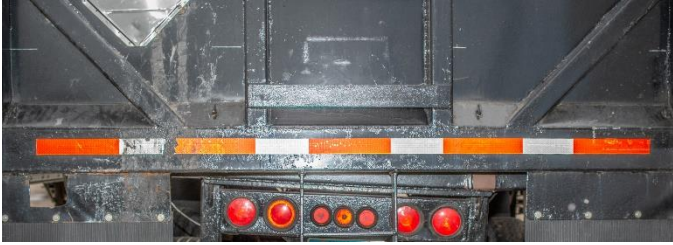
Figure 9 – Bent Trailer Frame

The tailgate of the trailer was used as a reference, shown in Figure 9. The tailgate was level with the ground, and shows that the trailer frame was bent. In Figure 10, the reference line of the top of the building showed that the bending extended the entire length of the trailer.

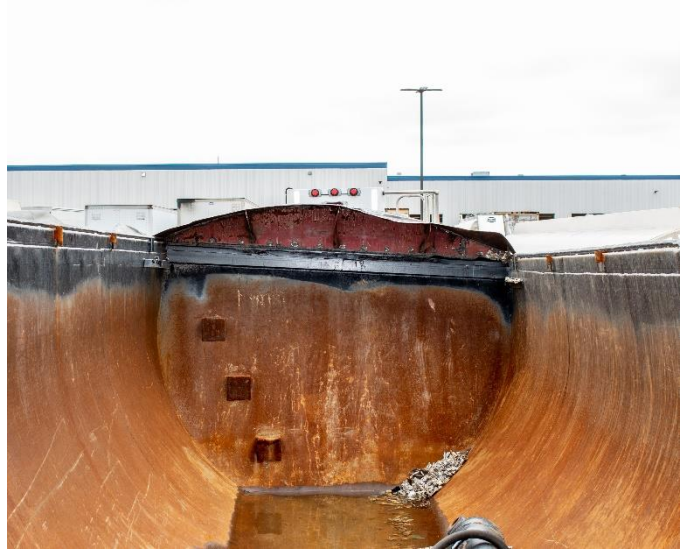
Figure 10 – Bent Trailer Frame

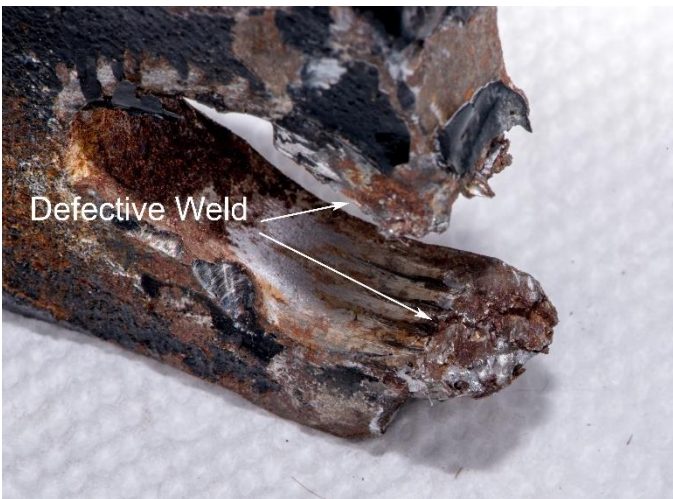
Figure 11 shows the defective weld that was used to repair the bracket. The defects were excessive porosity and cracks. A metallographic cross section was made through the weld.

Figure 11 – Weld Porosity and Cracks on Bracket

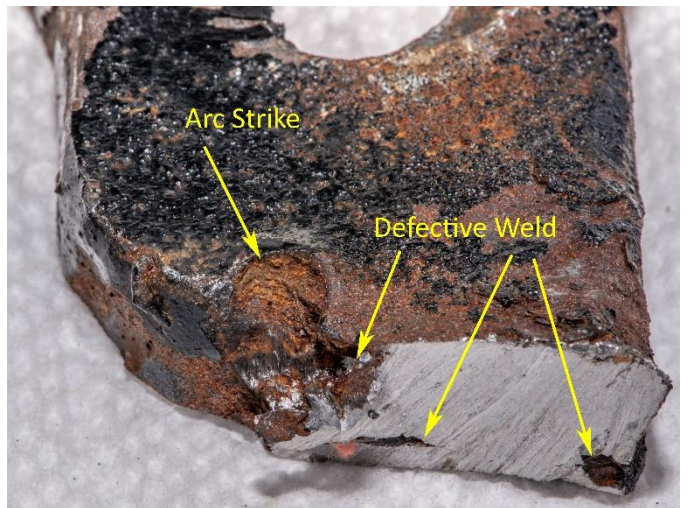
Figure 12 – Defective Weld at Base of Bracket

The weld at the base of the bracket is shown in Figure 12. This weld was defective, as shown by a lack of fusion and an unfilled arc strike. The welding on the bracket was done by an unqualified welder.

The weld at the base of the bracket has an allowable load of 9000 psi. The weld across the top of the bracket is not allowed, according to AWS D1.1, even if it had been of acceptable quality.
