Case Study – Tempered Martensite Embrittlement

Evaluation of two attachment holders to determine the cause of failure. The holders were examined by visual examination, hardness testing, metallographic examination, and fracture mechanics.

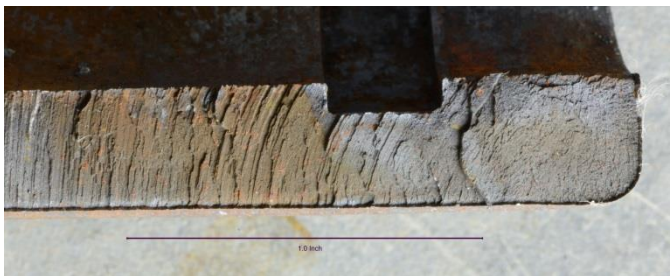
Figure 1 –Sample 1 Fracture

Figure 1 shows the fracture surface of Sample 1. This holder failed parallel to the parting line on the forging. The fracture was perpendicular to the forge flow lines in the holder.

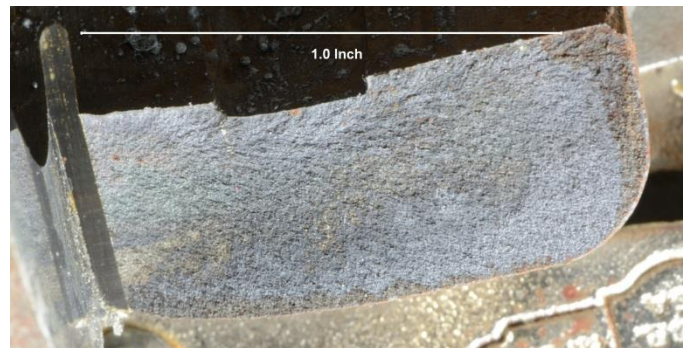
Figure 2 –Sample 2 Fracture

Figure 2 shows the fracture surface of Sample 2. This holder appears to have been cracked twice. The right side of the fracture has more rust than the rest of the fracture surface. This fracture was very fine grained and the surface was very flat, indicating that the failure mode was brittle fracture.

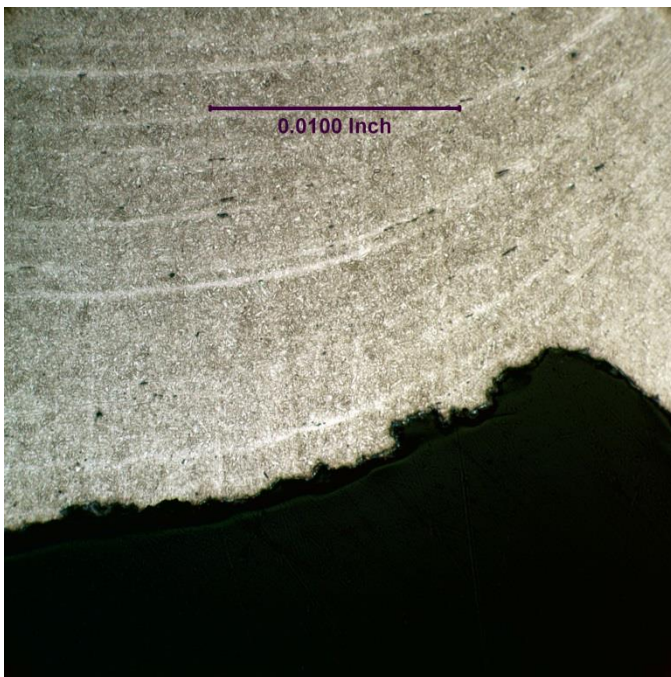
Figure 3 – 100X Sample 1 Forging Flow Lines

Figure 3 shows the forging flow lines in Sample 1. The flow lines are parallel to the fracture surface at the bottom of the photo. The strong presence of flow lines indicates that this holder may not have been normalized after forging and prior to heat treating. Steel normalized after forging and prior to heat treating has improved fracture toughness. During the energy crises in the early 1980's, it was attempted to drop

the normalizing after forging, with disastrous results in terms of equipment failures and warranty costs which out-stripped the energy cost savings.

1. Change the hardness specification on the attachment holder engineering drawing to 38 to 44 Rockwell C Scale.
2. Add the requirement that the forgings be normalized prior to austenitizing, quenching, and tempering.

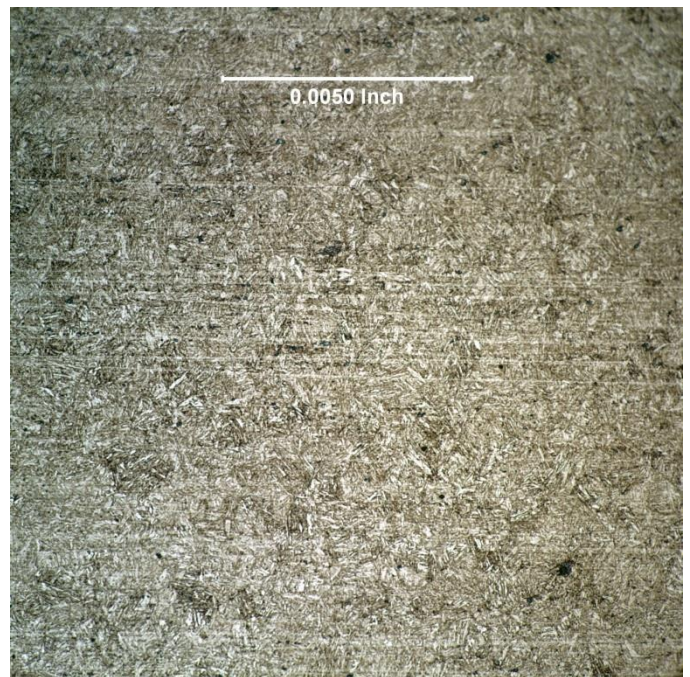
Figure 4 – 400X Sample 1 Microstructure

The microstructure of Sample 1, Figure 4, was fine grained tempered martensite. The grain size was determined to be 16.9 microns, which is ASTM grain size 9. The grain size indicates that the holder should have had good fracture toughness.

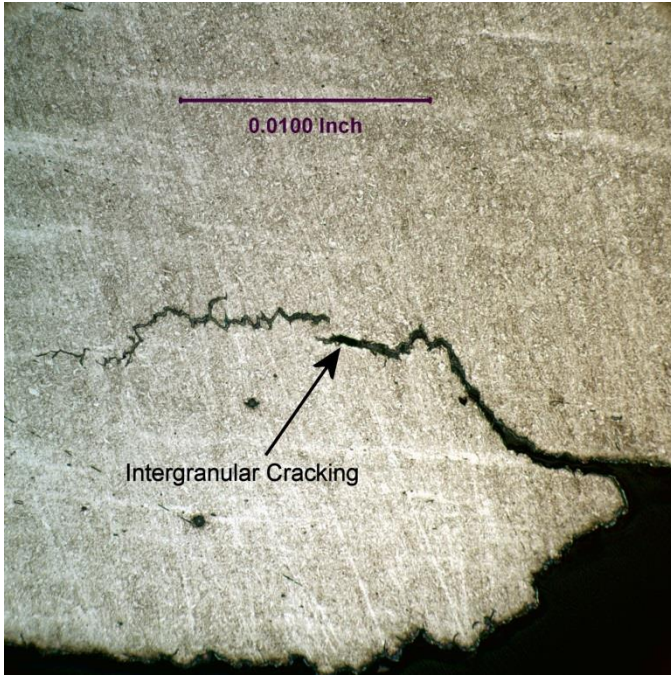
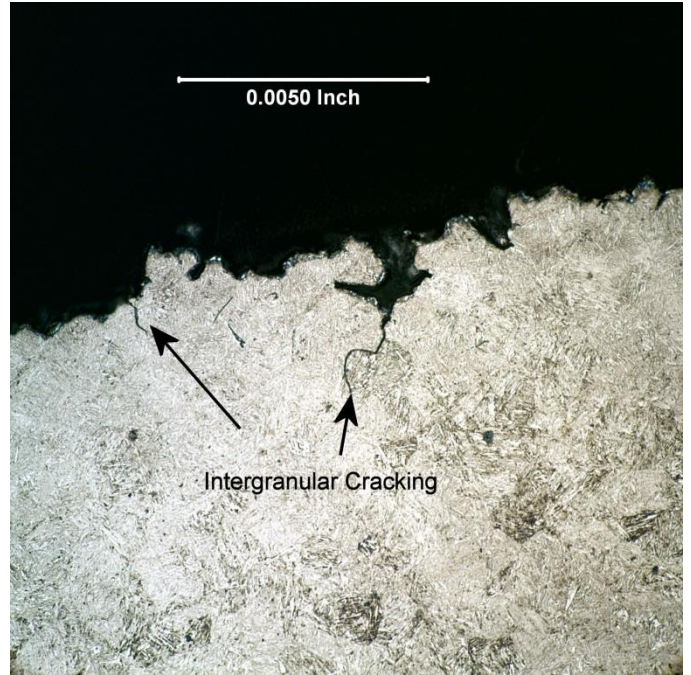
Figure 5 – 200X Sample 1 Intergranular Cracking

Figure 6 – 400X Sample 1 Intergranular Cracking

Figures 5 and 6 show intergranular cracking associated with the fracture of Sample 1. Intergranular cracking is a characteristic of brittle fracture. Brittle fracture in steels is the result of grain boundary weakening which is characteristic of temper embrittlement.

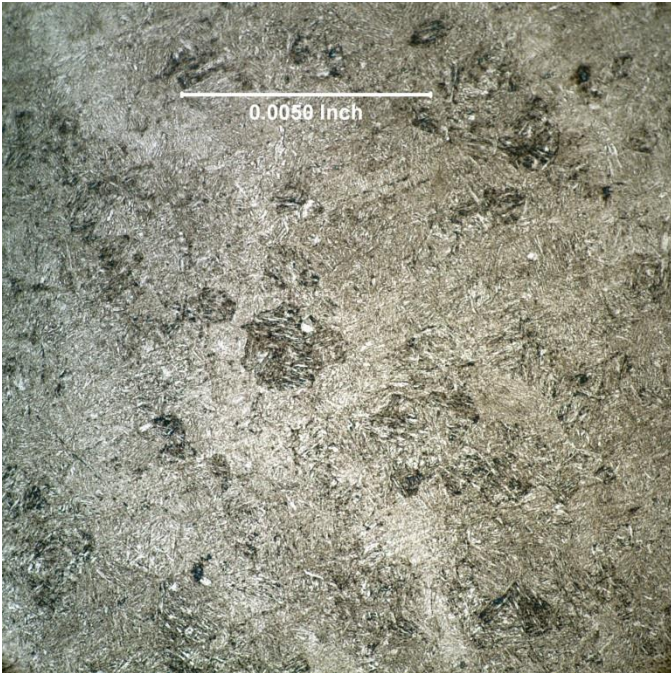
Figure 7 – 400X Sample 2 Microstructure

Figure 7 shows the microstructure of Sample 2. The grain size was determined to be 28 microns, and the ASTM grain size was 7.5, which is also fine grain steel. There was no evidence found of forging flow lines associated with the fracture.

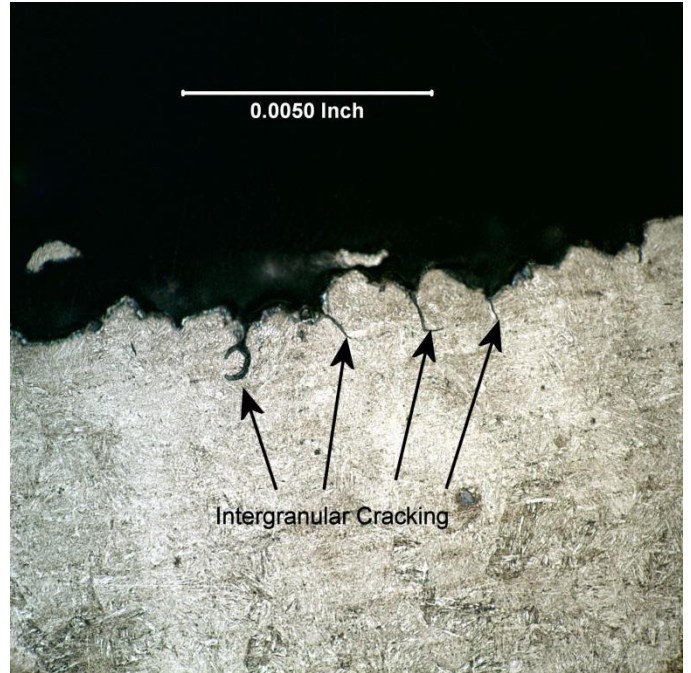
Figure 8 – 400X Sample 2 Intergranular Cracking

Figure 8 is a section of the cross section through the fracture surface. The intergranular cracking clearly indicates that this fracture was brittle. The likely cause of the brittle fracture was temper embrittlement.

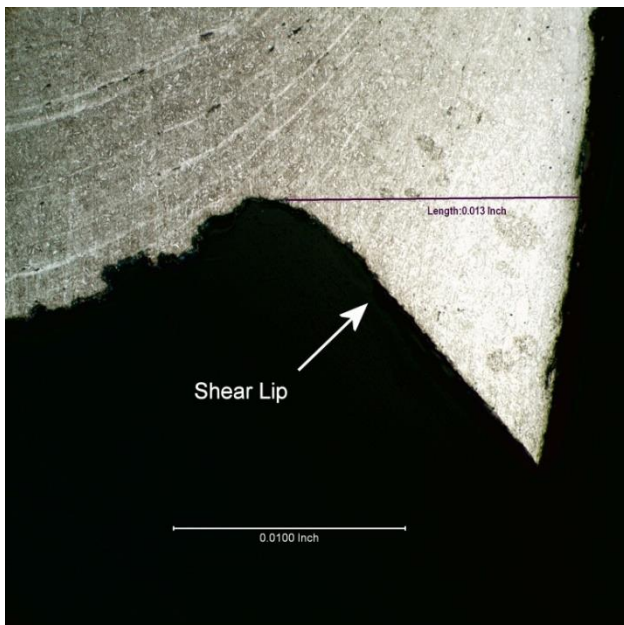
Figure 9 – 200X Sample 1 Shear Lip

Figure 9 shows the Sample 1 shear lip, which is 0.013 inches. Assuming that the holder was within the specified hardness range, the size of the shear lip indicates that the Charpy impact strength was 14.4 ft-lbs, which for 42CrMo steel is brittle fracture.

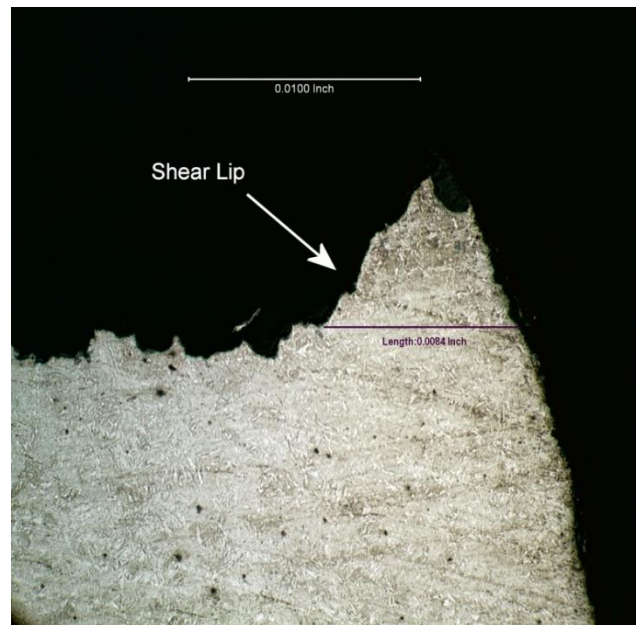
Figure 10 – 200X Sample 2 Shear Lip

The shear lip associated with Sample 2 is shown in Figure 10. The size of this shear lip is 0.0084 inches, indicating that the Charpy impact strength at the time of failure was 11 ft-lbs. This is clearly brittle fracture.
