## Chase Study: Hydrogen Embrittlement

Merlin E. Williams, P.E.

Examination of broken spring to determine cause of failure. The spring was examined by visual examination, hardness testing, scanning electron microscopic examination, and metallographic examination. The spring was a torsional spring fabrication for oil tempered spring wire, that broke during installation.

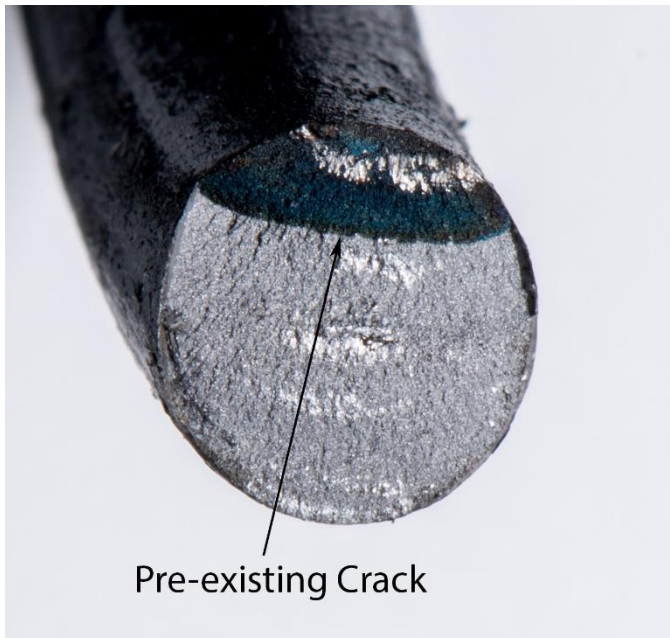
Figure 1 – Fracture 1

There were pre-existing cracks at the two fracture locations, Figures 1 and 2. The blue-black areas, indicating the pre-existing cracks, were probably open prior to the tempering of the wire. The blue-black color was caused by heating to over 700° F. The light, sparkling surface appearance indicates intergranular fracture. This characteristic was present in the blue-black area also. The pre-existing cracks were on the inside diameter of the spring.

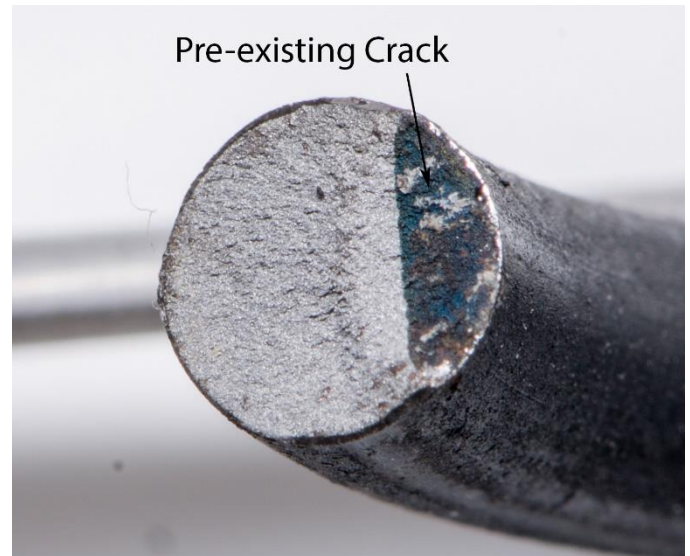
Figure 2 – Fracture 2

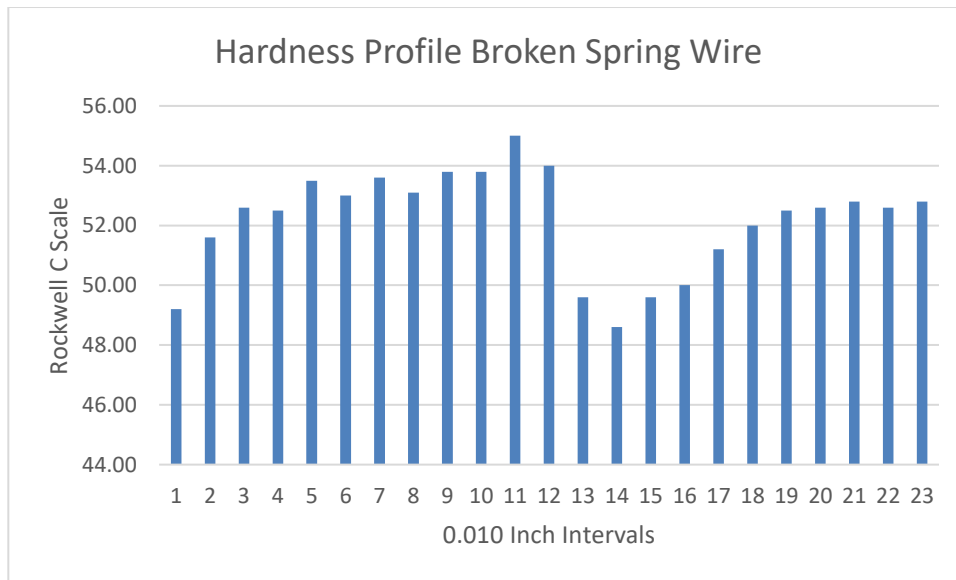
The average hardness across the diameter of the spring was 52.17 on the Rockwell C Scale. Typical spring wire has an average hardness across the diameter of 45 to 47 on the Rockwell C Scale.

Figure 3 – Hardness Profile Across Diameter of Broken Spring – Spring OD to ID

Figure 3 shows the hardness profile of the broken spring wire. The appearance of the profile is typical of wires examined in the past, but the wire was harder. Reading 1 was near the outside diameter of the wire.

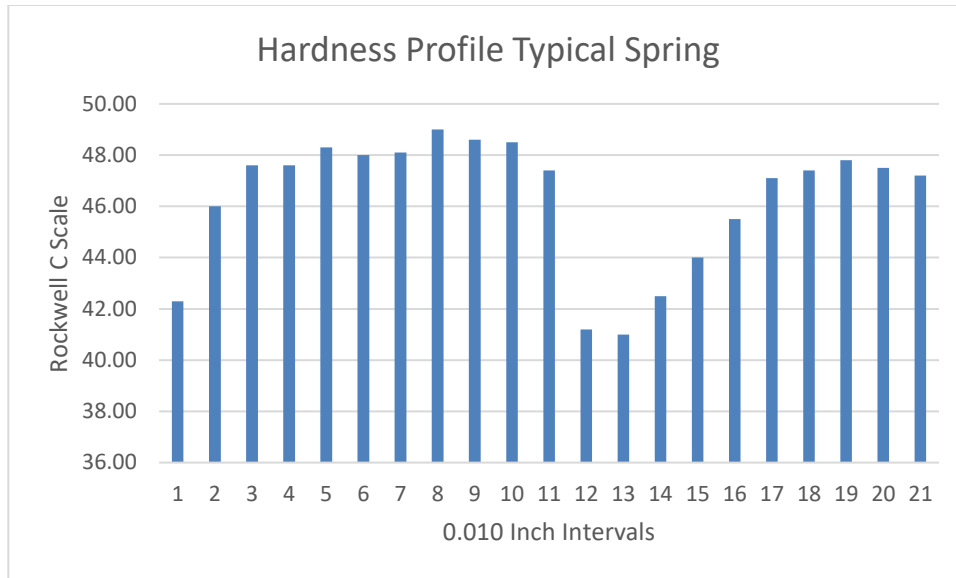
Figure 4 – Hardness Profile of Typical Spring – Spring OD to ID

Figure 4 shows the rechecked hardness profile for Typical Spring – spring outside diameter to inside diameter. The hardness of this failure is greater than the normal hardness in a typical spring.

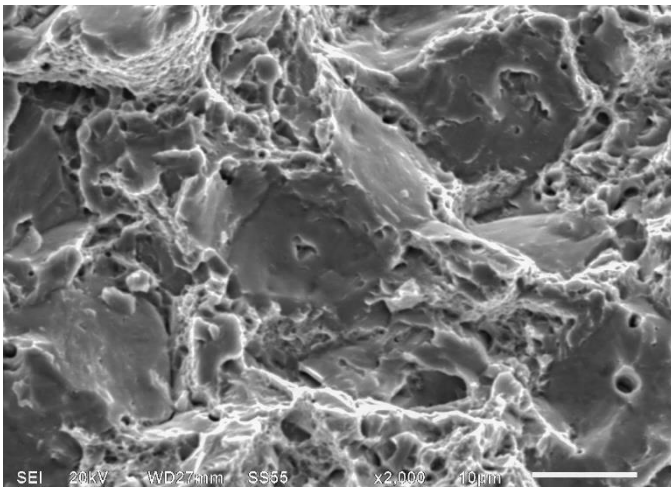
Figure 5 – 2000X Fracture 1 – Mixed Mode Fracture

Figure 5 shows the fracture surface of Fracture 1. Both intergranular fracture and ductile rupture are present. There are apparent bubbles associated with the intergranular facets. These characteristics are typical of hydrogen embrittlement. Hydrogen can be picked up at any point in the spring wire manufacturing process, during melting and formulating steel, pickling and cleaning of the wire, and

exposure to rusting. To my understanding, there are no processes at the spring manufacturers that will cause hydrogen embrittlement.

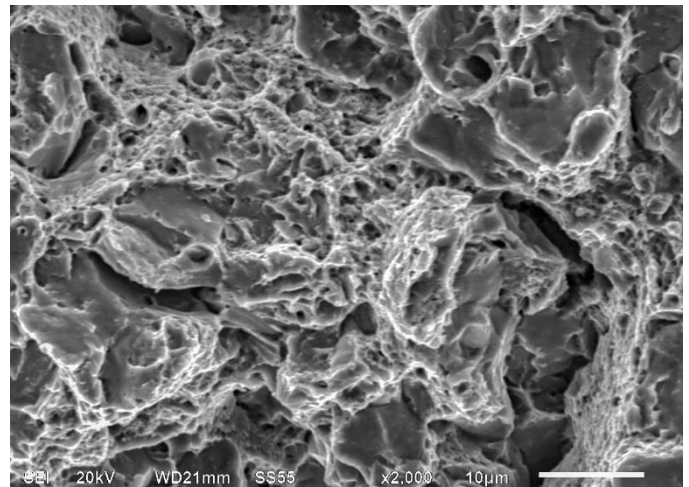
Figure 6 – 2000X Fracture 2 – Mixed Mode Fracture

Figure 6 shows Fracture 2, which has similar conditions to Fracture 1. This fracture was the result of hydrogen embrittlement.

The higher than normal hardness of the spring wire makes it more susceptible to hydrogen embrittlement.

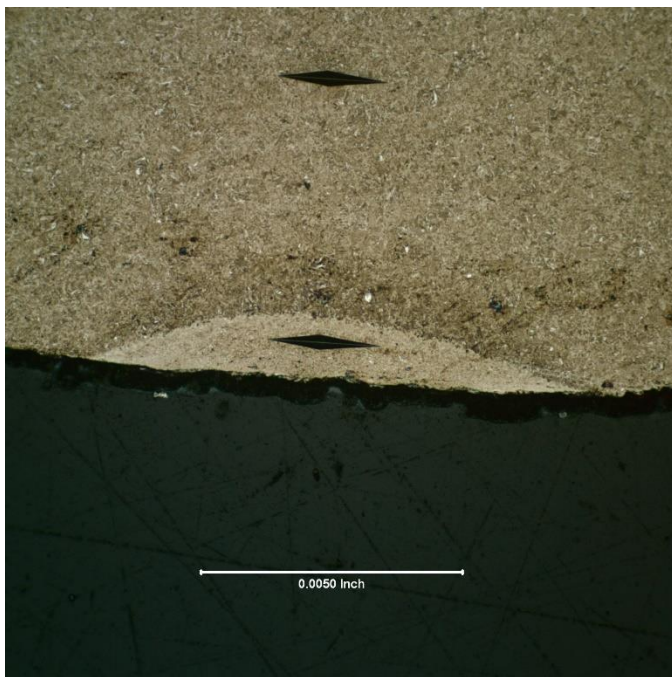
Figure 7 – 400X Tool Mark – Spring OD

Figure 7 shows a tool mark that was on the outside diameter of the spring. Tool marks are indications of lubrication breakdown during forming of the spring, and often are the cause of spring failure. This is larger than a typical tool mark. The hardness impression in the tool mark was the first value given in the graph in Figure 3. The hardness at this location was 49.2 on the Rockwell C scale. The presence of tool marks lowers the fatigue strength of the spring by causing localized reduction ductility. The tool mark shown in Figure 8 is typical of tool marks found on the springs that have previously been evaluated for this client.

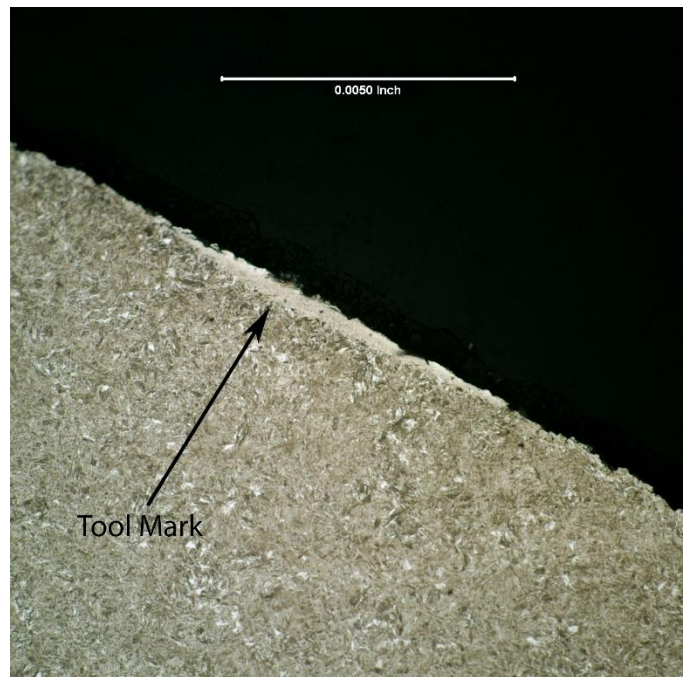
Figure 8 – 400X Tool Mark

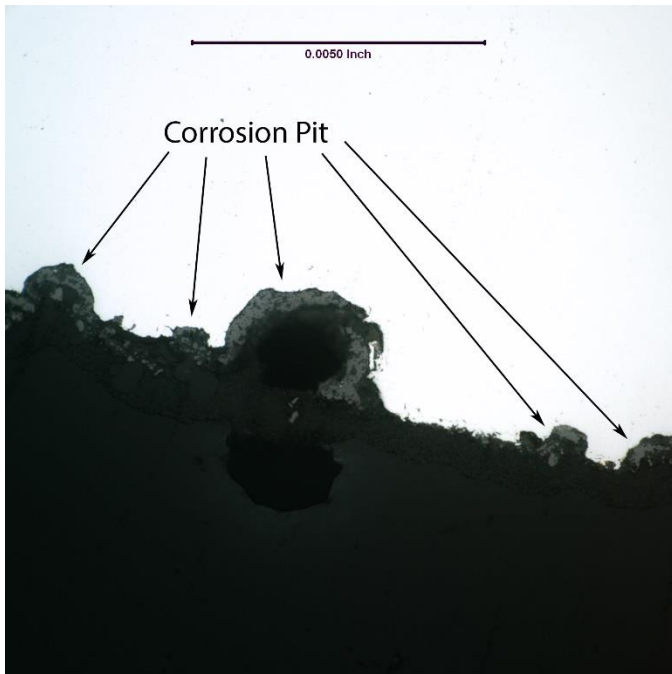
Figure 9 shows corrosion pits on the surface of the spring wire. The presence of the corrosion pits indicates that the most probable cause of the hydrogen embrittlement was corrosion of the wire.

Figure 9 – 400X Corrosion Pits on Spring Wire Surface

1. The spring failed in two locations due to hydrogen embrittlement of the spring wire.
2. The most probable source of the hydrogen embrittlement was corrosion on the surface of the wire, as shown in Figures 9 and 10.
3. The hardness of the spring wire was significantly harder than the wire normally used. The higher hardness makes the wire more susceptible to hydrogen embrittlement.
4. The tool marks were not involved in the failure of this spring.

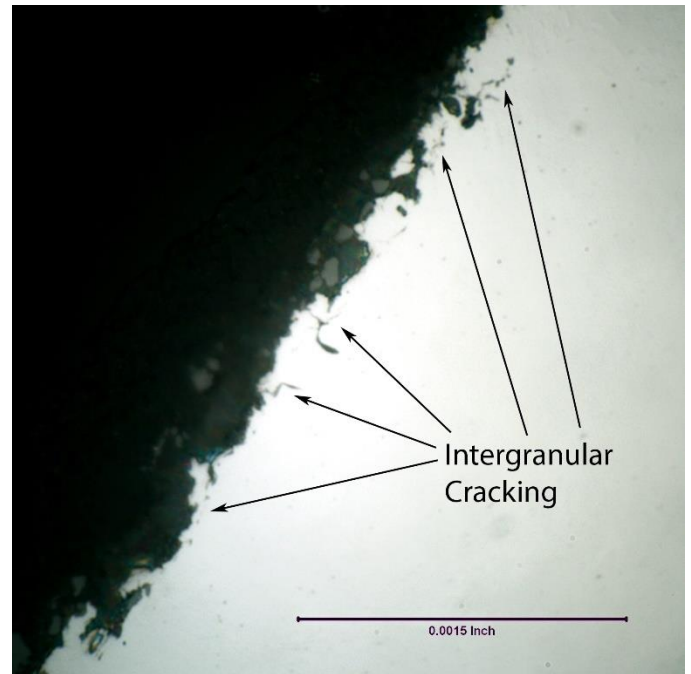
Figure 10 shows another area on the spring wire surface where there was corrosion and intergranular cracking.

Figure 10 – 1500X Intergranular Cracking on Spring Wire Surface
