M. E. Williams and Associates, Inc.

Case Study: Robotic Welder Qualification

Subject

Two square butt samples welded by a robotic welder were examined to determine their compliance with AWS D1.1. Both samples were rejected for lack of fusion at the root. The samples were examined by root Bend Testing, visual examination, and metallographic examination.

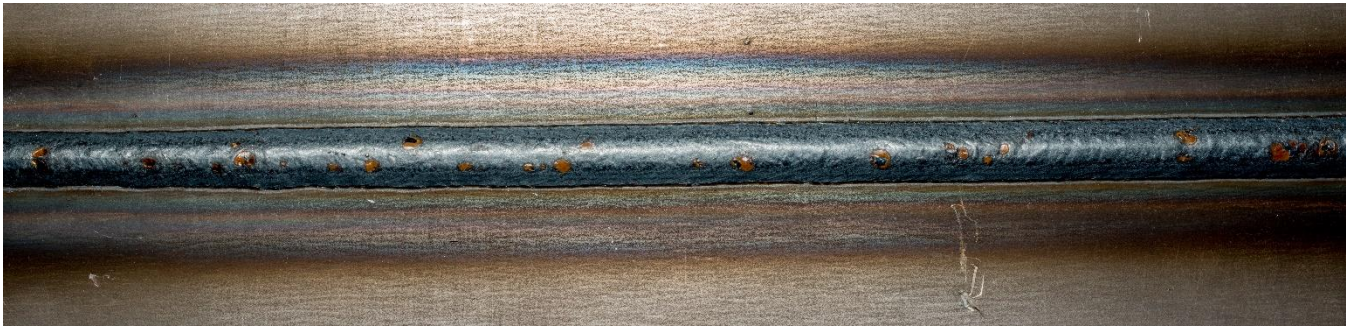
Figure 1 – Sample 1 CO₂ Cover Gas - Top Side

Figures 1 and 2 show Sample 1. The sample was identified as CO₂ Cover Gas. The cover gas was 90% Argon and 10% CO₂. The left side of Figure 2 shows where the root pass had full penetration. There was excellent root fusion in the full penetration section of the weld.

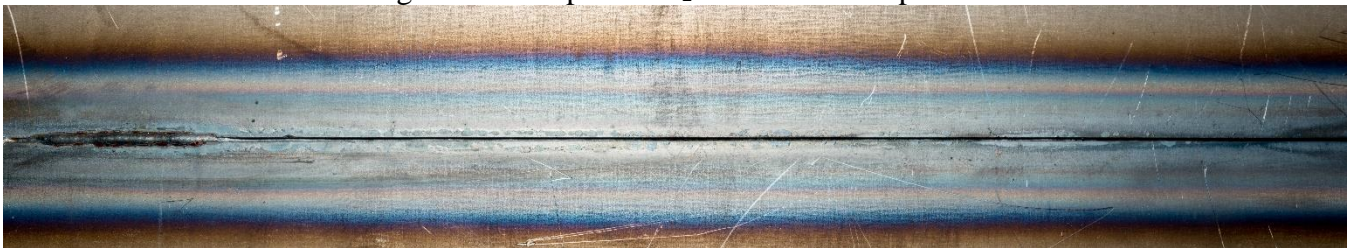
Figure 2 – Sample 1 CO₂ Cover Gas - Root Side

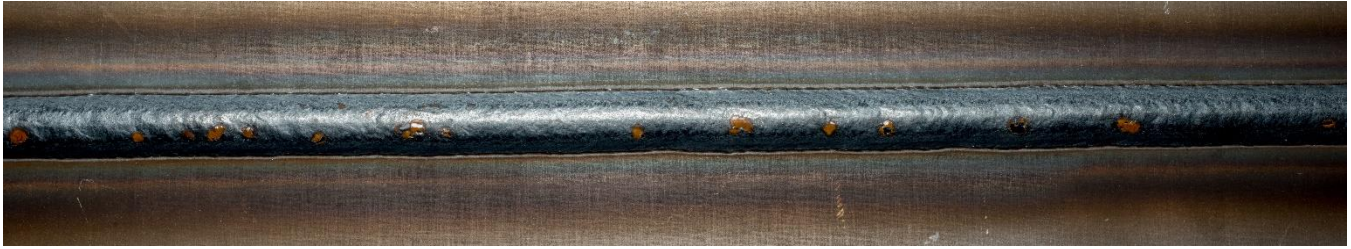
Figure 3 – Sample 2 Top Side

The weld from Sample 2 is shown in Figures 3 and 4. There were no locations where the weld penetrated to the root. The cover gas used was not specified.

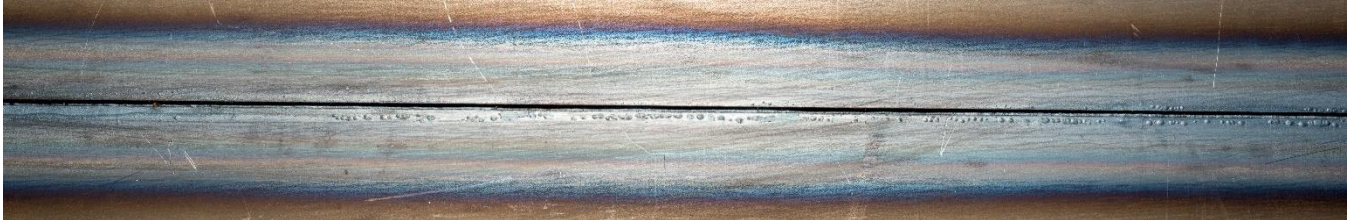
Figure 4 – Sample 2 Root Pass

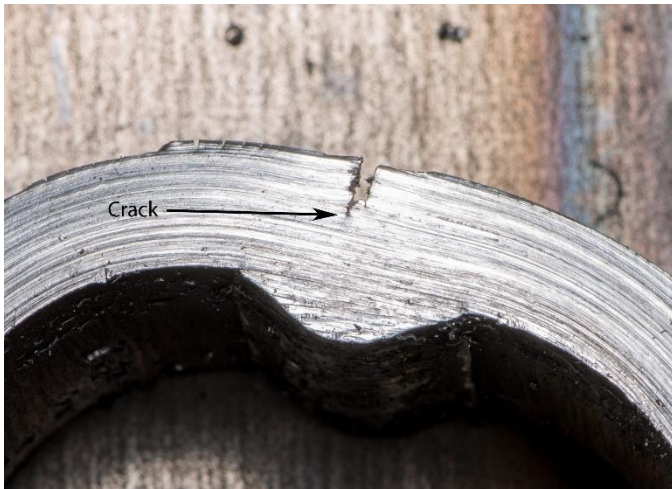
Figure 5 – Sample 1 Bend Test 1

Figure 5 shows a crack that developed in the root of Bend Test 1. This sample was taken from an area where the weld had not penetrated to the root. Figure 6 shows Bend Test 2. There was a small crack near the location where full penetration had occurred.

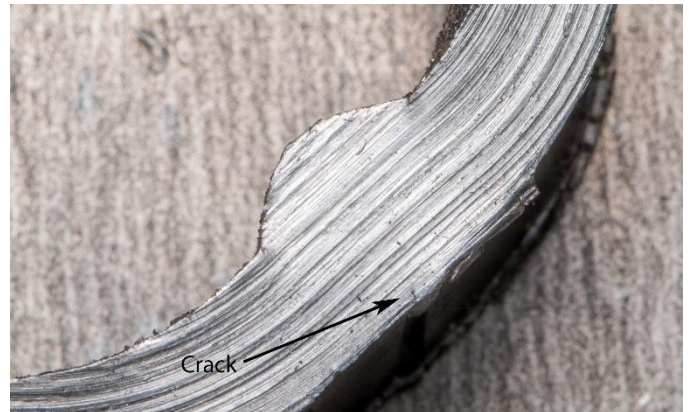
Figure 6 – Sample 1 Bend Test 2

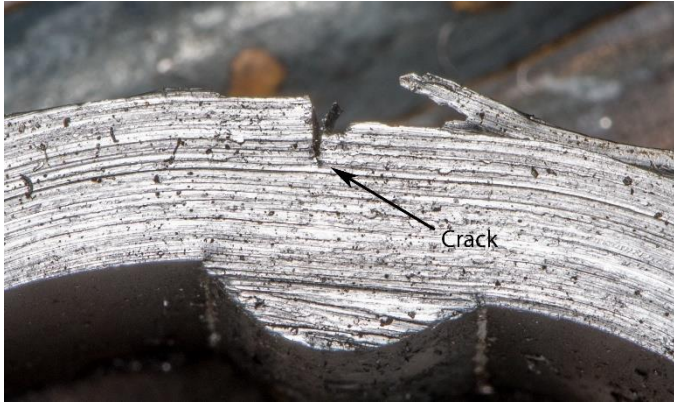
Figure 7 – Sample 2 Bend Test 1

Figure 7 shows a fine crack that developed at the root of the weld from Sample 2, Bend Test 1. Figure 8 shows lack of fusion at the root of the weld in Bend Test 2.

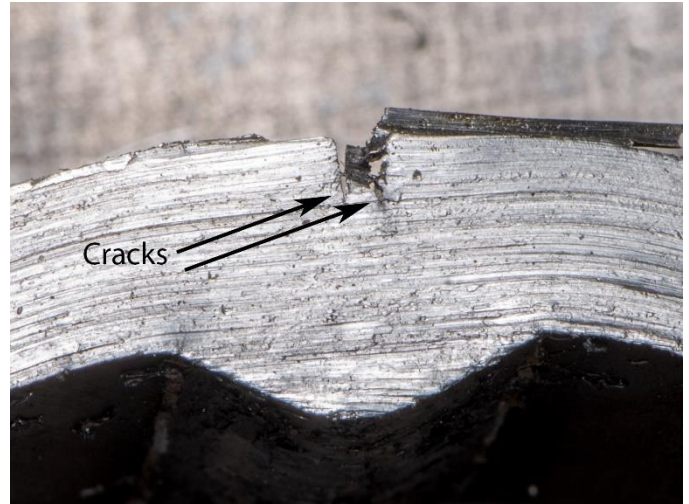
Figure 8 – Sample 2 Bend Test 2

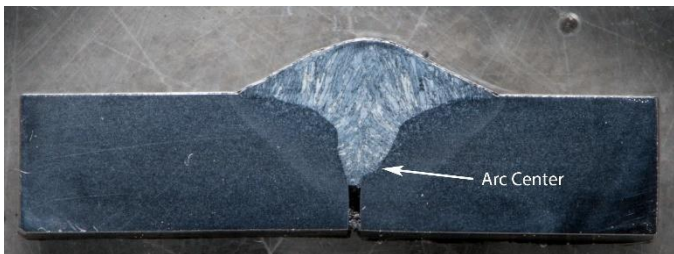
Figure 9 – Macro of Weld – Sample 1

Figure 9 shows the etched weld from Sample 1. The weld arc was not centered on the spacing between the two $\frac{1}{4}$ inch plates.

The lack of centering of the weld arc was the cause of failure of these two welds.

- 1) The weld arc must be centered on the center line between the two plates to avoid lack of fusion in the weld root.
- 2) Robotic welders require very precise setup to produce quality welds.

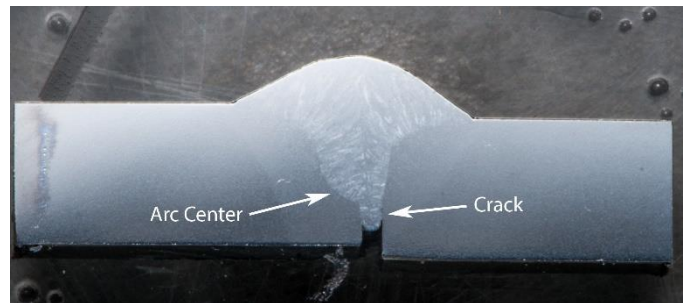
Figure 10 – Macro of Weld – Sample 2

Figure 10 shows the etched weld from Sample 2. The weld arc was not centered on the spacing between the two $\frac{1}{4}$ inch plates, resulting in a visible crack at the root of the weld.

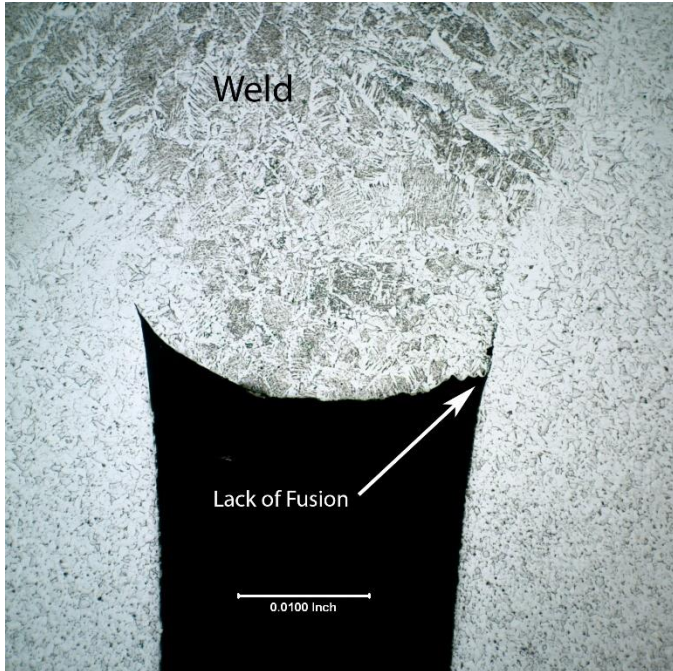
Figure 11 – 100X Lack of Fusion in Weld Root – Sample 1

The weld root in Sample 1 is shown in Figure 11. There was lack of fusion on the right side. The lack of fusion was caused by the off-centering of the welding arc. The plate heat affected zone, HAZ, is shown in Figure 12. The microstructure of the HAZ is a mixture of ferrite and acicular ferrite, which is excellent for the grade of steel used. There was no evidence of excessive grain growth and no evidence that “Carburization” had any effect on the weld quality.

Lack of fusion is not permitted for partial penetration welds under AWS D1.1.

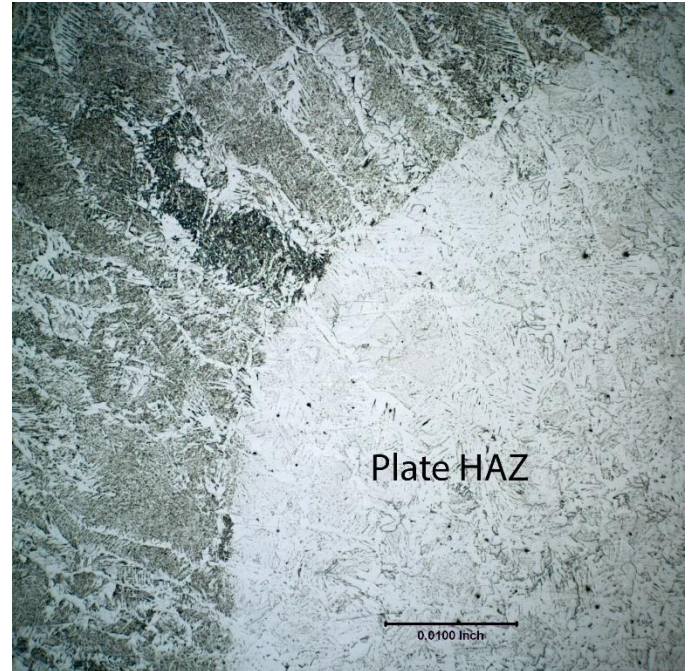
Figure 12 – 100X Plate HAZ

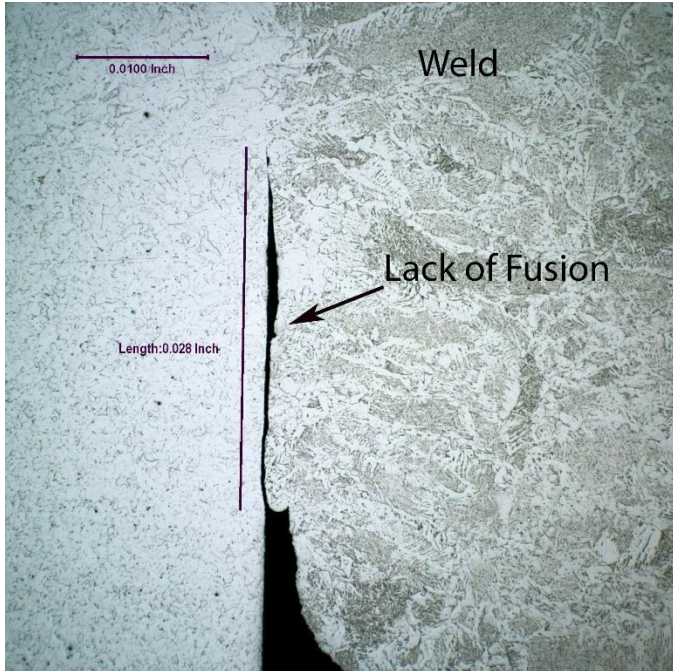
Figure 13 – 100X Lack of Fusion in Weld Root – Sample 2

There was a significant amount of lack of fusion at the root of Weld Sample 2, Figure 13. The lack of fusion was the result of the weld arc not being centered on the spacing between the $\frac{1}{4}$ inch plates. The amount of the lack of fusion shown would likely result in eventual failure of the part. The plate HAZ is shown in Figure 14. The microstructure of the HAZ was a mixture of ferrite and acicular ferrite, which is excellent. There was no evidence of excessive grain size.

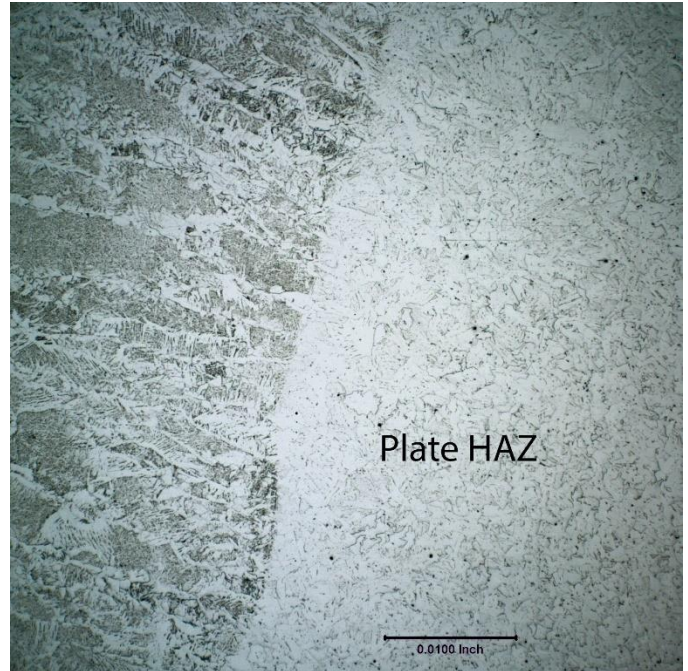
Figure 14 – 100X Plate HAZ – Sample 2
