M. E. Williams and Associates, Inc.

Case Study: Residential Sprinkler Head Failure

Merlin E. Williams, P.E.

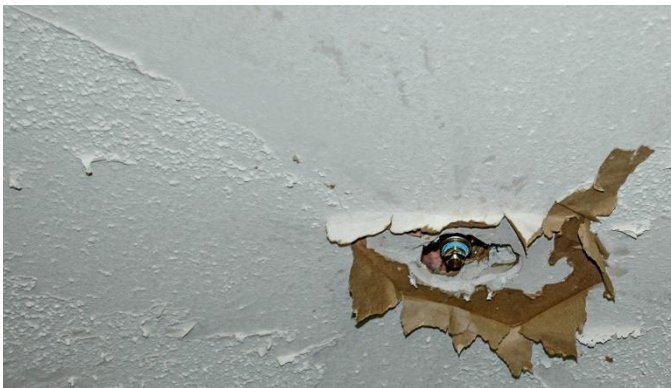
Figure 1 – Location of Failed Sprinkler

Figure 1 shows the location of the failed sprinkler. It was in the center of the living room. The plug in the sprinkler and the end of the piping is shown in Figure 2.

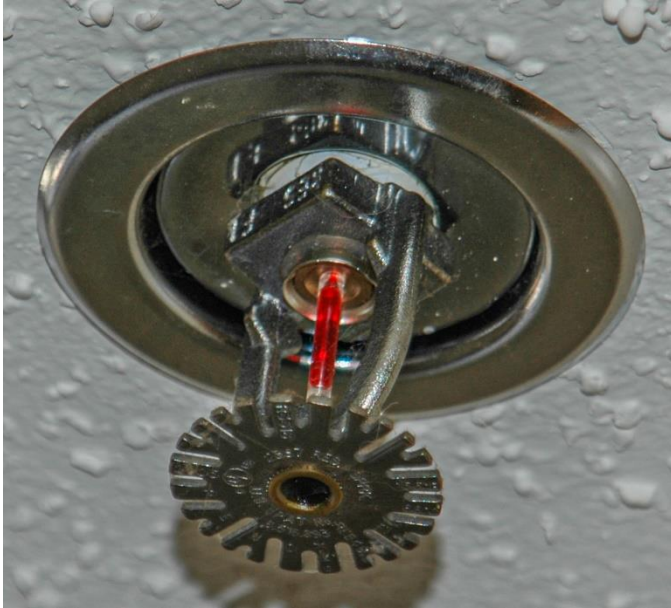
Figure 3 – Hallway Sprinkler

The hallway sprinkler head is shown in Figure 3. There were a few paint splatters and dirt on this sprinkler head. The laundry room sprinkler head had paint, corrosion, and a significant amount of dirt on it, Figure 4. The sprinkler head manufacturer maintenance bulletin has the following statement: *Sprinklers should be inspected quarterly, and the sprinkler system maintained in accordance with NFPA 25, 13, 13D, and 13R. Do not clean sprinkler with soap and water, Ammonia or any other cleaning fluids. Remove dust by using a soft brush or gentle vacuuming. Remove any sprinkler which has been painted (other than factory applied) or damaged in any way. A stock of spare sprinklers should be maintained to allow quick replacement of damaged or operated sprinklers. Prior to installation, sprinklers should remain in the original cartons and packaging until used. This will minimize the potential for damage to sprinklers that could cause improper operation or non-operation.*

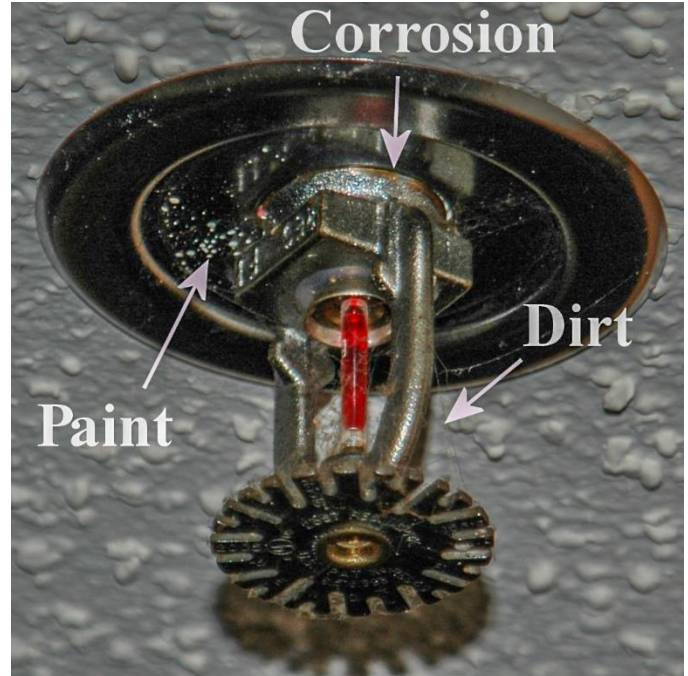
Figure 4 – Laundry Room Sprinkler

Based on the manufacturer's recommendations and NFPA 25 statements, the sprinkler in this rental unit had not been maintained properly.

5.2.1.1.2 *Any sprinkler shall be replaced that has signs of leakage; is painted, corroded, damaged, or loaded; or in the improper orientation.*

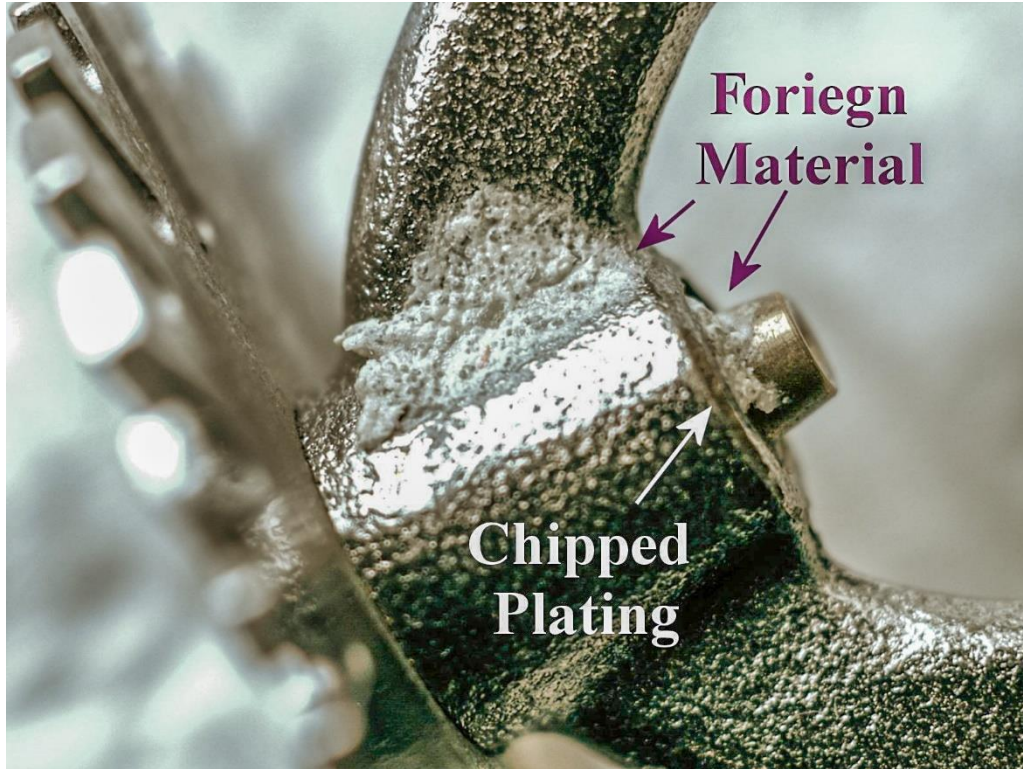
Figure 5 – Foreign Material on Failed Sprinkler Head

The failed sprinkler head is shown in Figure 5. The electroplating on the head was chipped and there was foreign material present. This area was examined with the scanning electron microscope and x-ray dispersive analysis to determine the identity of the foreign material.

The sprinkler head should have been replaced after being contaminated by texturing material, or during any of the subsequent inspections and cleanings that were supposed to have taken place. The cause of this failure was failure to follow sprinkler head manufacturer’s inspection and maintenance procedures.

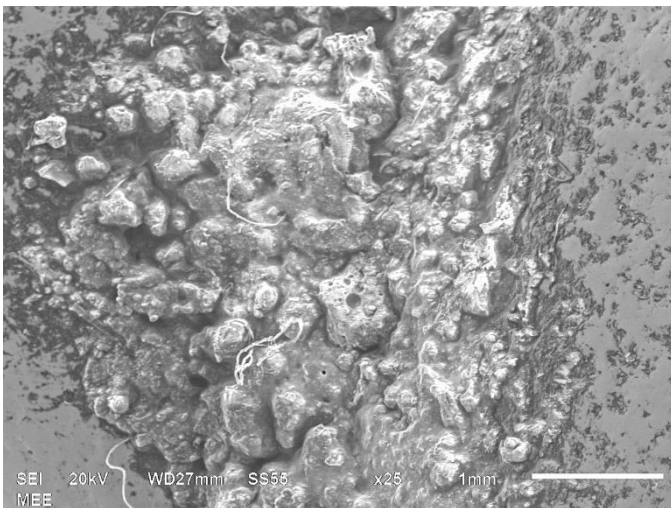
Figure 6 – Foreign Material on Failed Sprinkler Head

Figures 6 and 7 show the foreign material that was on the failed sprinkler head. These two photos show the area in more detail than is shown in Figure 5. In Figure 6, the foreign material appears to contain a crystalline substance. Figure 7 shows the area where the plating was chipped. The chipping of the plating

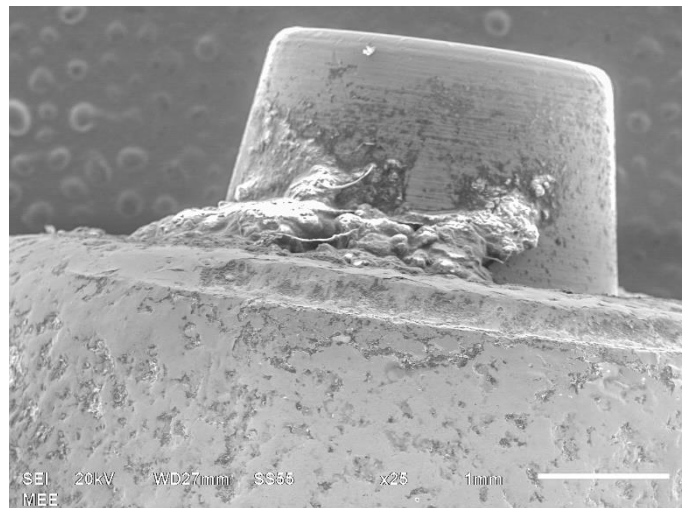
Figure 7 – Foreign Material on Failed Sprinkler Head

could have occurred during installation of the sprinkler head. The dark material in Figure 7 is also foreign material, therefore, the deposit of the foreign material occurred after the plating was chipped from the sprinkler head.

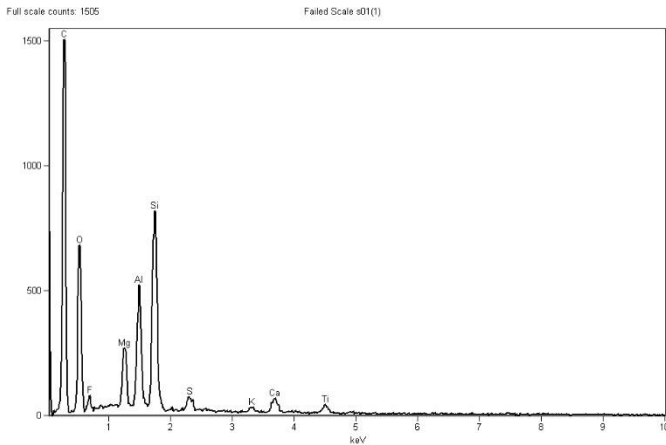
Figure 8 – Spectrum of Foreign Material Figure 6

The energy dispersive x-ray spectra shown in Figures 8, 9, and 10, compares the ceiling texturing, Figure 10, with the foreign material found on the sprinkler head. The texturing contains magnesium, aluminum, silicon, potassium, and calcium. The foreign material found has basically the same elements present. The foreign material on the failed sprinkler head is most likely texturing material from the original ceiling texturing done in the apartment. There is also evidence that an attempt was made to clean the texturing off the head after it was applied. The silicon material in the texturing is likely as hard or harder than the glass in the tube. Wiping the texturing material from the tube could have scratched the glass tube, weakening it. This is the most likely cause of failure of the sprinkler head.
