Case Study: Wind Turbine Spring Failure

Merlin E. Williams, P.E.

Visual examination of a broken, zinc plated spring from a wind turbine to determine the cause of failure. The broken spring caused malfunctioning of the wind turbine. This spring failed shortly after being installed, and may have been cycled once or twice. The spring was manufactured from oil tempered spring wire, ASTM A229.

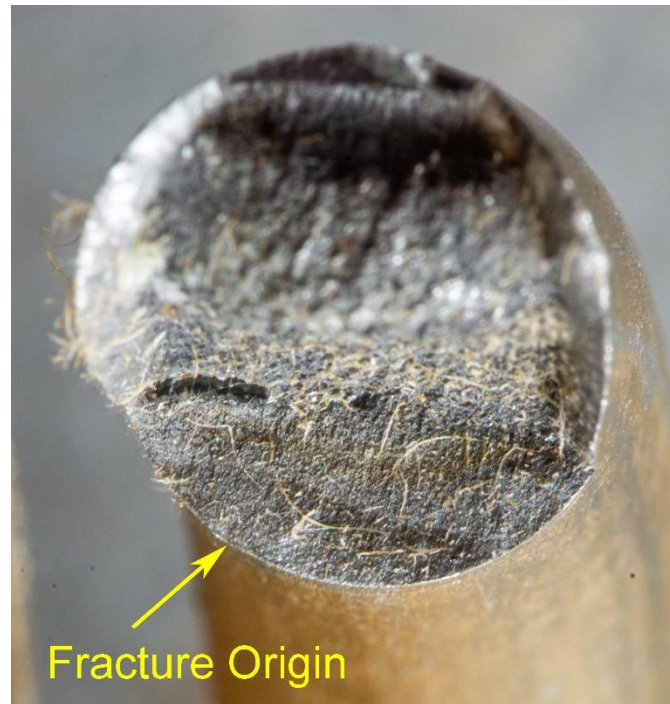
Figure 1 – Fracture Surface

Figure 1 shows the fracture surface of the broken spring. The fracture origin is indicated. There were no material defects found at the fracture origin. Only the flat fracture area is in focus in the photo, but the crystal structure of the steel is apparent. Changing the light angle shows glittering on the fracture surface. There are two fracture modes that will have glittering on the fracture surface: cleavage, and intergranular fracture. The likelihood of cleavage occurring in oil tempered spring wire is very low. The likelihood of intergranular fracture in zinc electroplated oil tempered spring wire is relatively high.

Intergranular fracture in zinc electroplated spring wire is the result of hydrogen embrittlement. To avoid hydrogen embrittlement after electroplating oil tempered spring wire, it is necessary to bake the plated spring wire at 395° F. +/- 5° within four hours of plating. Minimum baking time is eight hours. Because high carbon steel is used for oil tempered spring wire, baking temperatures exceeding 400° F. will form methane in a reaction between carbon in the steel and hydrogen from the plating process. This causes methane embrittlement, which is identical to hydrogen embrittlement.

The most likely cause of the failure of this spring was hydrogen embrittlement.

Existing plated springs can be tested for hydrogen embrittlement by stressing them at 80% of yield strength for a week. Any springs that do not break during that time can be assumed to have very low levels of hydrogen, and will not likely break in use. This test is not an absolute guarantee, however.
