M. E. Williams and Associates, Inc.

Case Study – Brass Fitting Failure

Introduction

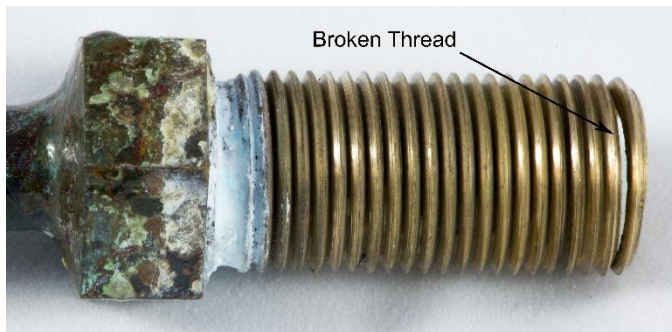
Figure 1 – Broken Fitting 1

Broken Fitting 1 is shown in Figure 1. This fitting broke in the first thread. Figure 2 shows Fitting 1 after sectioning for metallographic examination. The thin sliver of material in the lower right was used for scanning electron microscopic examination and energy dispersive x-ray analysis.

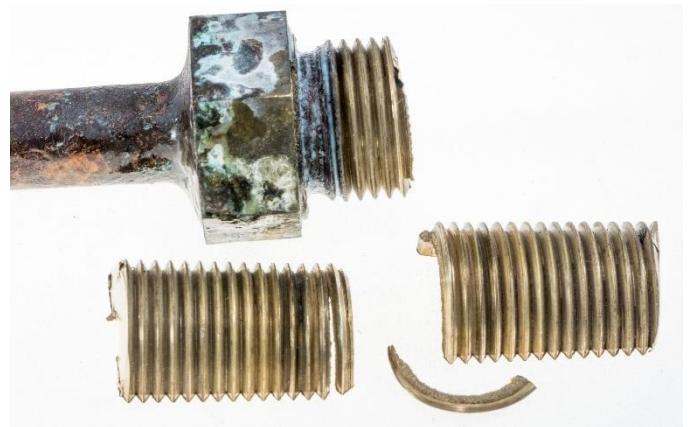
Figure 2 – Fitting 1 after Sectioning

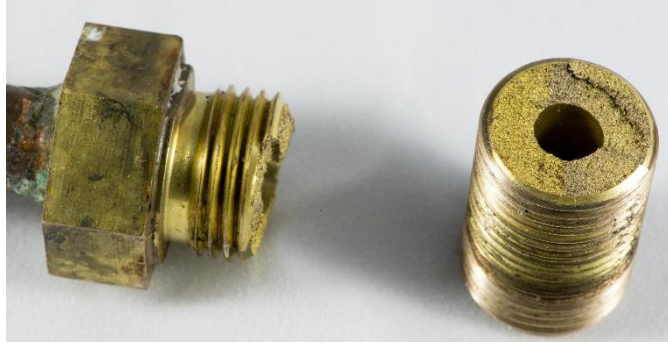
Broken Fitting 2 is shown in Figure 3. The only tests done on Fitting 2 were scanning electron microscopic examination and energy dispersive x-ray analysis.

Visual examination showed that the fracture characteristics of the two fittings were different.

Figure 3 – Broken Fitting 2

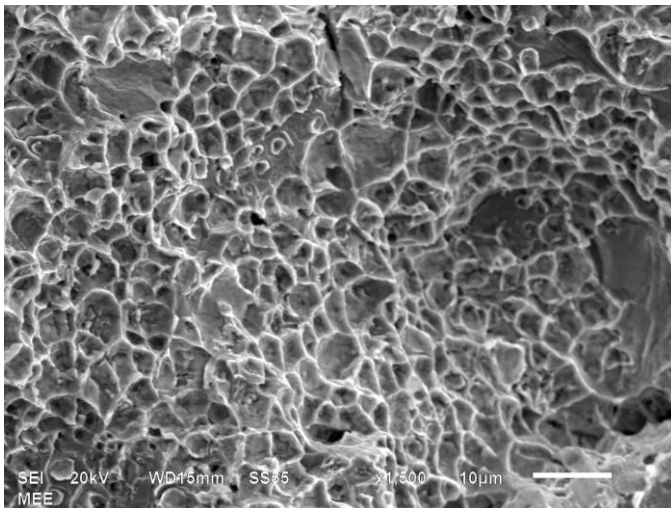
Figure 4 – 1500X Fracture Surface of Fitting 1

Figures 4 and 5 show the fracture surface of Fitting 1. The fracture mode is ductile rupture, which means the fitting failed in the ductile fracture mode at stress levels exceeding the tensile strength of the brass.

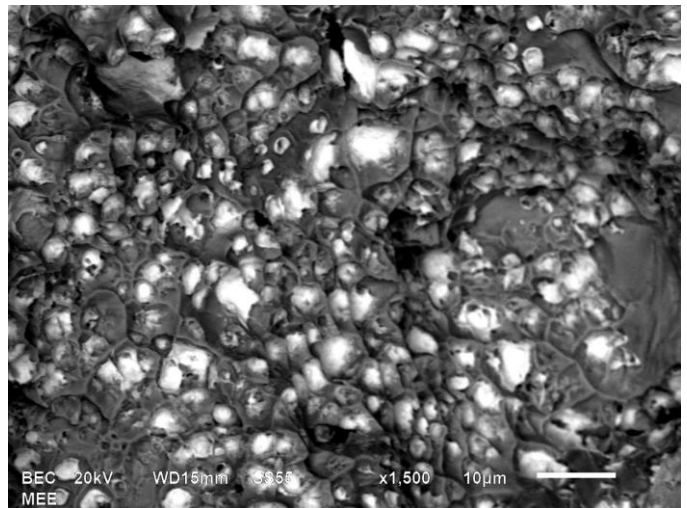
Figure 5 – 1500X Fracture Surface of Fitting 1 – Backscatter Mode

Figure 5 shows the same area as shown in Figure 4, but in backscatter mode. In backscatter mode the higher atomic number elements show up as white. All of the white areas were found to be lead in this case.

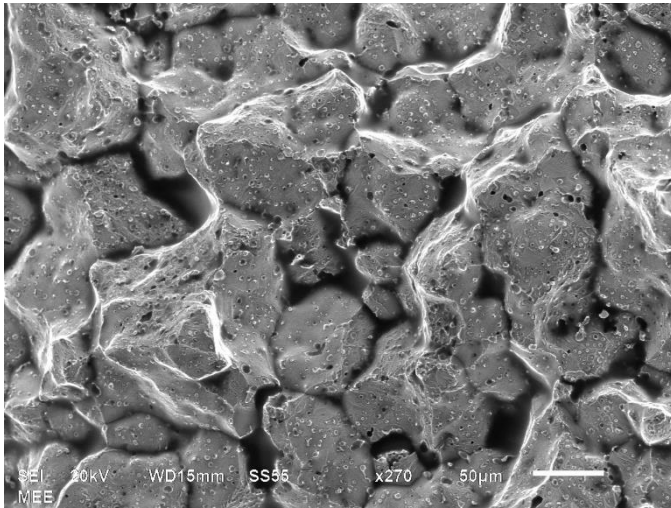
Figure 6 – 270X Fracture Surface Fitting 2

The fracture surface of Fitting 2, Figure 6, shows intergranular fracture. Intergranular fracture is a brittle fracture mode, meaning there was no ductility present. Intergranular fracture in a copper alloy is usually the result of exposure to nitrates or mercury. That does not appear to have happened in this case. The grain boundaries are covered with fine particles which are better seen in Figure 7. These particles were determined to be lead.

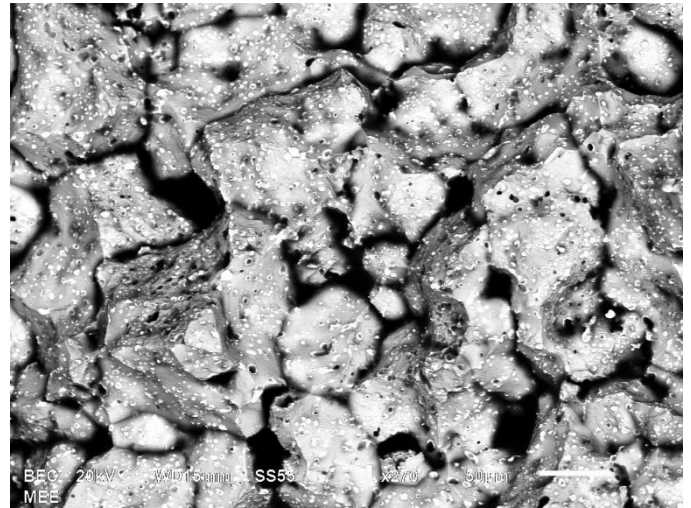
Figure 7 – 270X Fracture Surface Fitting 2 – Backscatter Mode

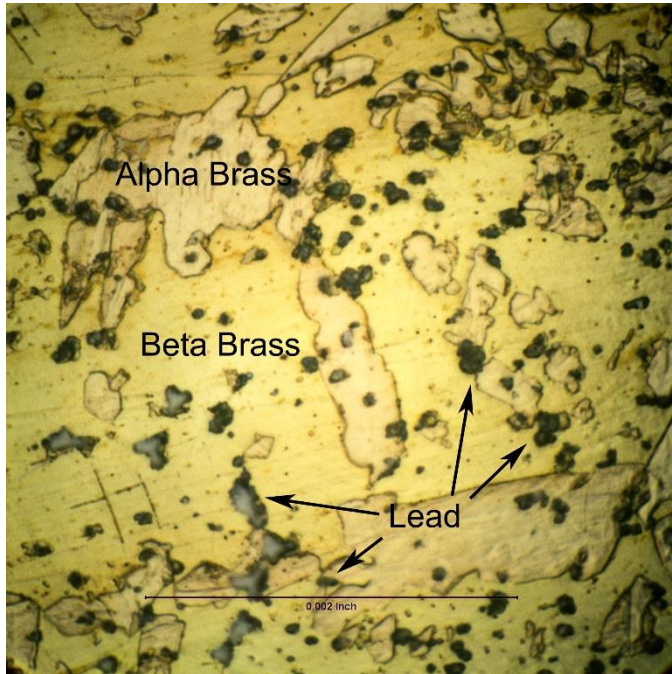
Figure 8 – 1500X Microstructure of Fitting 1

Figure 8 shows the microstructure of Fitting 1. The microstructure consists of three phase: lead, and Alpha and Beta brass, with Beta brass as the predominant phase. Beta brass has a higher zinc content of typically 50%, than Alpha brass. The high levels of Beta brass indicate that overall copper levels in the fitting were too low.

The microstructure shown in Figures 8 and 9 indicates that the fitting was a brass casting. Leaded cast brass alloys typically contain tin to provide for additional strength. These castings were free of tin. The maximum limit for lead in cast brass alloys is 5%. The copper levels are usually around 70%, tin up to 1.5%, and the balance is zinc. These castings were about 52% copper, 33% zinc, and 13% lead.

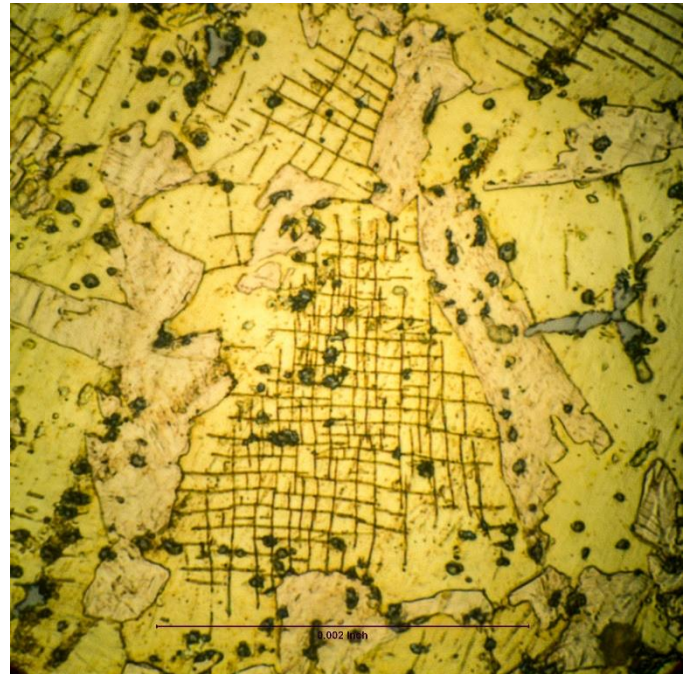
Figure 9 – 1500X Slip Plains in Beta Brass

Figure 9 shows slip plains in the Beta brass near the fracture surface. The presence of slip plains indicates that the Beta brass was stressed almost to the point of failure.
