## Case Study: Switch Contact Sticking

Merlin E. Williams, P.E.

Failure analysis of A101AS12VDC Switch to determine the cause of contact sticking during operation. The Switches were examined by visual examination, optical microscopic examination, scanning electron microscopic and EDS examination, hardness testing, and metallographic examination. A total of 9 switches were examined, but only three switches were completely tested. The results of only one switch are used in this case study.

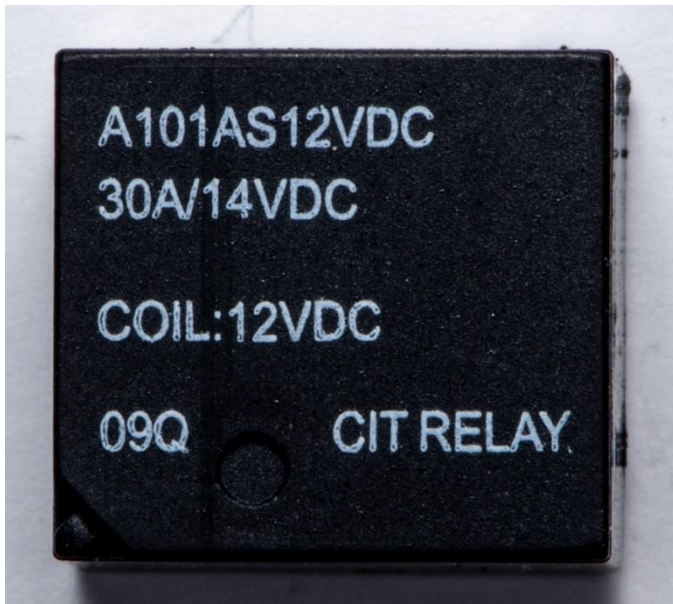
Figure 1 – Switch Package and Description

Figure 1 shows the identification cover of a switch. Switches had a date code of 09Q in the lower left-hand corner.

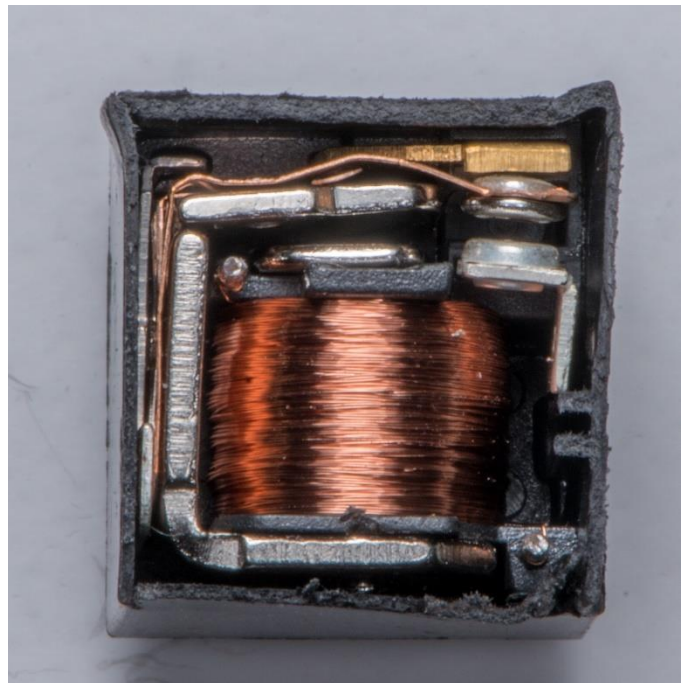
Figure 2 – Switch Cover Removed

Figure 2 shows the internal assembly of a switch. The contact spring was bent during the cover removal.

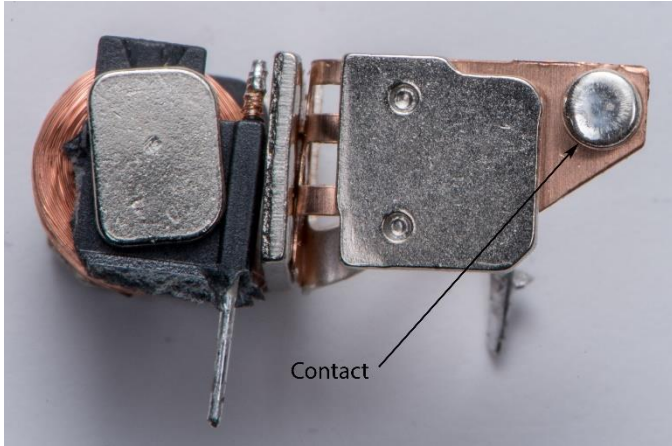
Figure 3 – Armature Contact

Figure 3 shows a switch coil and armature contact. Figure 4 shows the stator contact. The failure of the switch was caused by the bonding of the armature and stator contacts during use.

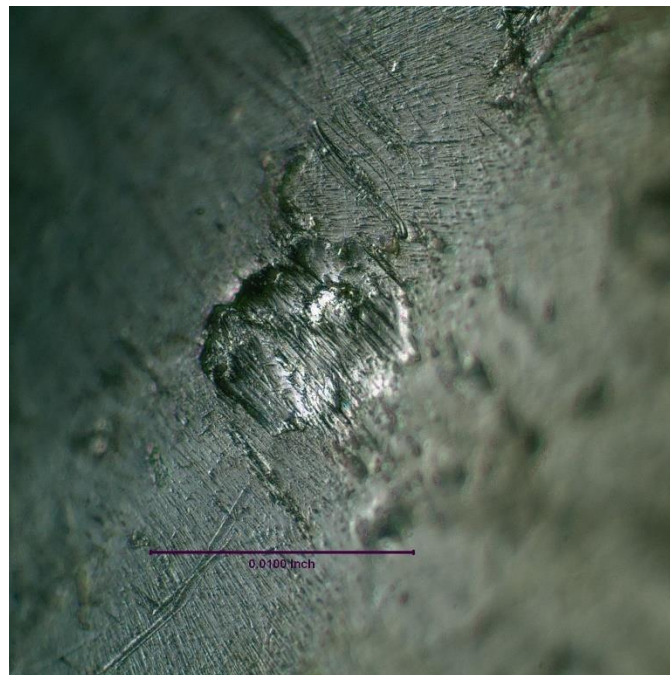
Figure 5 – 200X Contact Mark on Armature Contact of Switch

Figure 5 shows the contact point on the armature contact for the switch. Material from the stator contact was welded into the surface of this contact.

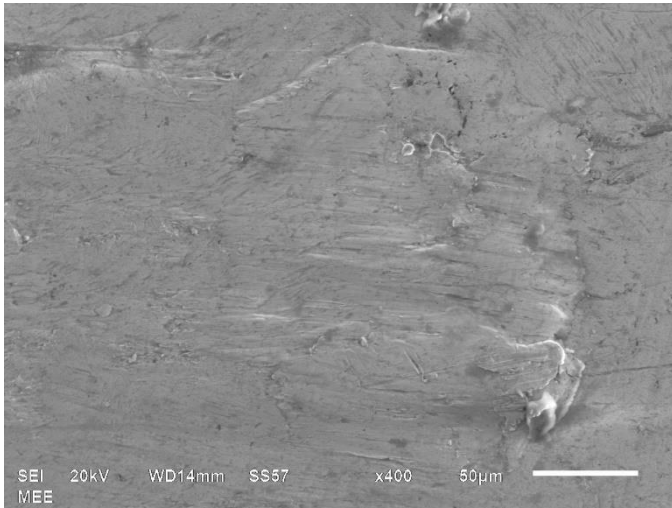
Figure 6 – 400X Armature Contact Point of Switch

Figures 6 and 7 show the armature and stator contact point of the switch. There was material imbedded in the surface of the armature contact, with the source of that material being the stator contact. The stator contact showed evidence of melting and material removal.

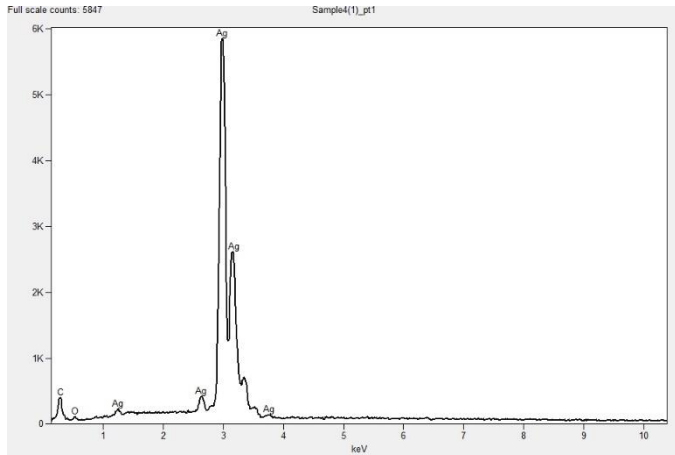
Figure 8 – Spectrum of Stator Contact of Switch

Table 1 shows the semi-quantitative analysis of the stator and armature contacts. The armature contact was a silver-tin oxide mixture, and the stator contact was silver.

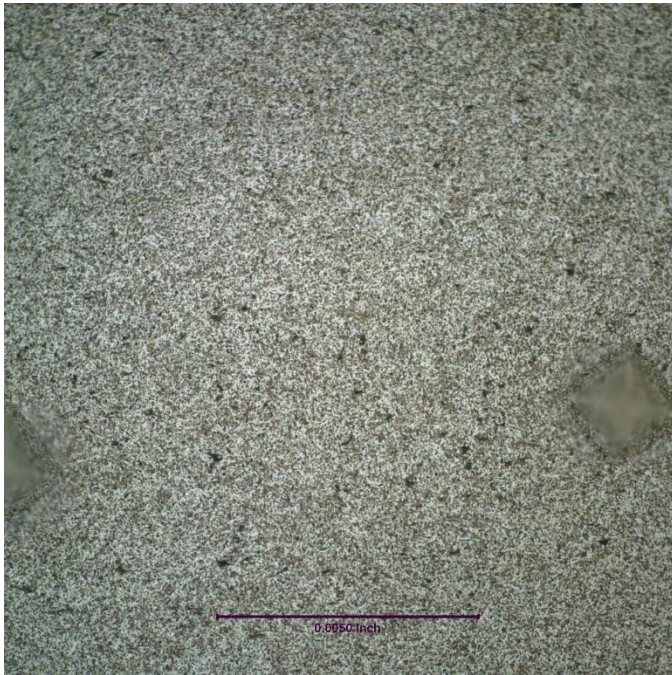
Figure 10 – 400X Microstructure of Stator Contact

Figure 10 shows the microstructure for the stator contact point shown in Figure 7.

Figure 10 shows the microstructure of the stator contact. The very fine, dark particles are tin-oxide, and the white areas are silver. The contact material is made by mixing silver and tin oxide powders and then sintering them.

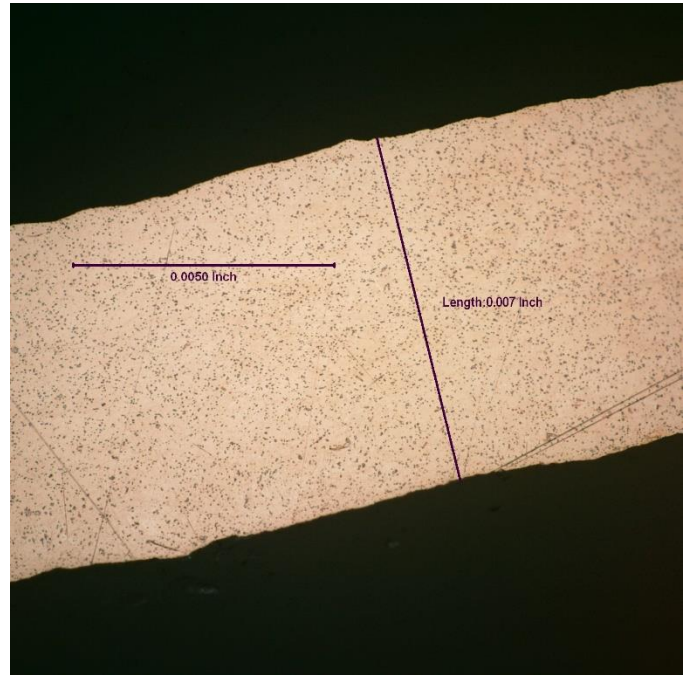
Figure 11 – 400X Microstructure of Armature Spring

The hardness of the spring material used in the armature was about 260 Vickers Hardness, which indicates that the material was a beryllium copper alloy.

Figure 11 shows the microstructure of the armature spring material. This is a typical microstructure of a heat treated beryllium-copper alloy. The thickness of the spring material was 0.007 inches, which results in a very weak spring. The force to move the contact is very low, meaning that any welding between the contact materials would prevent the switch contacts from opening.
