Case Study: Low Cycle Fatigue

Failure analysis of a Grade 8 Flange Bolt secured with a flat washer and nut to determine the cause of failure. The bolt was examined by visual examination, hardness testing, scanning electron microscopic examination, metallographic examination, and fracture mechanics.

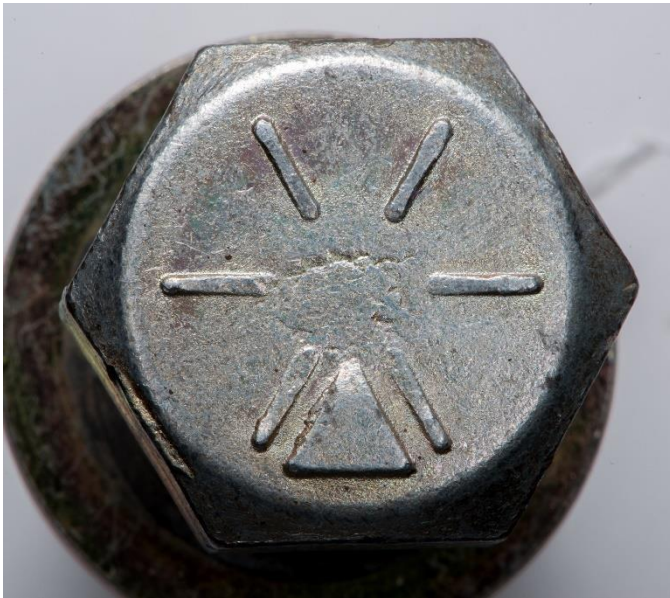
Figure 1 – Bolt Head

The bolt head, shown in Figure 1, indicates that the bolt was a Grade 8, manufactured in the United States.

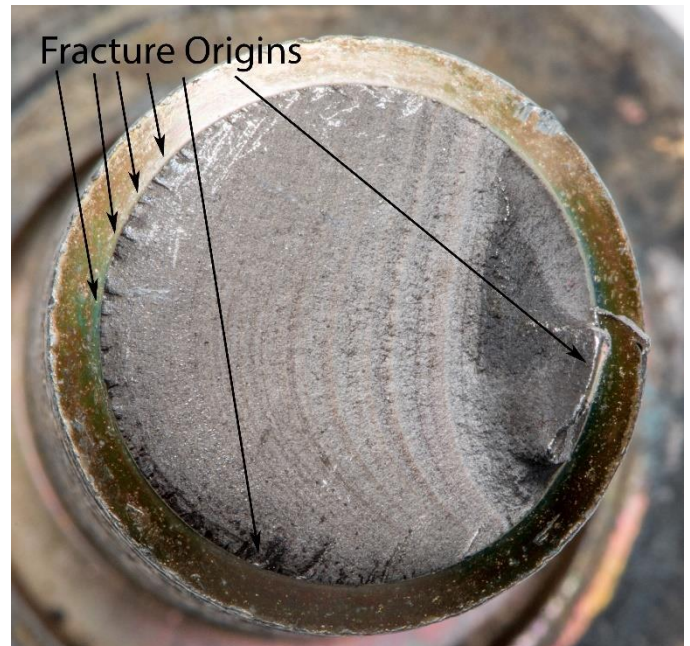
Figure 2 – Multiple Fracture Origins

Figure 2 shows at least 36 fracture origins around the circumference of the bolt. It appears that initial overloading occurred from many different directions. Multiple fracture origins are typical with fatigue fracture.

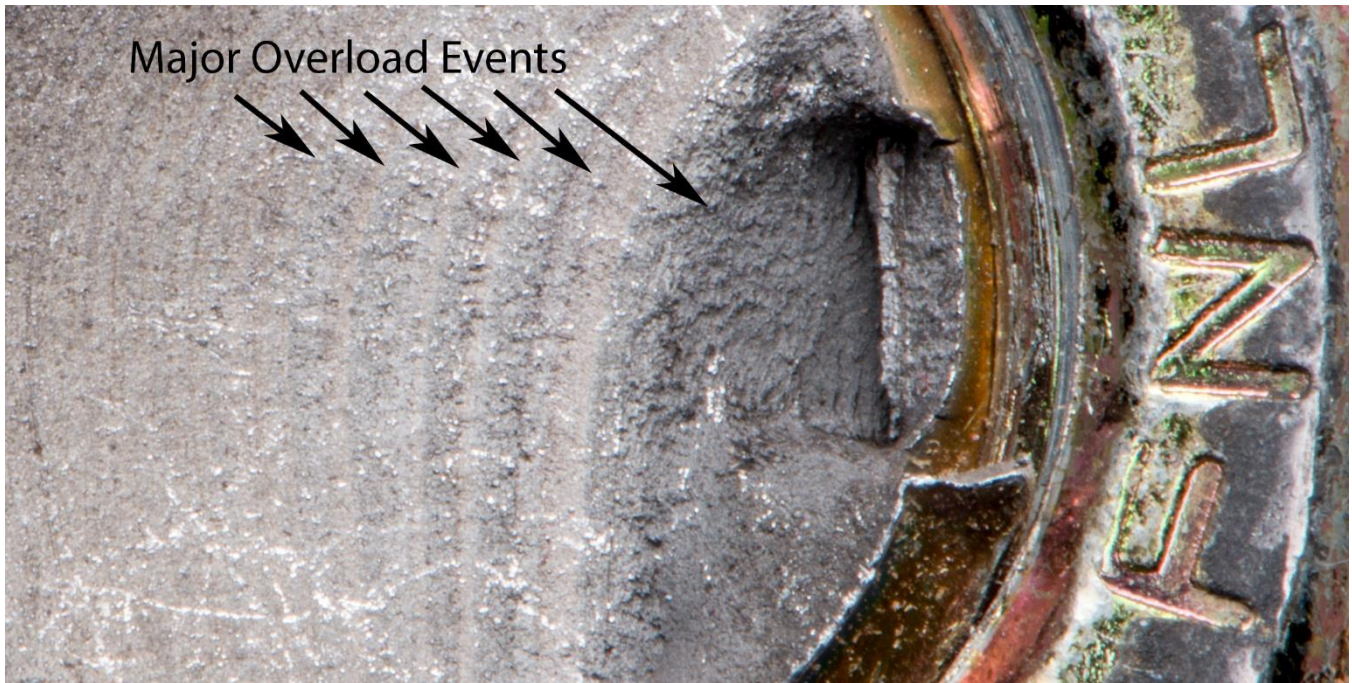
Figure 3 – Major Cyclic Overload Events

Figure 3 shows the fracture surface on the nut side of the bolt. There appears to have been over a dozen major overload events that occurred prior to the bolt failure. The actual fatigue striations are visible on the right side of the fracture surface.

Visual examination shows that the bolt failed by fatigue, with occasional very high load conditions.

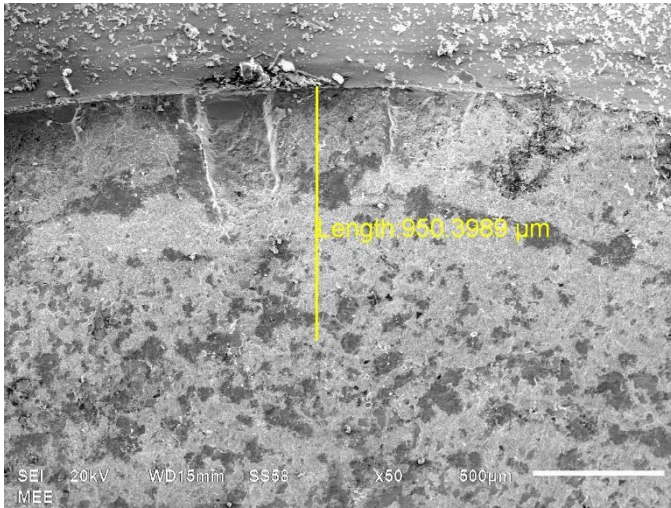
Figure 4 – 50X Fracture Surface near Fracture Origins

Figure 4 shows the fracture surface near several fracture origins. The location of this photo is on the left side of the fracture surface shown in Figure 2. The distance marking of 950.4 microns is from the fracture origin to the location of Figure 5. Figure 5 shows the fracture surface at higher magnification and shows very fine fatigue striations. The length shown in this photo is 11.95 microns. In that space there were 30 fatigue striations. The striation spacing was 1.57×10^{-5} inches, indicating low cycle fatigue. There are numerous secondary cracks or fissile fractures, shown in Figure 5. Fissile fractures occur when the cyclic load exceeds the tensile strength of the material.

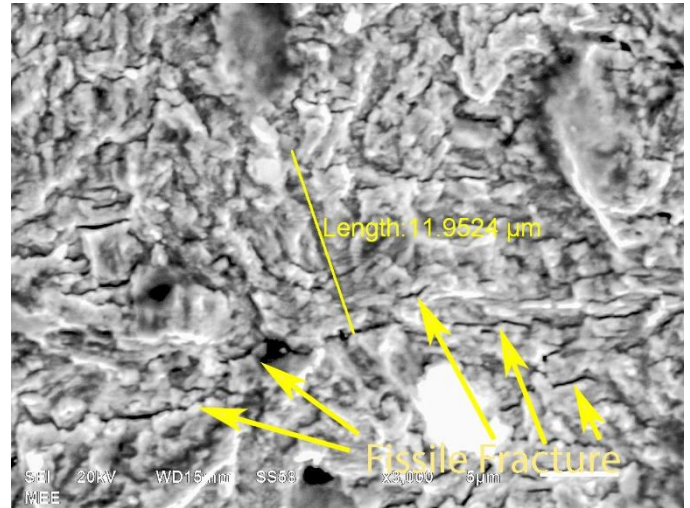
Figure 5 – 3000X Fatigue and Fissile Fracture

The estimated cyclic stress, based on the fatigue striations shown in Figure 5, was 119,000 psi. The endurance limit for this bolt was about 50,000 psi. The loading on the bolt was very close to the bolt's yield strength and exceeded the bolt's endurance limit.

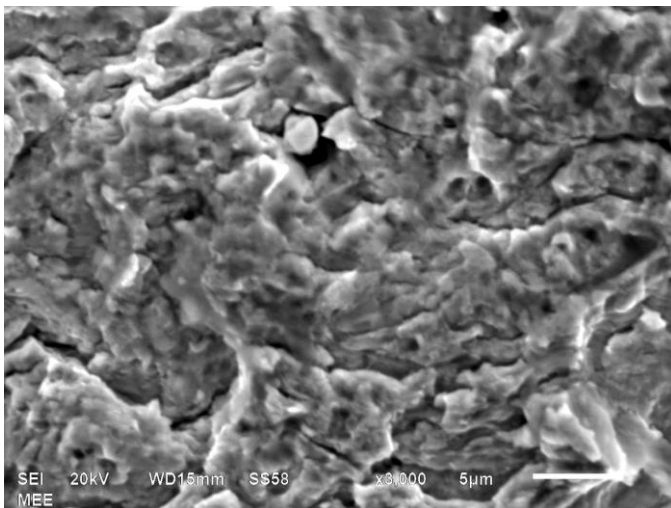
Figure 6 – 3000X Fracture Surface near Overload Band

Figure 6 shows the fracture surface near an overload band near the center of the bolt, see Figure 2. Shown in the photo is a combination of fine fatigue striations and coarser striations, plus fissile fracture.

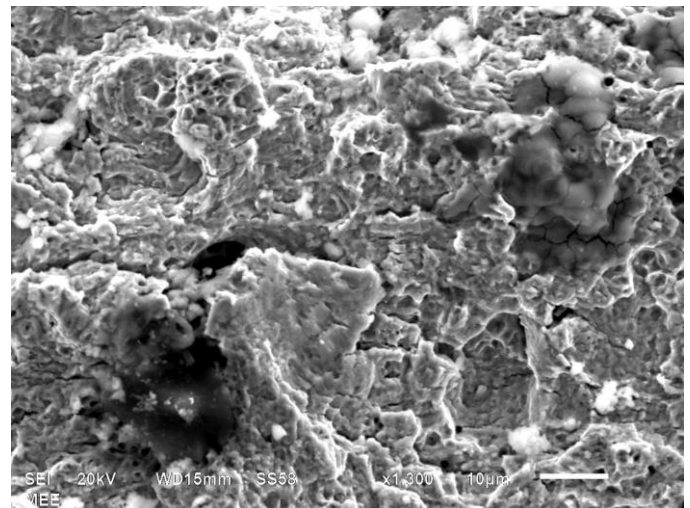
Figure 7 – 1300X Fracture Surface near Overload Band

Figure 7 shows the fracture surface in the second band from the right in Figure 2. At this location, ductile rupture is added to the fatigue and fissile fracture. The ductile rupture shown at this location is not unusual.

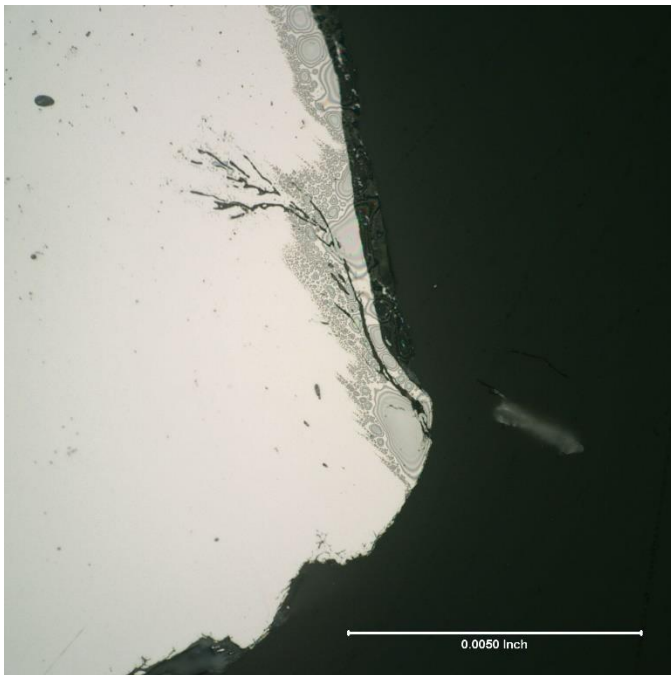
Figure 8 – 400X Rolled Thread Crest

Figure 8 shows the crest of one of the bolt threads. The cracking of the crest indicates that the threads were formed by thread rolling, which produces the most fatigue resistant bolts.

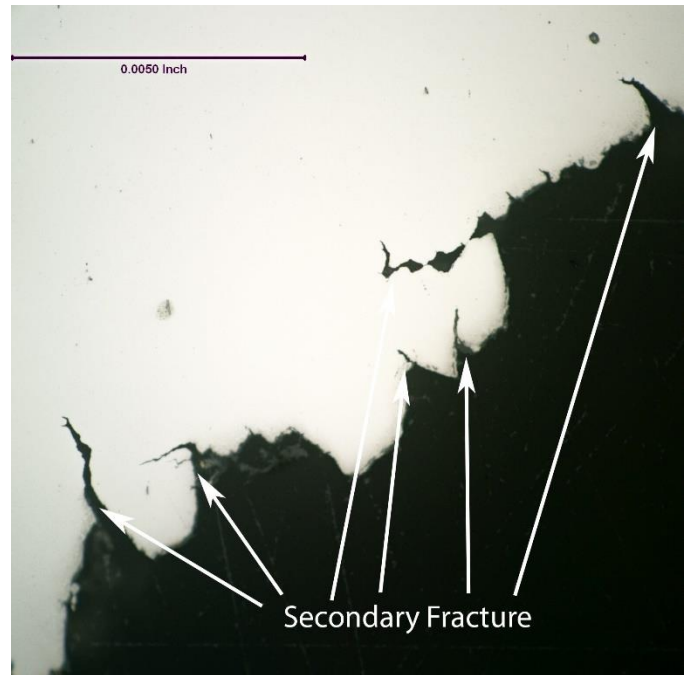
Figure 9 – 400X Fracture Surface

Figure 9 is a cross section through the fracture surface. Secondary or fissile fracturing was quite evident at this location. It appears that some of the cracking could have been intergranular, indicating impact loading.

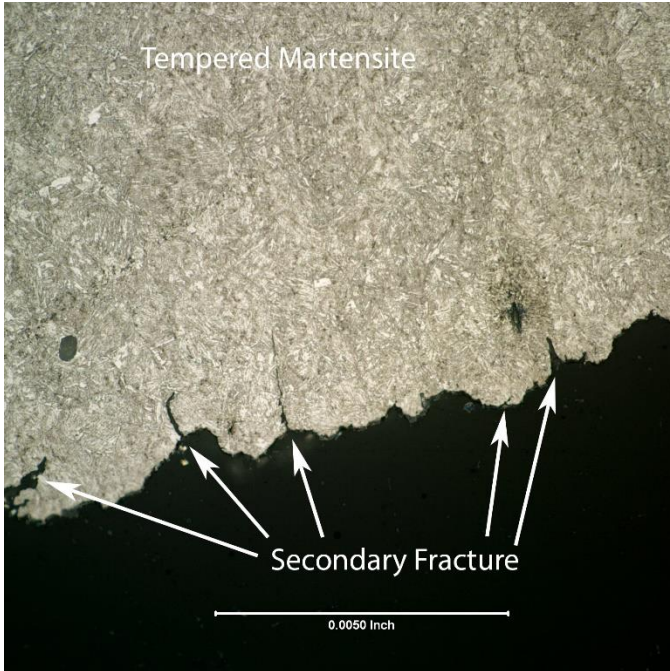
Figure 10 – 400X Microstructure Associated with the Fracture Surface

Figure 10 shows the tempered martensitic microstructure associated with the fracture surface. The microstructure was very fine grained, which increases the fatigue resistance of the bolt. There was secondary fissile fracture present.

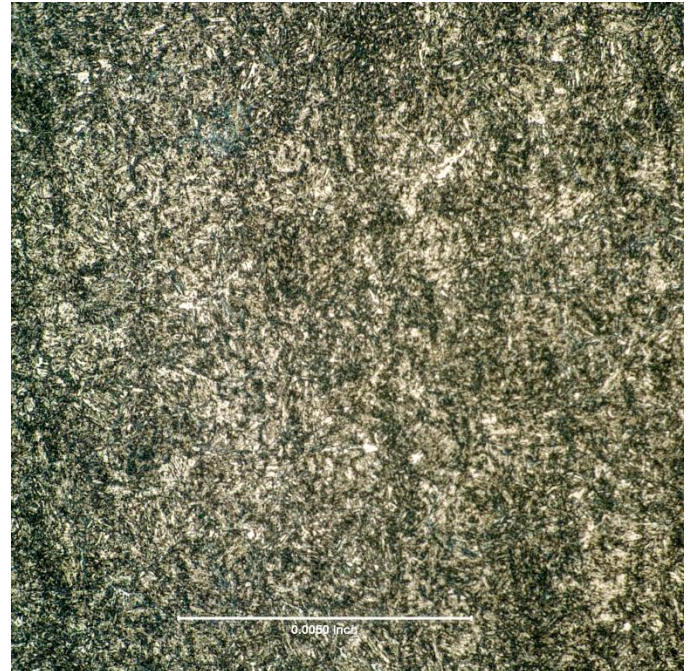
Figure 11 – 400X Core Microstructure

Figure 11 shows the very fine grained tempered martensite core microstructure. There were no microstructural defects found with the bolt.
