M. E. Williams and Associates, Inc.

Case Study: Corrosion Caused by Packaging Material

Merlin E. Williams, P.E.

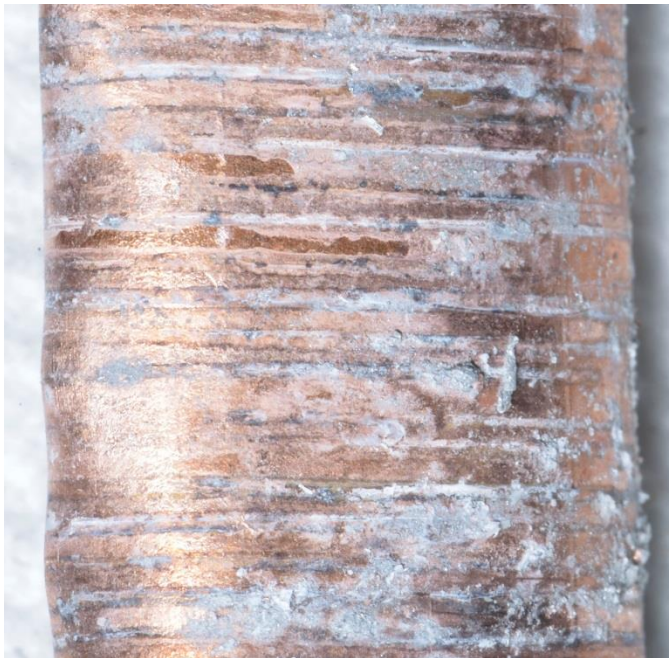
Figure 1 – Scale on Sheet Tube

Figure 1 shows a white scale deposit on a sheet tube. There was evidence of white scale on the aluminum fins associated with this tube. The white scale was forming on the interface between the aluminum fins, Figure 1, and the copper tubing. The tube was wet when it was removed from the coil. This tube was used for energy dispersive x-ray analysis.

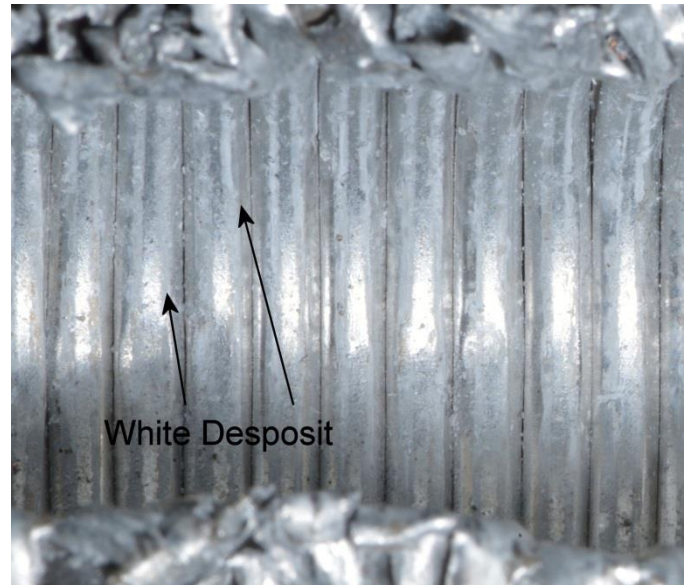
Figure 2 – Condition of Fin Associated with Tube

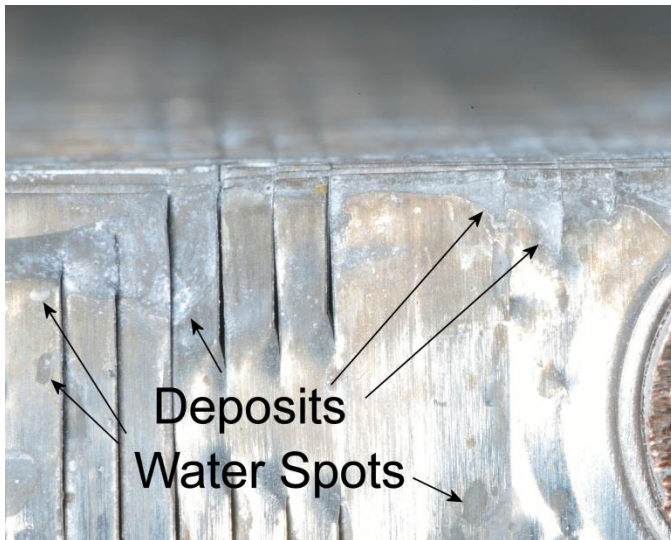
Figure 3 shows gray-white deposits on the edge of fins where they had been in contact with the galvanized drip pan. These deposits were used for the energy dispersive x-ray analysis. Figure 4 shows white crystalline material between the coil fins. This material was used for energy dispersive x-ray analysis.

Figure 3 – Deposits and Water Spots on Aluminum Fin

The semi-quantitative analysis of the gray deposits on the edge of the fin material, Figure 3, is given in Table 3. The gray deposit on the material was zinc from the galvanized drip pan or galvanized frame. The active element present was sulfur, and again, the likely source of the sulfur was cardboard packing material.

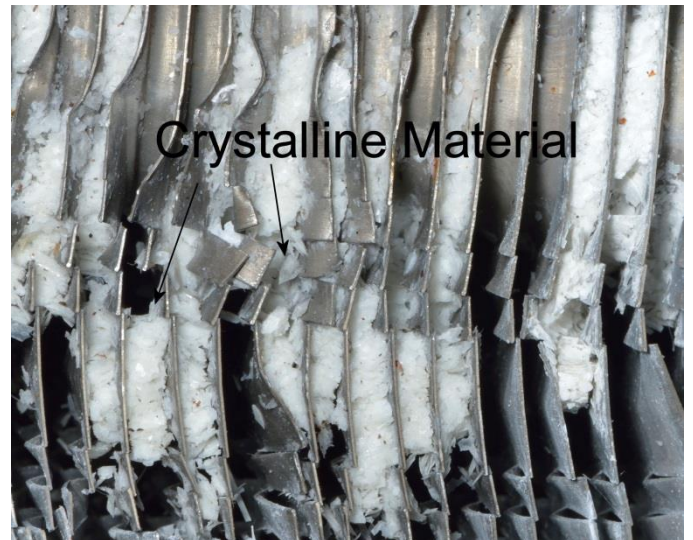
Figure 4 – White Crystalline Deposits between Fins

The semi-quantitative analysis of the crystalline material, Table 4, indicates that the powder is a mixture of aluminum and zinc oxides, and that the corrosive agent was sulfur.

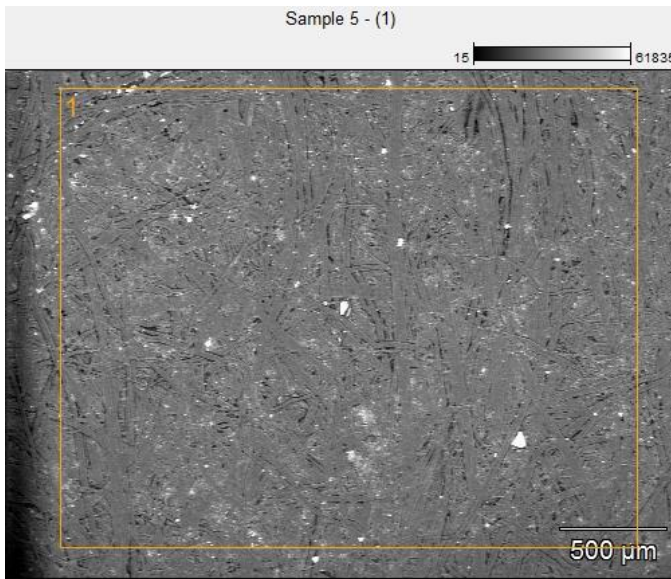
Figure 5 – Cardboard Surface that was Analyzed

The active elements found in the cardboard, Table 1, were sodium, sulfur, and chlorine. The sulfur and chlorine compounds used in the manufacturing of cardboard will form acids in the presence of water. Acid-sulfur compounds are corrosive to aluminum, copper, and zinc. Acid-chlorine compounds are corrosive to aluminum and zinc. Neutral salts of chlorine are soluble in water and are corrosive to aluminum. Soluble sodium, sulfur, and chlorine compounds are electrolytes, and will cause galvanic corrosion of dissimilar metals, such as aluminum, copper, and zinc. Wet cardboard and other paper products in contact with any active metal, such as aluminum, usually results in corrosion.

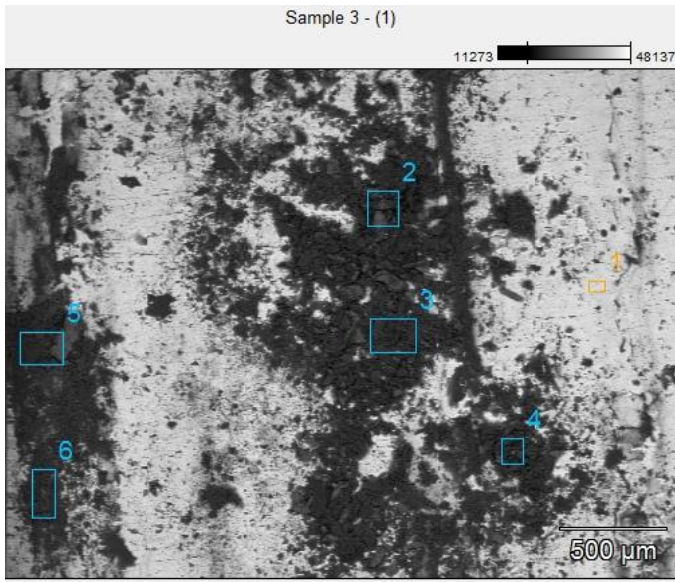
Figure 7 – Analysis Locations, Sheet Tube

Table 2 gives the semi-quantitative analysis of the sheet tube. The tube was wet when it was removed from the coil. Any dissolved ions present would have made the water conductive, resulting in corrosion of the aluminum fin material by galvanic corrosion. The energy dispersive x-ray analysis did not indicate any chlorine or sulfur. The white material on the surface of the copper sheet tube was aluminum oxide. Location 1, shown in Figure 7, was a clean spot.

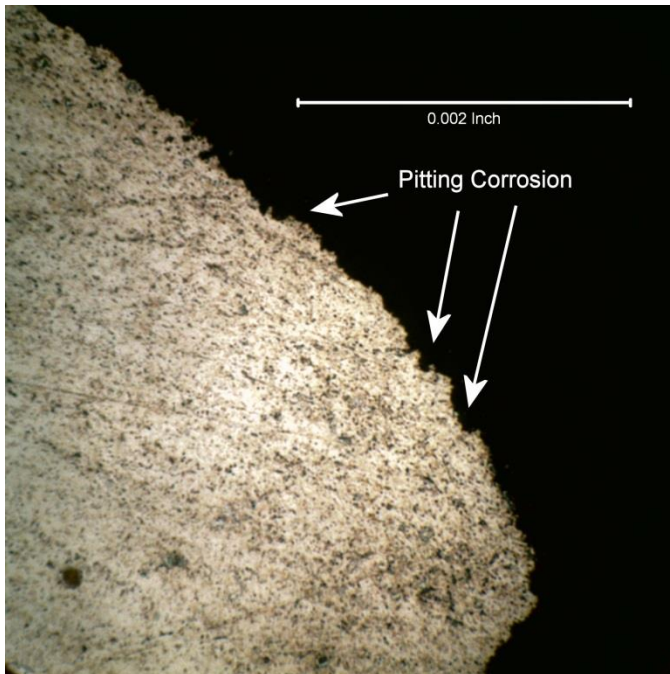
Figure 25 – 1500X Initiation of Pitting Corrosion

Figure 25 shows the initiation of pitting corrosion on the fin material. The pitting corrosion was associated with the zinc oxide and sulfur compounds on the tips of the fins, Figure 3 and Table 3. The presence of small corrosion pits would make cleaning and coating similar coils very difficult. The corrosion products need to be completely removed to insure complete coating of the fin material.

- 1) The cardboard packing material was the source of the chlorine and sulfur, Table 1. Chlorine and sulfur materials are used in the production of paper products such as cardboard. The chlorine and sulfur compounds that are used in the production of paper products are acid, and the cardboard becomes corrosive in the presence of water.
- 2) The primary agents in the corrosion of the aluminum fins, copper tubing, and galvanized framing were chlorine and sulfur compounds.
- 3) The aluminum fin material was acting as an anode to protect the copper sheet tubes.
- 4) Cleaning and coating of the coils will not likely stop or eliminate further corrosion because of the degree of corrosion associated with the interface between the copper sheet tube and the aluminum fins.
- 5) The coils showing this type of corrosion needed to be replaced.

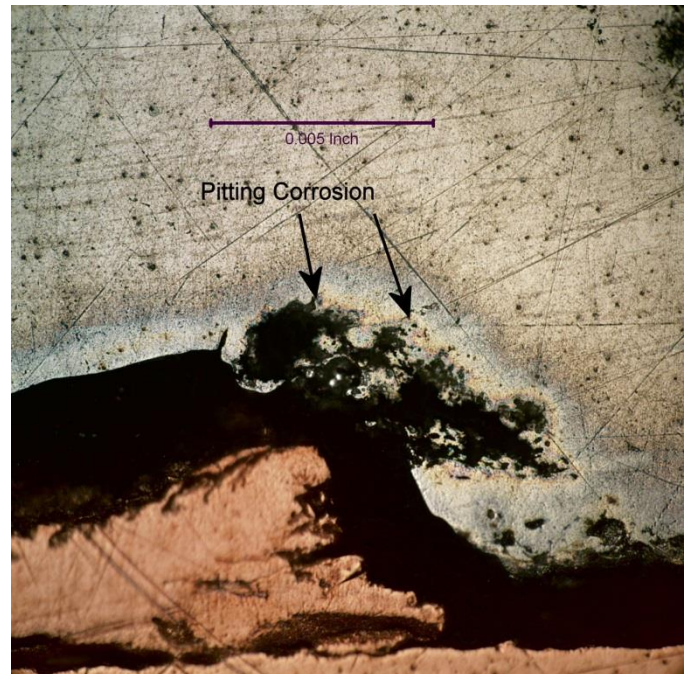
Figure 26 – 400X Initiation of Pitting Corrosion

The interface between the aluminum fins and a copper sheet tube are shown in Figure 26. At this location there is pitting corrosion of the fin material. The aluminum fin material is acting as an anode protecting the copper tubing from corrosion. Not every tube-fin interface had corrosion of the aluminum fin material. The apparent cause of most of the white powder is the anodic corrosion of the aluminum fin material. The white powder can be caused by the presence of chlorine, sulfur, and even tap water, under the right conditions.
