## Case Study: Aluminum Flatbed Trailer Failure

Merlin E. Williams, P.E.

Examination of 1996 Raven aluminum frame flatbed trailer to determine the reason for failure. The trailer was put into service in 1997. The trailer suspension separated from the frame while the driver was negotiating a turn on an Interstate off ramp. The useful life of aluminum flatbed trailers is ten to fifteen years. The trailer was over 20 years old at the time of the failure, and had been repaired once prior to the accident.

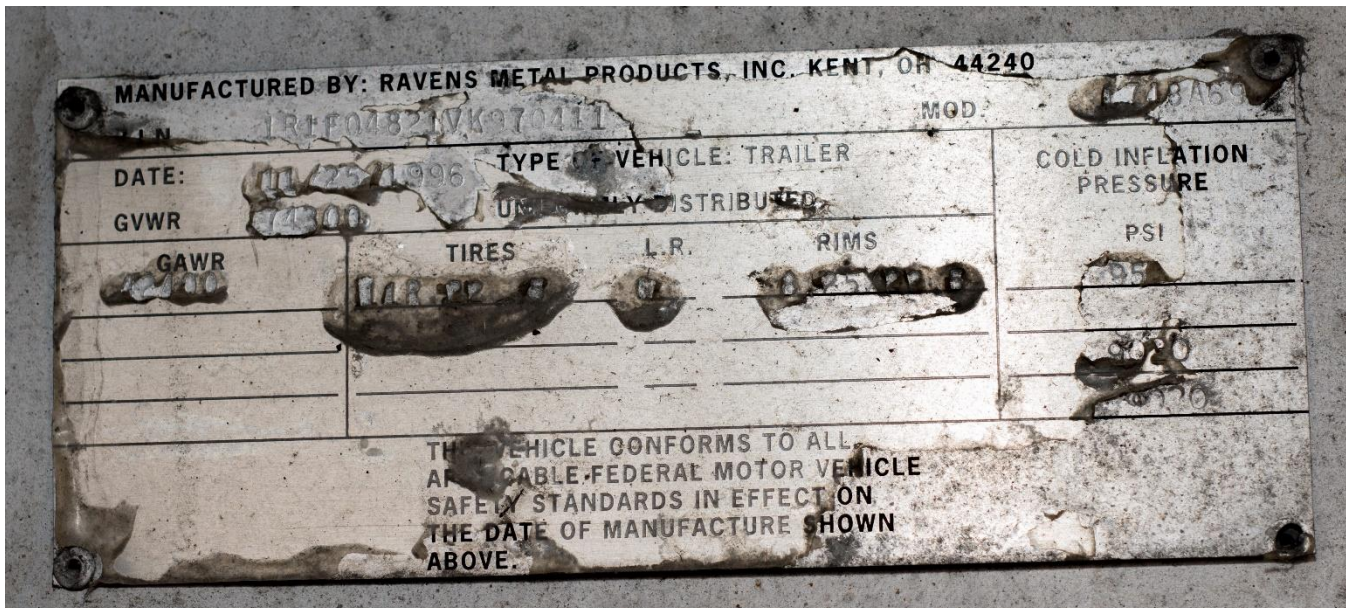
Figure 1 – Manufacturer's Identification Tag Containing Manufacturing Date

Figure 1 shows the vehicle identification tag for the trailer that was examined.

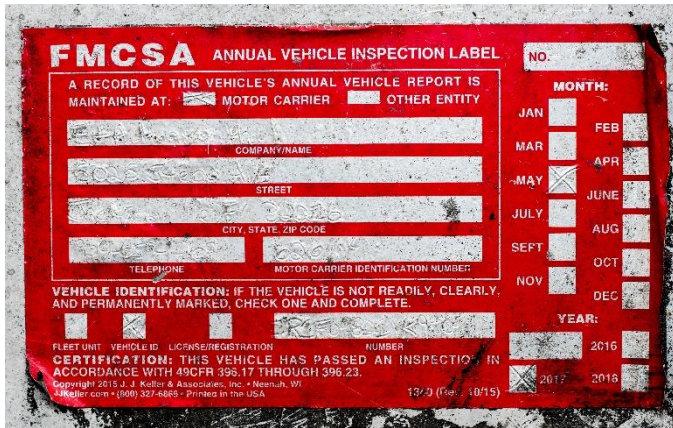
Figure 2 – Vehicle Inspection Label

The label showing the last inspection in May of 2017 is shown in Figure 2. The inspection procedure, specified as 49 CFR 396.17 through 396.23, is basically a records review of maintenance and repair and has nothing to do with the cause of failure of this trailer, although a visual inspection by the user is required every time the trailer is used.

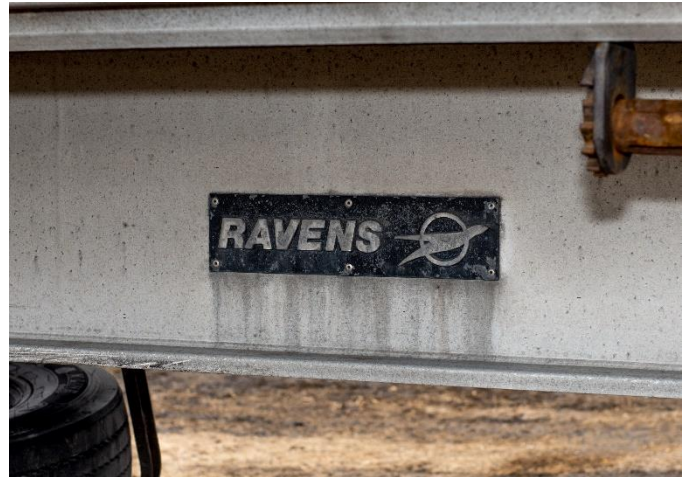
Figure 3 – Manufacturer’s Identification

Figure 3 shows the attached manufacturer’s plaque.

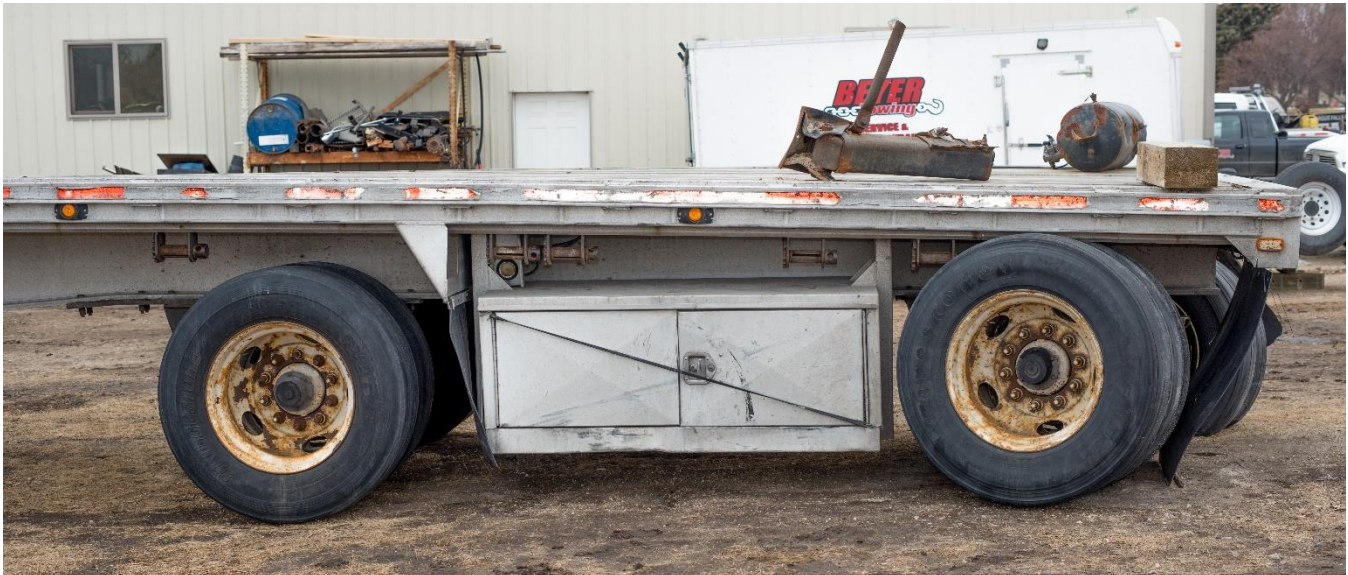
Figure 4 – Rear of Driver’s Side of Trailer

The rear of the driver’s side of the trailer is shown in Figure 4. The rear set of duals on this side appear to be distorted. Other than the distorted duals, there was no other visible damage. There was also no evidence of any repairs having been made on this side of the trailer.

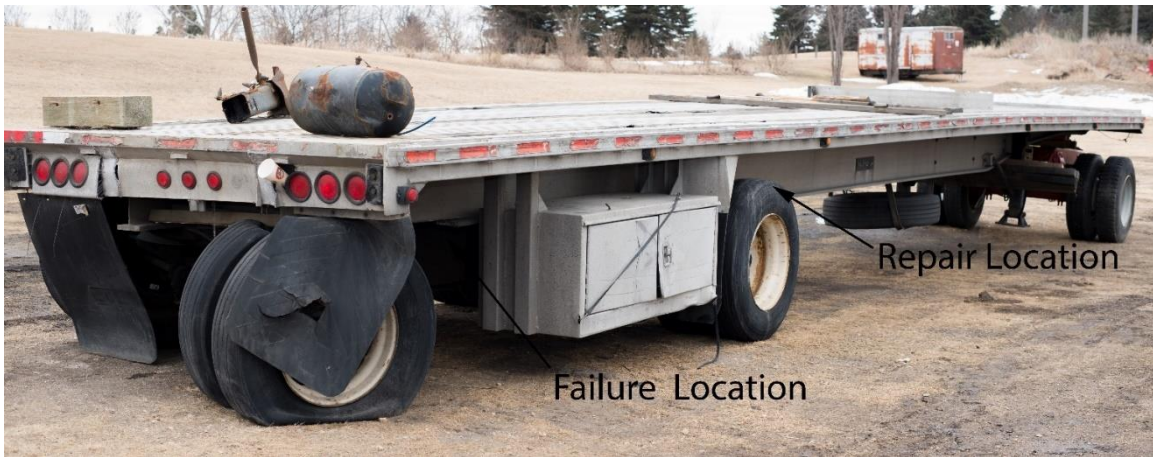
Figure 5 – Damaged Passenger Side of Trailer

Figure 5 shows the most damaged, or passenger, side of the trailer. There had been weld repairs made to the trailer frame in the area supporting the front set of duals. The rear set of duals had separated from the trailer frame.

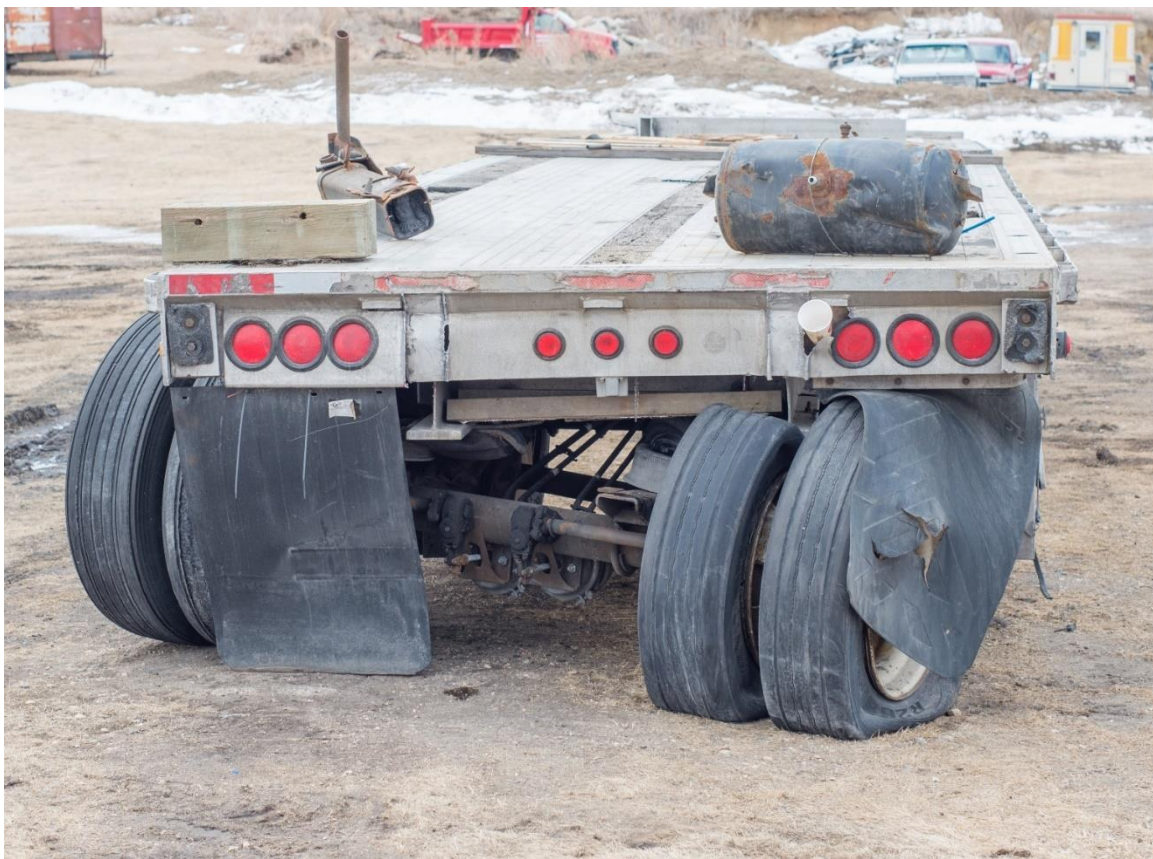
Figure 6 – Damage Shown from Rear of Trailer

The rear of the trailer is shown in Figure 6. The right side of the duals had moved to the rear.

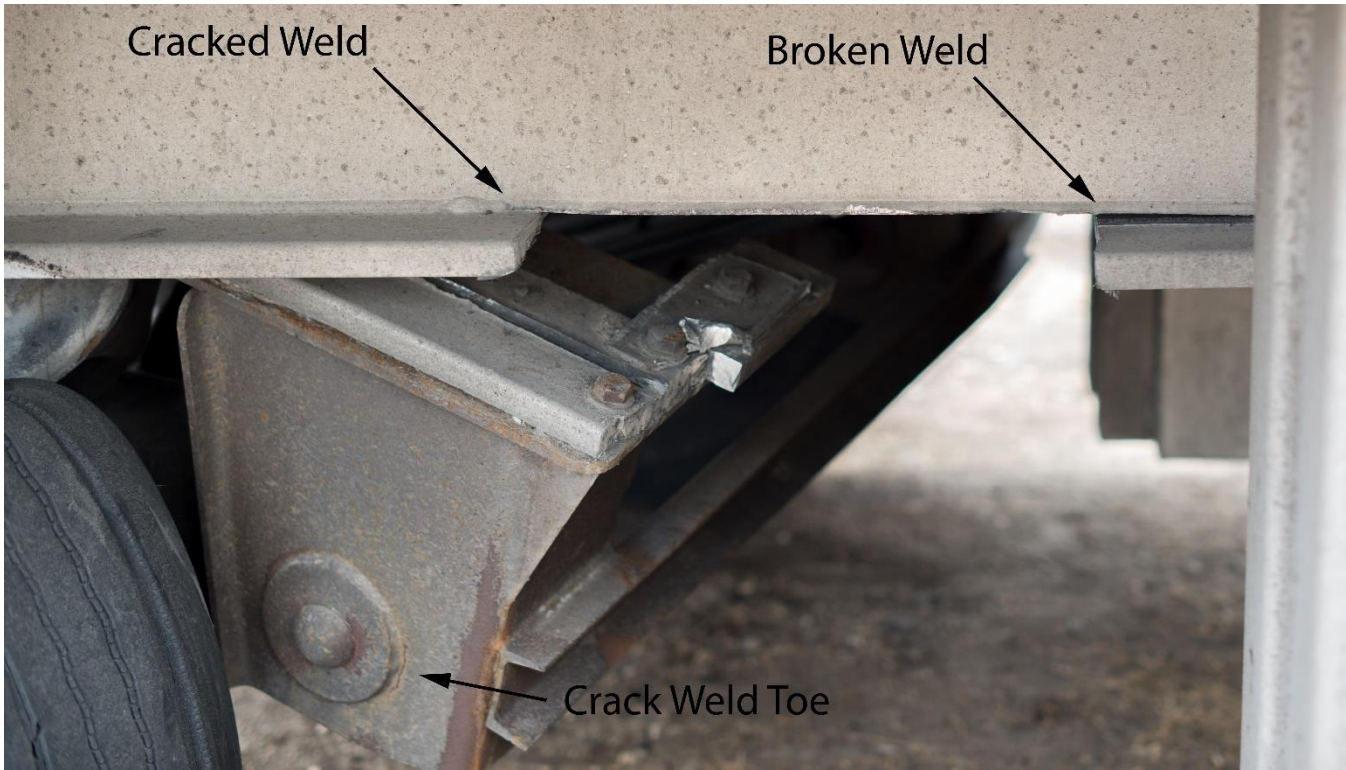
Figure 7 – Passenger Side of Trailer Frame and Suspension

Figure 7 shows the damage on the passenger side of the trailer frame. The flange of the frame where the suspension was bolted had broken free of the frame. The weld was broken, and the flange was broken in two locations. Normal visual inspection would not likely have detected the crack between the weld and flange. There was also a crack (Crack Weld Toe) in the steel of the suspension frame.

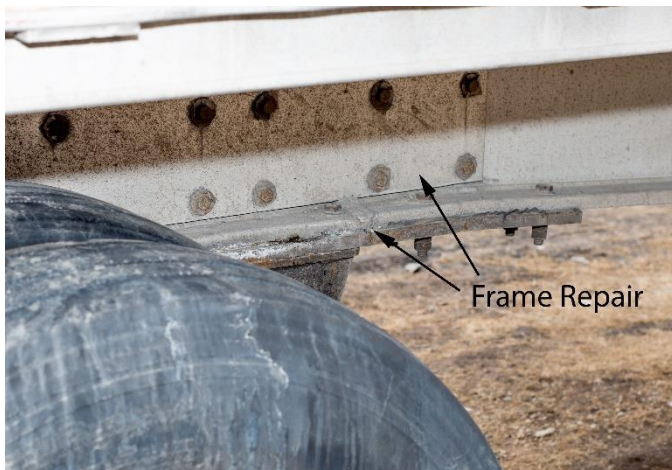
Figure 8 – Frame Repair ahead of Front Duals

The repair location ahead of the front duals on the passenger side of the trailer is shown in Figure 8. The frame flange was repair-welded, and the reinforcing plate was added to the frame gusset. The cracked repair weld is shown in Figure 9.

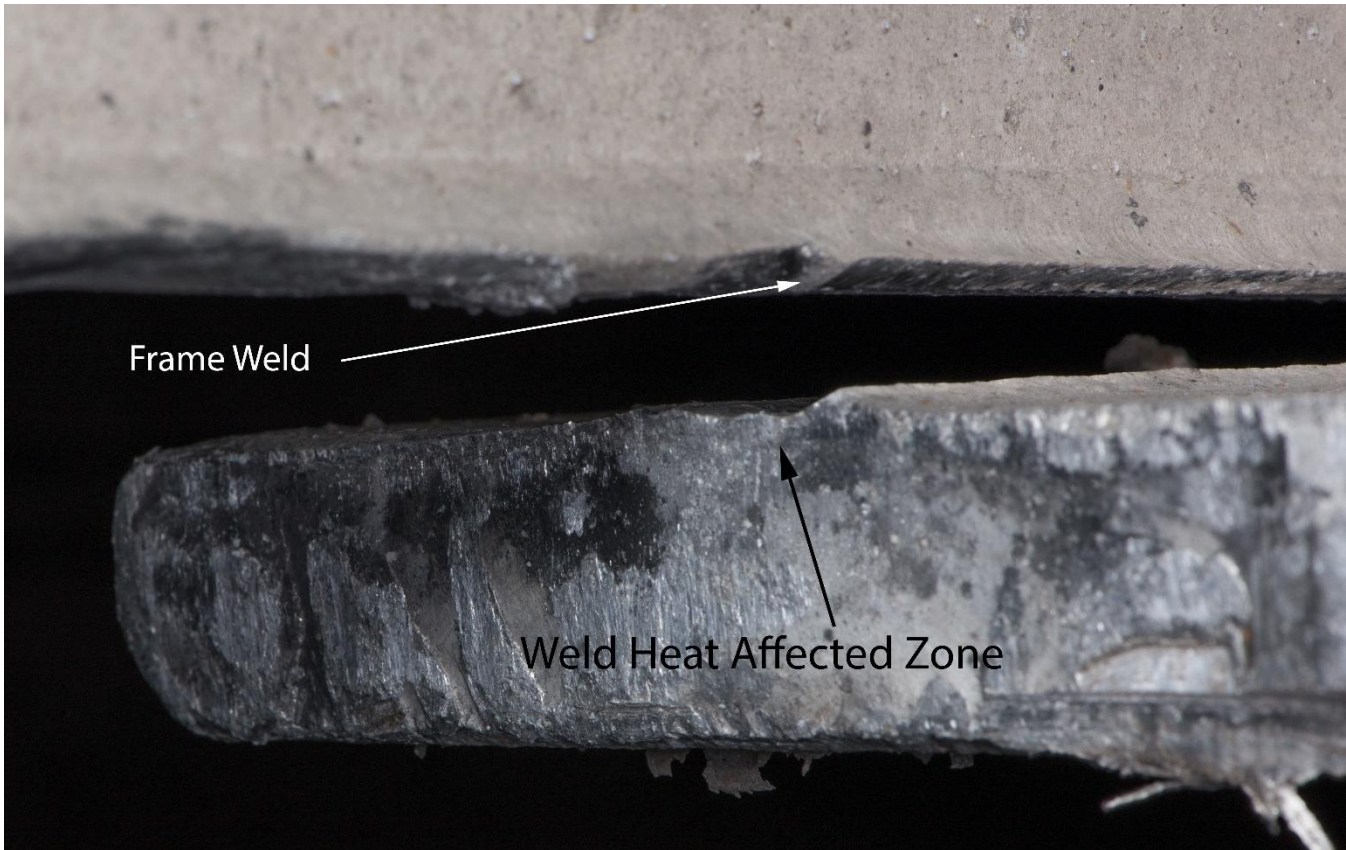
Figure 10 – Weld Failure in Frame-Flange Weld HAZ

The weld holding the frame web and flange together broke, Figure 10. The fracture was in the weld heat affected zone and was likely fatigue. The fracture surfaces on the frame weld were heavily Brinelled, and fatigue striations and beach marks were not visible. It is likely that the weld failed prior to the flange failing.

It was my conclusion that the weld between the frame web and flange failed by fatigue, followed by failure of the flange, also by fatigue, causing the passenger side rear suspension to come loose from the trailer.

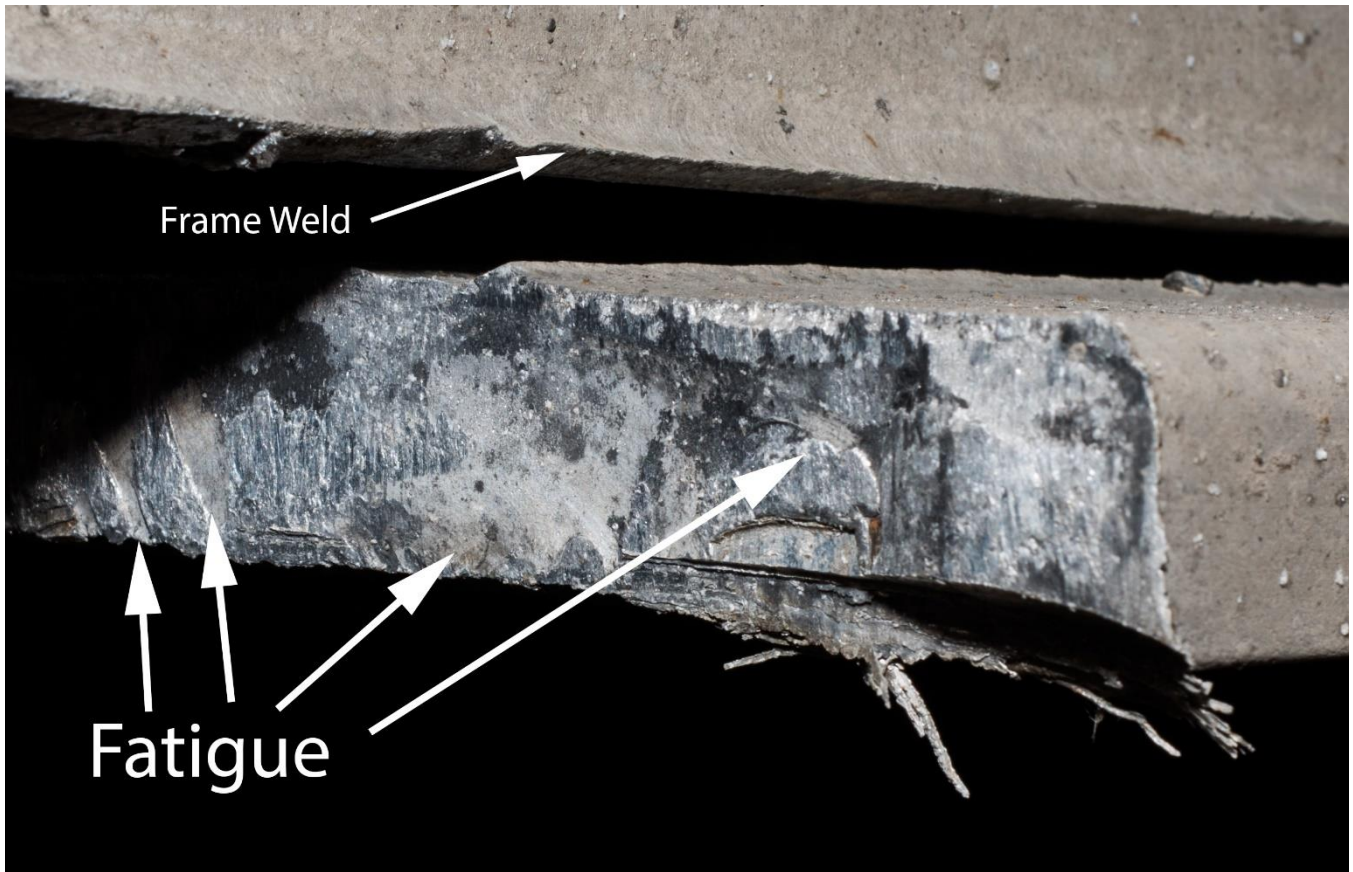
Figure 11 – Fatigue on Flange Fracture Surface

Figure 11 shows visible fatigue striations on the flange fracture surface, indicating that the fatigue is low cycle fatigue that started in the flange opposite the weld.

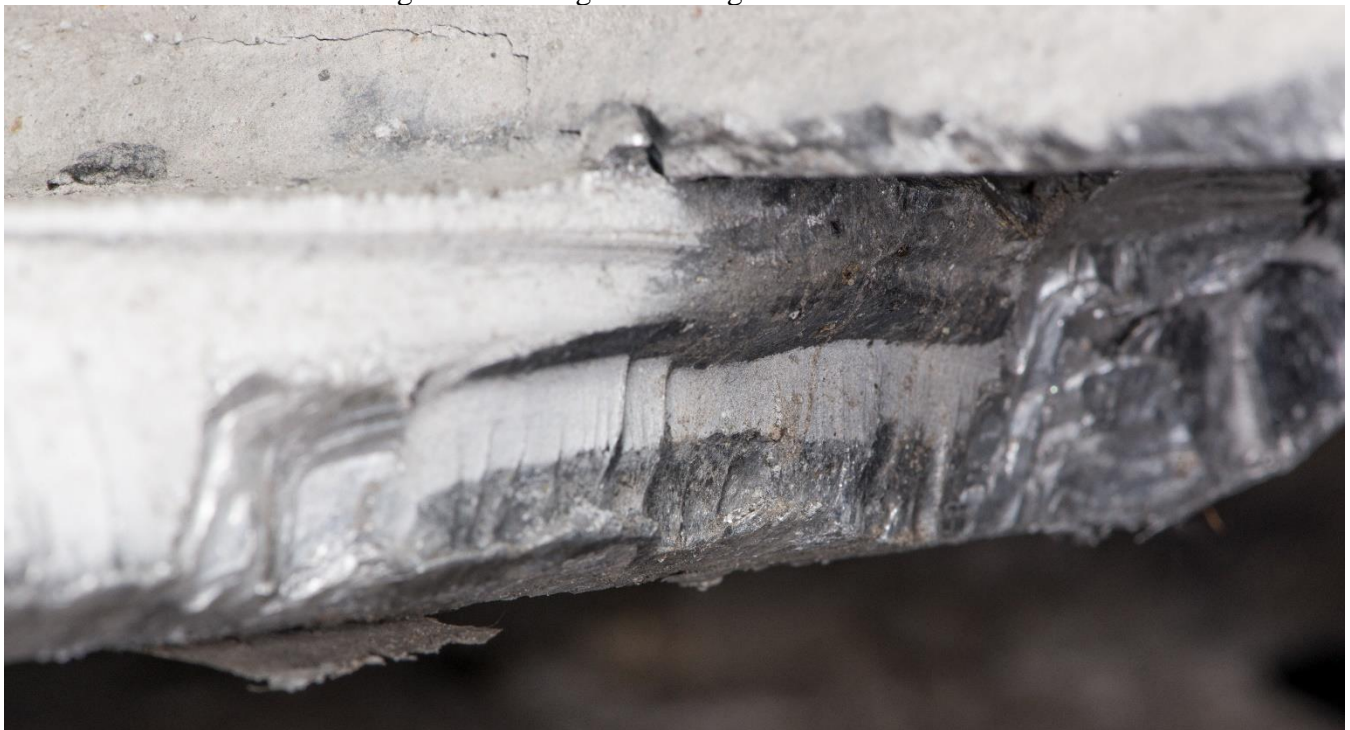
Figure 12 – Flange Fracture

The fracture shown in Figure 12 is also fatigue, but this section of the flange failed in three cycles. The third cycle failure was by shear fracture. The failure was in the flange in the frame near the rear of the trailer, as shown in Figure 7.

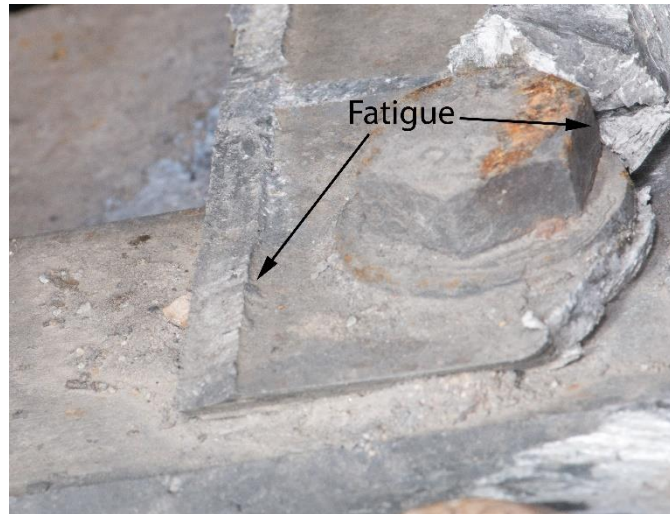
Figure 13 – Bracket Fatigue Fracture

Figure 13 shows fatigue fracture of one of the brackets bolted to the rear suspension.
