M. E. Williams and Associates, Inc.

Structural Failure – Case Study

Merlin E. Williams, P.E.

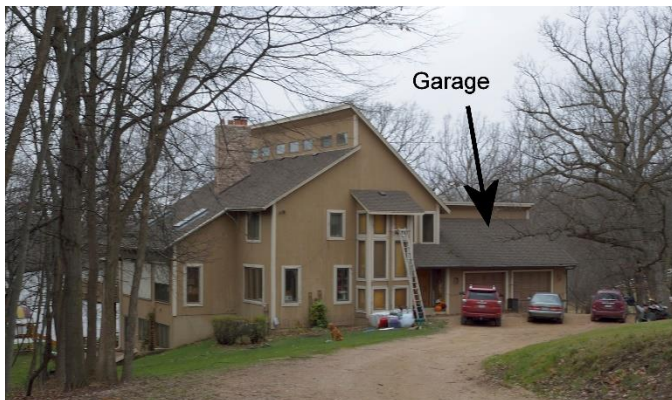
Figure 1 – Garage Location

Figure 1 shows the location as viewed from the south. The garage floor had the structural damage. The drainage on the property was away from the house and garage, and was not a factor in the damage.

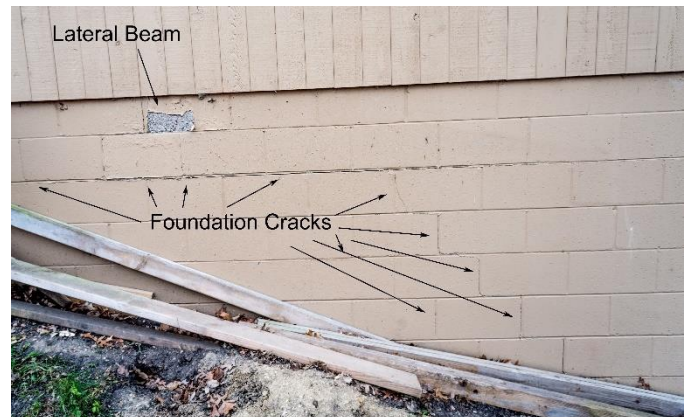
Figure 2 – Cracks in Foundation Mortar Joints

Figure 2 shows cracks in the garage east foundation wall mortar joints. The cracks in the mortar joints indicated that there had been settling in the garage side of the foundation over the years. This is also apparent in the cracking along the masonry joint between the house and the garage foundations, which met on the northside, Figure 3. It appeared that the garage had settled.

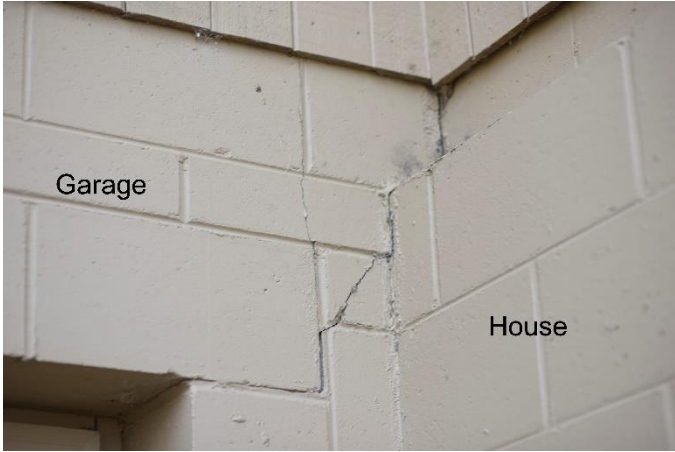
Figure 3 – Cracking in Foundation Joint Between House and Garage

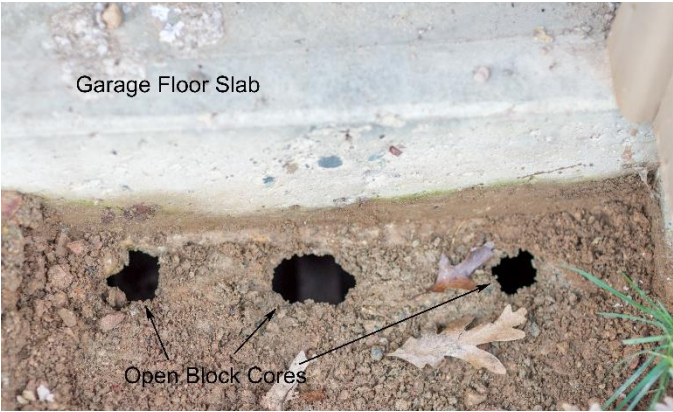
Figure 4 – Open Cores in Foundation Block

Figure 4 shows open cores in the masonry foundation at the front of the garage. The garage floor slab at this location was supported by the inside edge of the block.

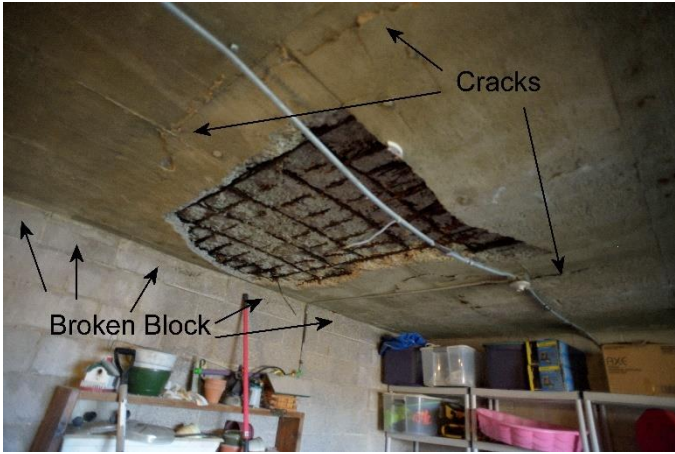
Figure 5 – Location of Garage Floor/Ceiling Collapse

Figure 5 shows the collapsed section of the basement ceiling side of the garage floor. The cause of the collapse was the corrosion of the reinforcing bar and concrete by road salt that had infiltrated from above. Another contributing factor was the tipping and cracking of the masonry block along the front of the garage/basement. Broken and tipped block is shown in Figure 6.

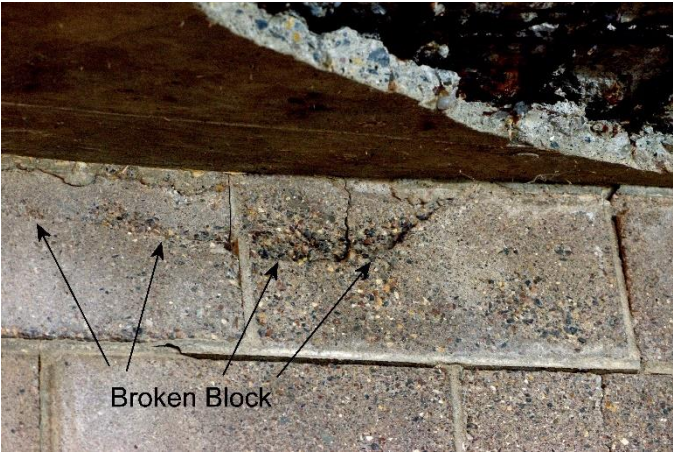
Figure 6 – Tipped and Broken Block

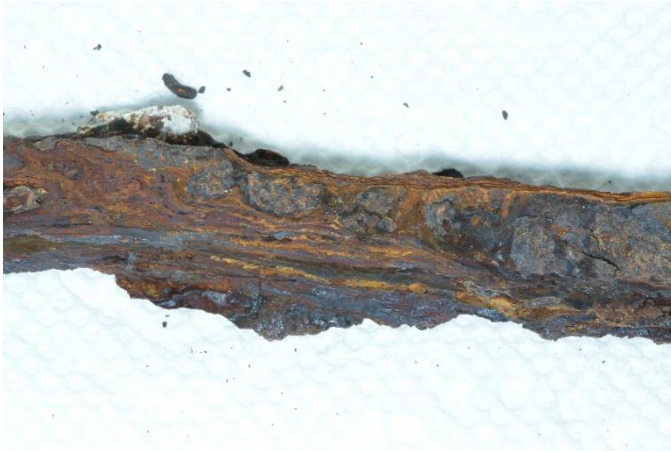
Figure 7 – Reinforcing Bar Sample 1

Reinforcing Bar Samples 1 and 2, Figures 7 and 8, were examined by energy dispersive x-ray analysis to determine the cause of corrosion. The results of the analysis are given in the table that follows and in Figures 9 and 10. The analysis showed the presence of sufficient chlorine and sulfur to explain the corrosion of the reinforcing bar.

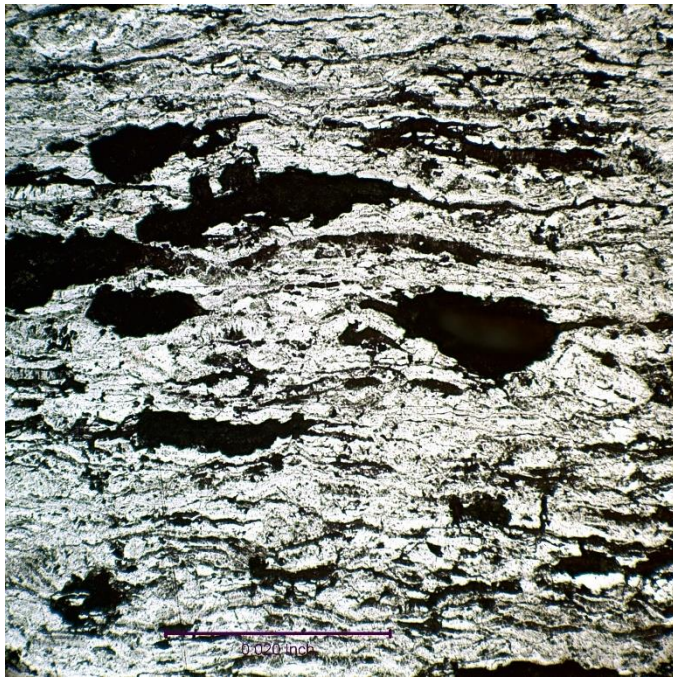
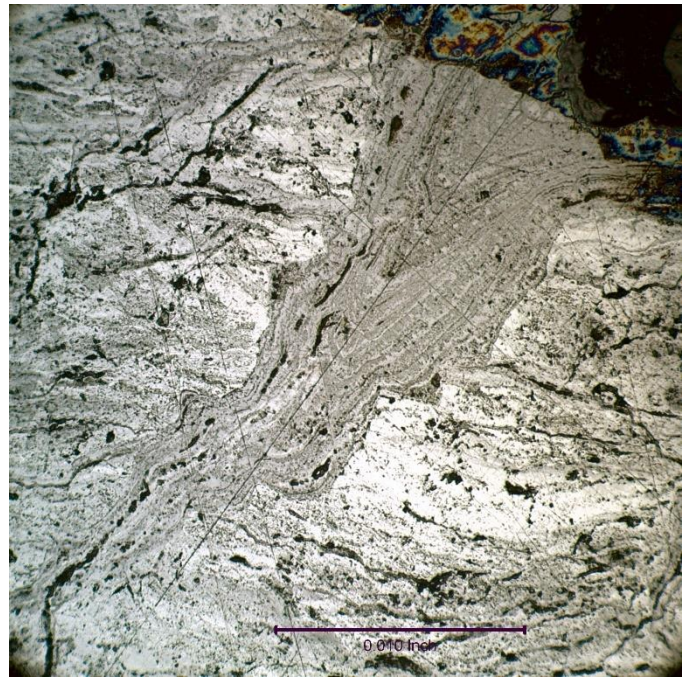
Figure 11 – 100X Corrosion in Reinforcing Bar Sample 1

Figure 12 – 200X Corrosion and Cold Working in Reinforcing Bar Sample 1

The black areas shown in Figures 11 and 12 are portions of Sample 1 reinforcing bar that had been corroded. The steel used in the reinforcing bar was cold worked. Cold working leaves a residual tensile stress in the steel, making it susceptible to stress corrosion. Chlorides cause stress corrosion in cold worked carbon steel. Figure 12 shows a highly cold worked section of the reinforcing bar. Therefore, because of corrosion associated with cold working, the strength of the bar was reduced to almost zero. **It should be noted that during the late 1970's and much of the 1980's, low carbon steels were cold worked to achieve strength levels to meet only the minimum strength requirements of ASTM structural grade steels.** Most of the reinforcing bar used for the garage floor was of this type.

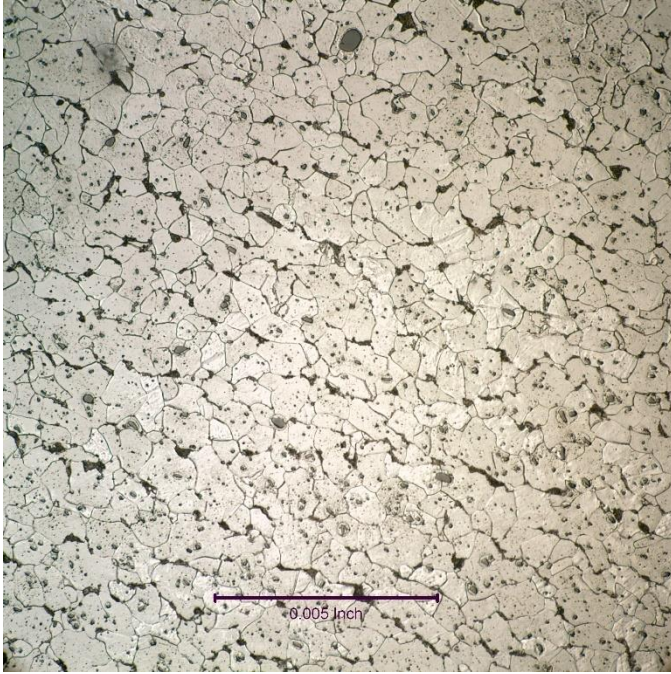
Figure 13 – 400X Microstructure of Sample 2

The microstructure of Reinforcing Bar Sample 2 is shown in Figure 13. The microstructure consisted of ferrite (light colored), which is pure iron, and pearlite (black). The grain size was very fine, indicating that the bar was hot rolled structural steel. The hardness of the steel was 144 Brinell Hardness Number, indicating that the tensile strength was 72,000 psi. The microstructural and hardness indicated that this reinforcing bar was made from ASTM A36 grade structural steel.

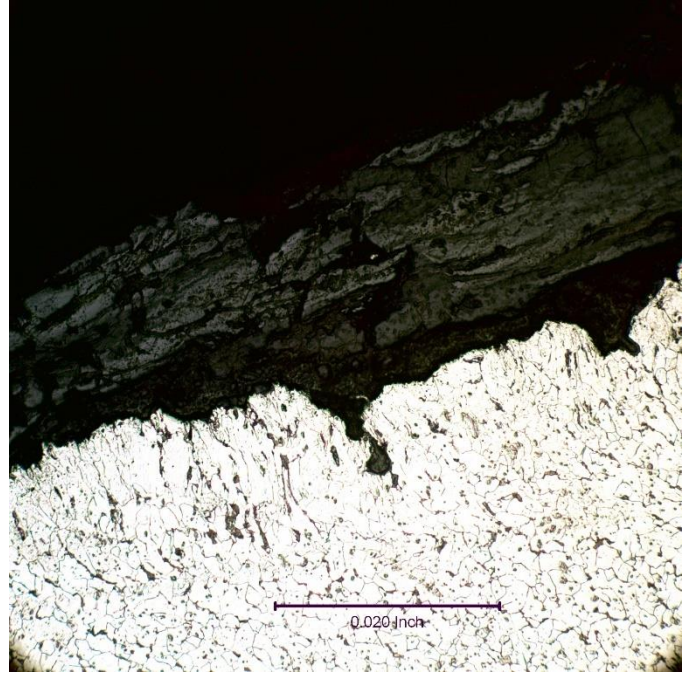
Figure 14 – 100X Pitting Corrosion – Sample 2

Figure 14 shows pitting corrosion on the surface of Sample 2. Pitting corrosion is normal for structural steel in the presence of chlorides and sulfates. The uncorroded steel retains its strength.
