Case Study: Very High Cycle Fatigue

Examination of a Coupler Pin that failed to determine cause of failure and to identify type of material that it was fabricated from. The pin was examined by visual examination, hardness testing, and metallographic examination. This was a custom coupler pin. The manufacturer, material, and heat treatment were unknown, and the client needed to produce a replacement that would have an equal or better service life.

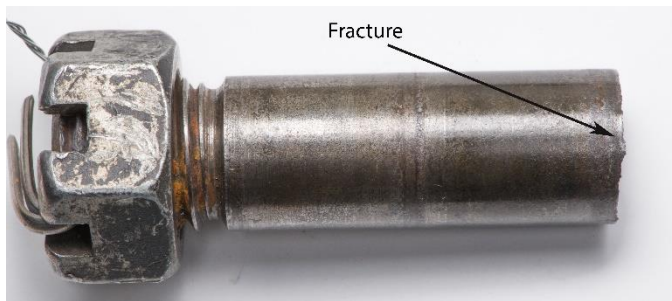
Figure 1 – Broken Coupler Pin

Close examination of Figure 1 showed that the surface of the pin had very fine pits.

Fabricate replacement pin from mill heat treated 8620, 4140, or 4340 steel. Note that mill heat treated 4340 will have better fatigue life than the other two steels.

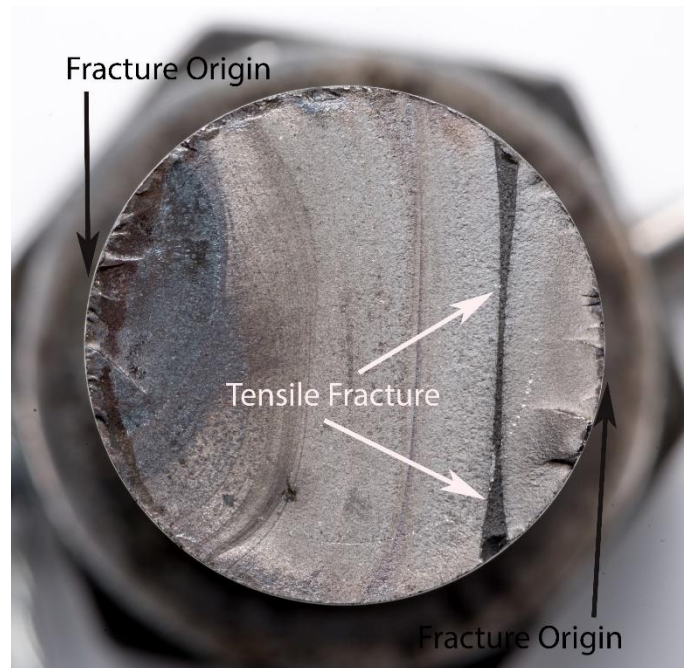
Figure 2 – Coupler Pin Fracture Surface

Figure 2 shows the fracture surface of the coupler pin. The pin clearly failed by very high cycle fatigue. The fatigue started on both sides of the pin. There was a black band near the right side, as shown in the photo. The band was 0.56 inches long, the width varying from 0.010 inches to 0.030 inches, and there was

an area of about 0.011 square inches. The material in the black band appeared to have failed by tensile fracture, and may have been the final failure of the coupler pin.

The hardness of the pin was 27.4 on the Rockwell C Scale, indicating that the tensile strength of the steel used for the pin was about 120,000 psi. This means that if the black band area in Figure 3 was the last area to break, the load on the pin was about 1300 pounds at the time of failure.

1. The Coupler Pin failed by very high cycle fatigue, with the fatigue cracks initiating in corrosion pits on the pin's surface.
2. The Coupler Pin was fabricated from mill heat treated 8620 steel.
3. The pin that failed had exceeded its useful life.

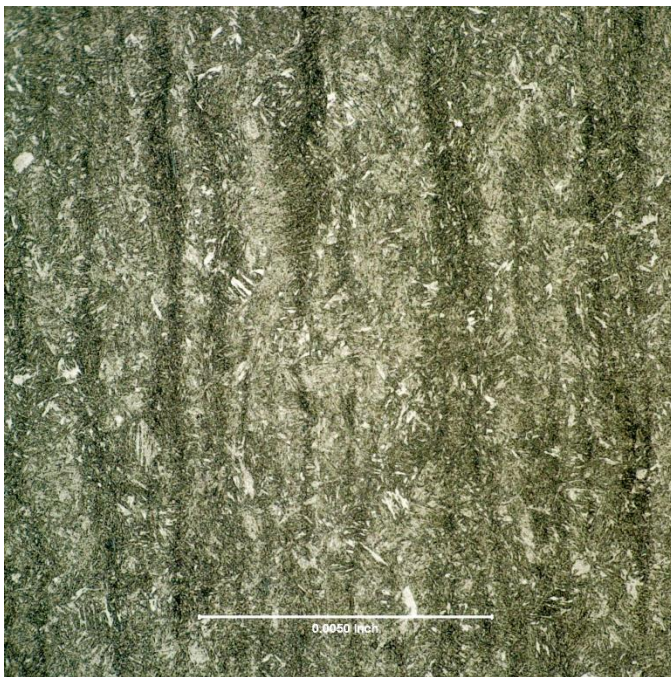
Figure 3 – 400X Microstructure of Coupler Pin

Figure 3 shows the microstructure of the Coupler Pin, which is tempered martensite. The microstructure and hardness of 27.4 Rockwell C scale indicates that the steel used for the coupler was probably mill heat treated 8620.

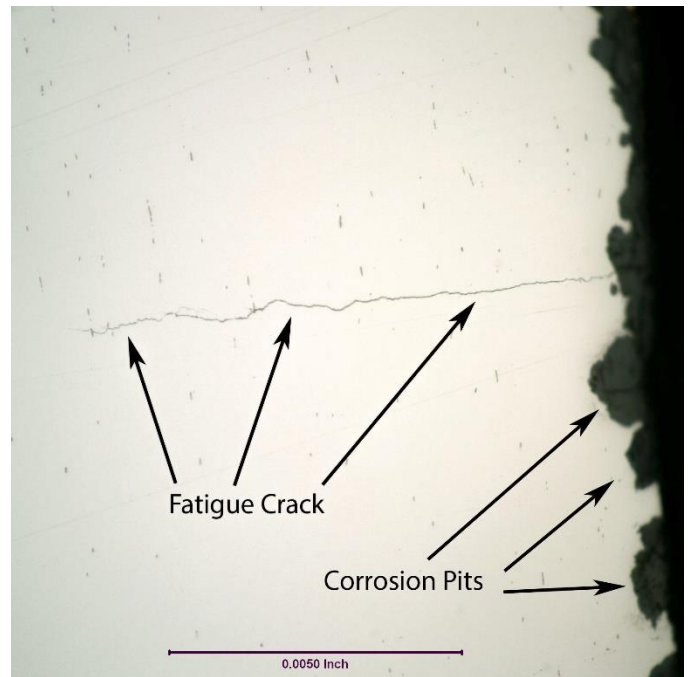
Figure 4 – 400X Internal Fatigue Crack

Figure 4 shows one of several internal fatigue cracks found in the metallographic cross section. All the fatigue cracks appeared to originate in the corrosion pits on the outside diameter of the Coupler Pin.
