M. E. Williams and Associates, Inc.

Water-to-Air Heat Exchanger Failure

Merlin E. Williams, P.E.

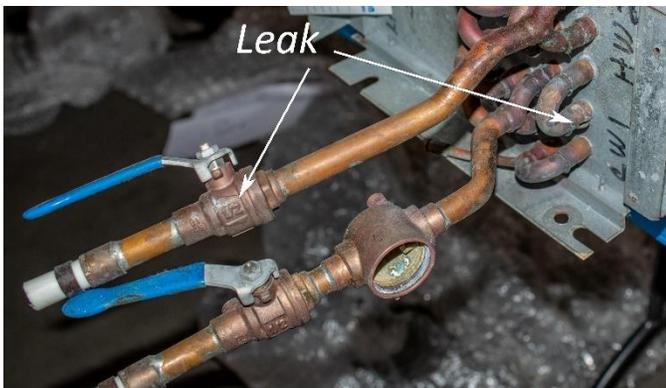
Figure 1 – Failed Fan Coil Leaks

Figure 1 shows the return bend end from the failed fan coil. Initial examination shows that the fan coil failed by freezing. Longitudinal splits, such as the ones shown in Figures 2, 3, and 4, are typical of freeze failures in copper tubing. The longitudinal split of the sheet tube shown in Figure 4 was chosen for further examination with the scanning electron microscope. The section of the sheet tube with the leak in it was split in half, Figure 5, to facilitate examination in the scanning electron microscope.

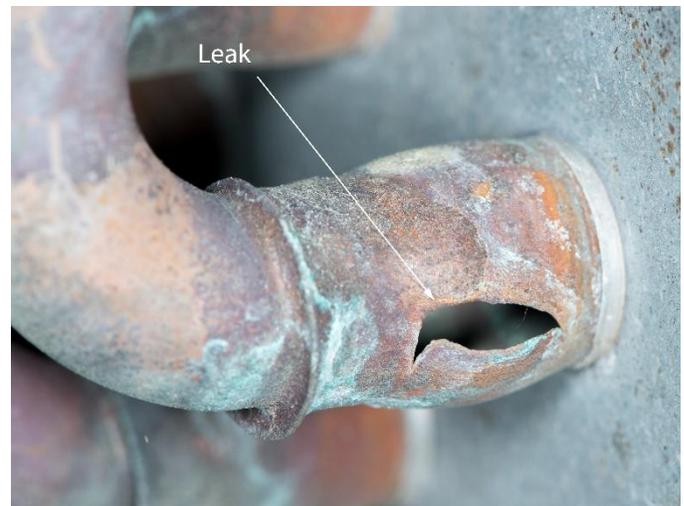
Figure 2 – Longitudinal Split in Sheet Tube

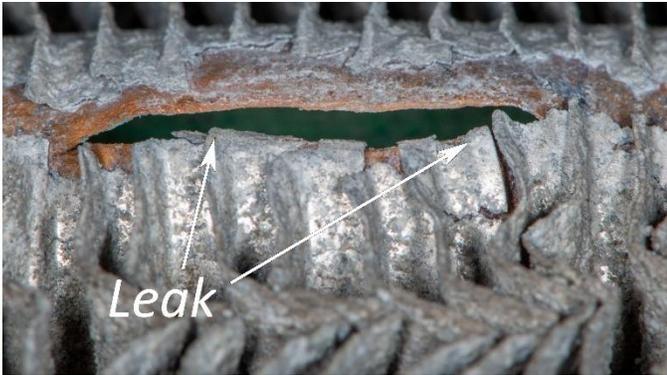
Figure 3 – Longitudinal Split in Sheet Tube

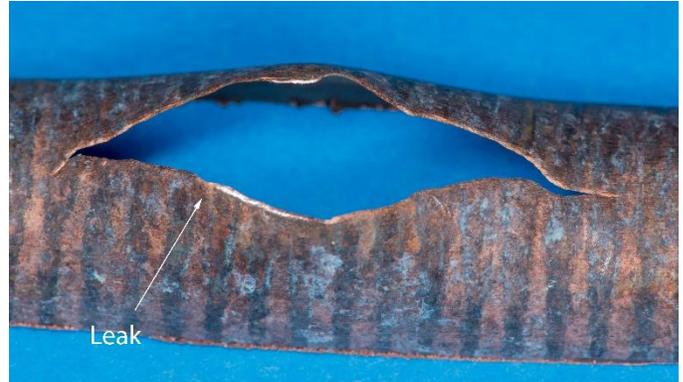
Figure 4 – Sheet Tube Examined in SEM

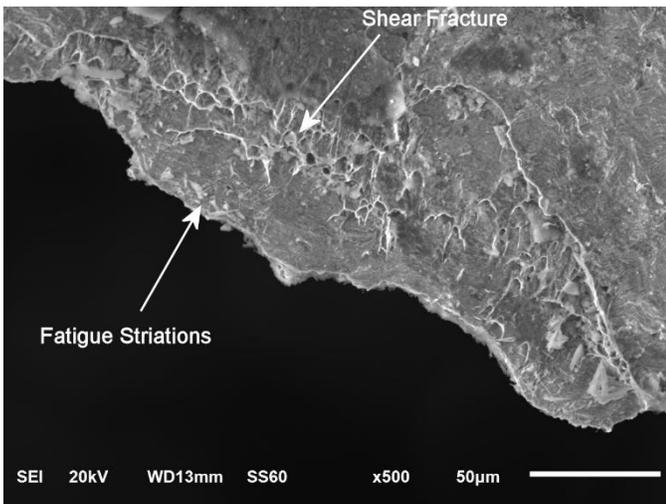
Figure 5 - 500X Fracture Surface

Figure 5 shows the fracture surface. The initial failure mode was fatigue, which was followed by shear. Figure 6 shows the fatigue striations more clearly. Each striation represents one over-pressure event. Eighteen fatigue striations are clearly shown in the photo. The failure was the result of freezing. This section of the coil was frozen at least 18 times prior to failure.

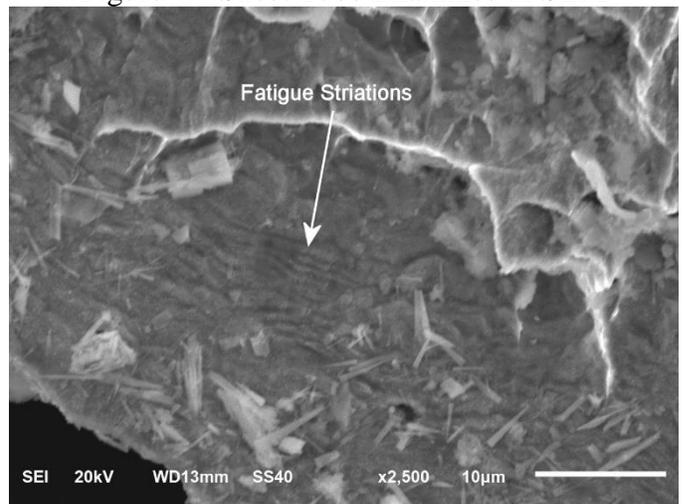
Figure 6 – 2500X Fatigue Striations in Fracture in Sheet Tube

The freezing of the unit and other units could have been prevented by allowing water to continually flow in the units. Continuous water flow would also have reduced the likelihood of sulfur reducing bacteria forming mounds in the sheet tubes and return bends.

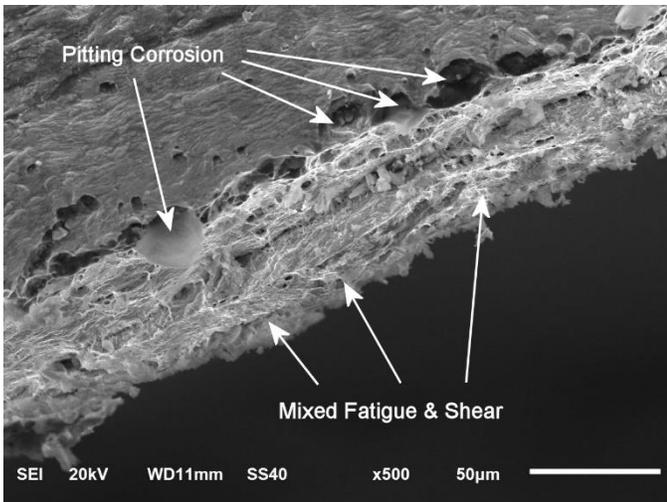
Figure 7 – 500X Mixed Mode Fracture and Pitting Corrosion of Sheet Tube

The fracture surface is shown in a different location in Figure 7. On the outside diameter, there was a mixture of fatigue and shear fracture, indicating that the cyclic stress exceeded the shear strength of the copper tubing.

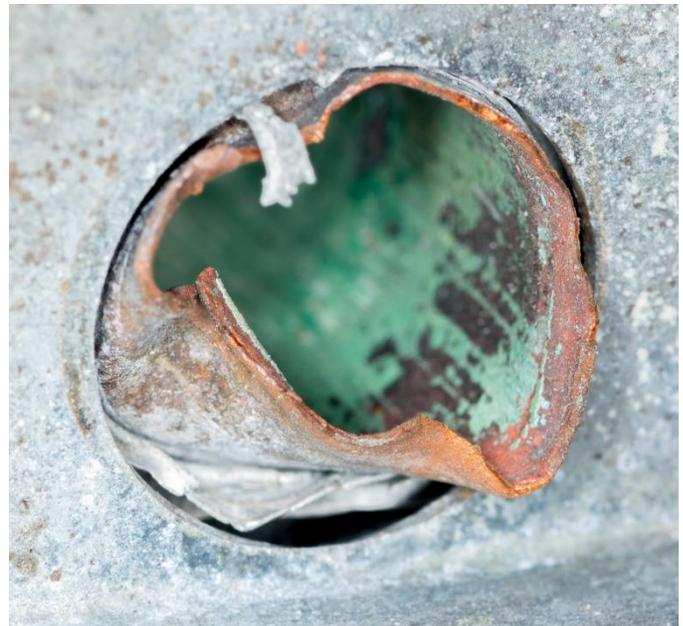
Figure 8 – Tube with Radial Fracture

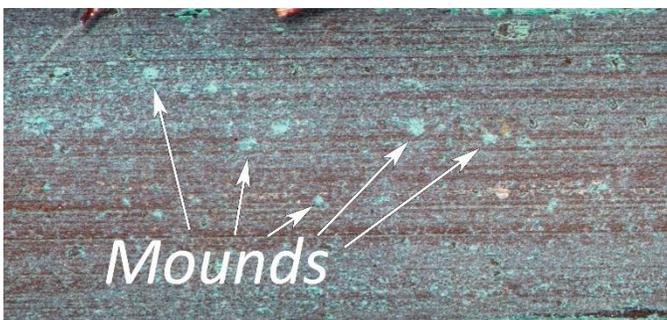
Figure 9 – Small Mound Deposits in the Sheet Tube with the Radial Fracture

On the inside diameter of the sheet tube there were initiation sights for pitting corrosion, which are indicated by small mounds of corrosion products, Figure 9. Figure 10 shows one of the small mounds on the inside diameter of the sheet tube.

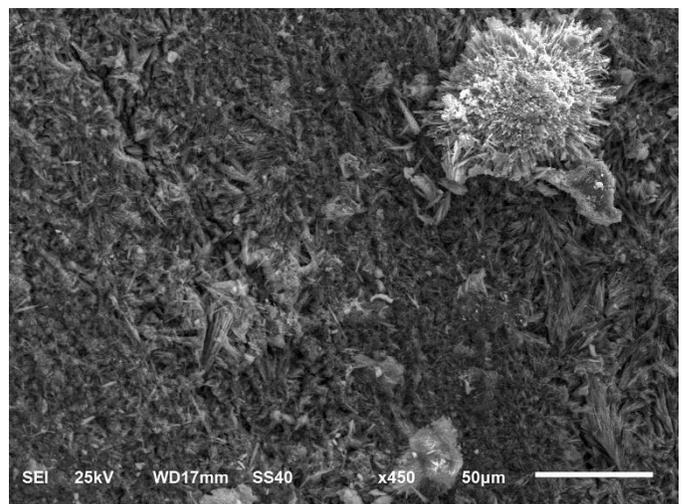
Figure 10 – 450X Small Mound Deposit in Sheet Tube with Radial Fracture

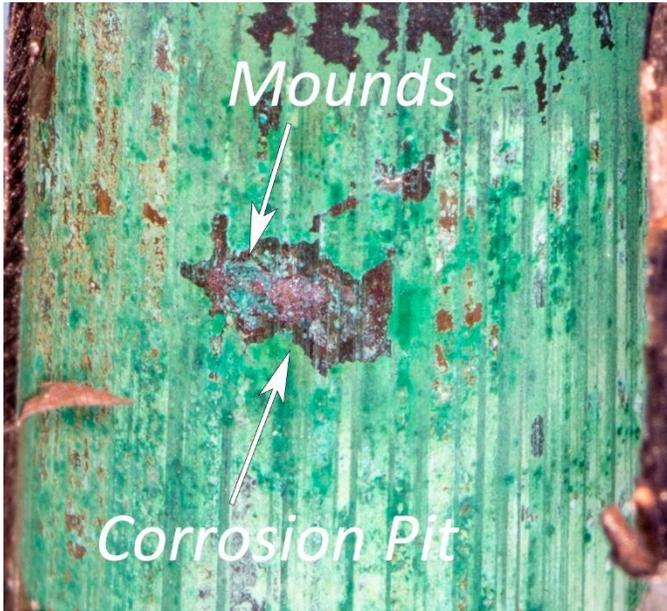
Figure 11 shows pitting corrosion at the end of a sheet tube that failed radially. There are small mounds of corrosion deposits present in the sheet tube. These small mounds are likely the result of microbiological

activity, and are often found in water systems that are not adequately treated. Characteristics of the tube surface may be similar to the pits shown in Figure 7.

Figure 11 – 7X Corrosion Pit and Mound Deposits in Sheet Tube with Radial Fracture

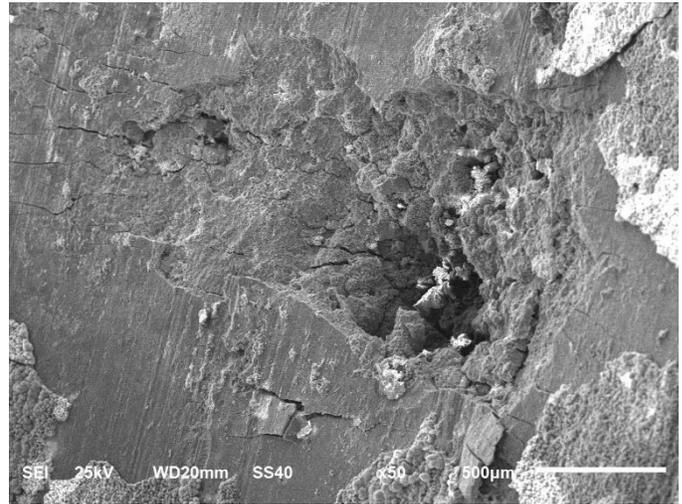
Figure 12 – 50X Corrosion Pit in Sheet Tube with Radial Fracture

The corrosion pit in the sheet tube with a radial crack, Figure 12, has the appearance of microbiologically induced corrosion, MIC. The pitting appears to be similar to pits formed by sulfur reducing bacteria. There were mounds of corrosion products over portions of the pit. The remnants of the mound are still present. There is a visible radial crack emerging from the pit. A scanning electron microscopic view of the corrosion pit is shown in Figure 12. Sulfur reducing bacteria was likely present, and the cracks shown are characteristic of stress corrosion cracking, SCC, caused by hydrogen sulfate produced by sulfur reducing bacteria. Since DNA testing was rejected from the Testing Protocol, positive identification of sulfur reducing bacteria was not determined. The EDS spectrum and semi-quantitative analysis data for the corrosion pit are shown in Figure 13. The sulfur levels are not elevated, but in my experience that is not unusual, and does not indicate that the bacteria is not present.

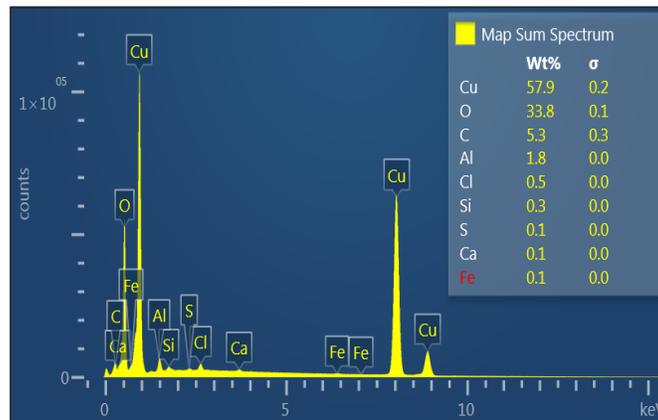
Figure 13 – EDS Spectrum of Corrosion Pit in Sheet Tube with Radial Fracture

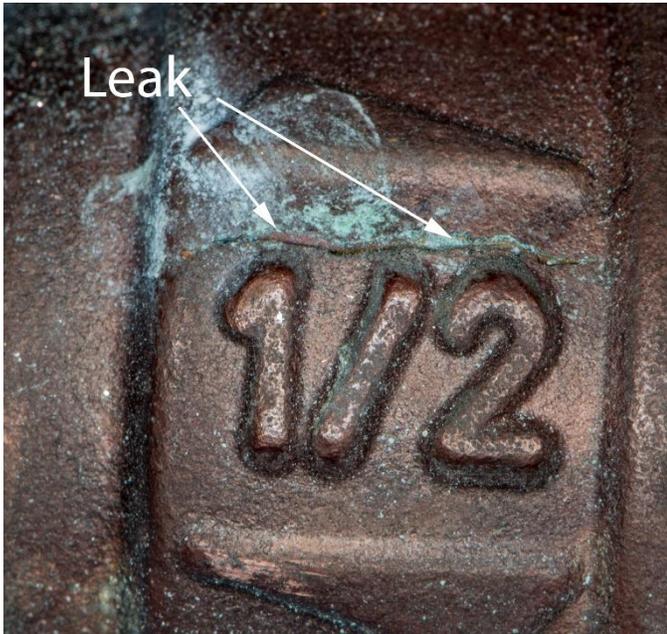
The Ball Valve leak is shown in Figure 14. Figure 15 shows the leak opened up so that it could be examined with the scanning electron microscope.

Figure 14 – Crack in Ball Valve

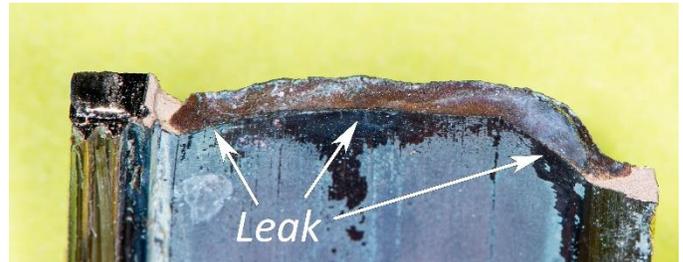
Figure 15 – Ball Valve Crack

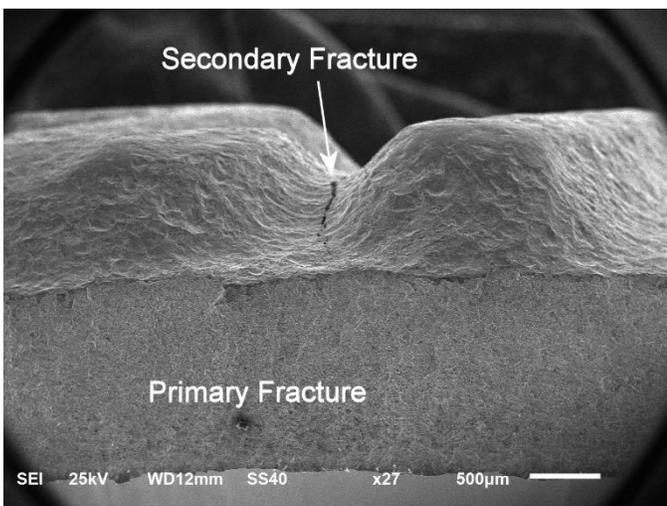
Figure 16 – 27X Ball Valve Fractures

The scanning electron microscopic view of the Ball Valve showed both primary and secondary fractures, Figure 16. The primary fracture, shown in Figure 17, is ductile. EDS, Figure 18, of the fracture surface shows a higher concentration of sulfur and chloride compounds on the Ball Valve fracture surface than was found in the sheet tube fractures. The secondary fracture, Figure 19, was ductile. The probable cause of failure of this ball valve was a single freezing event.

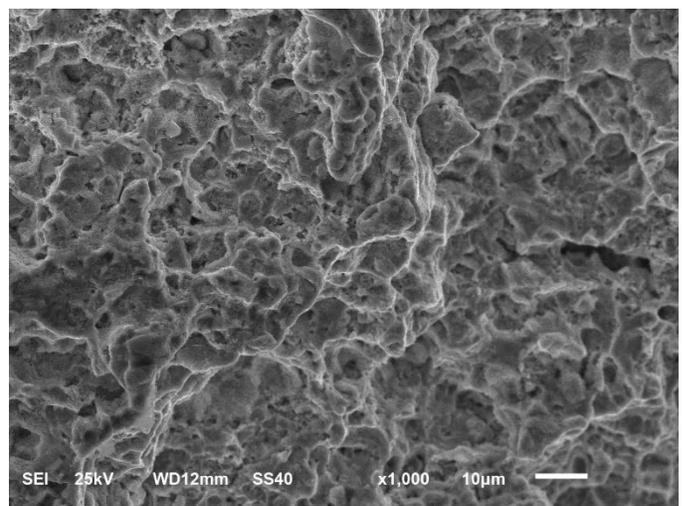
Figure 17 – 1000X Ductile Primary Fracture, Ball Valve

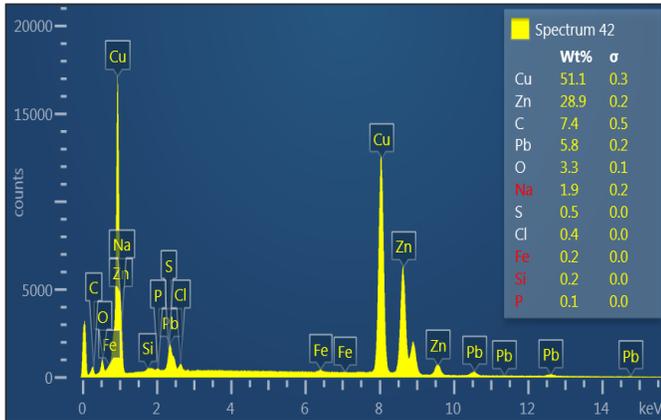
Figure 18 – EDS Spectrum of Primary Fracture Surface of Ball Valve

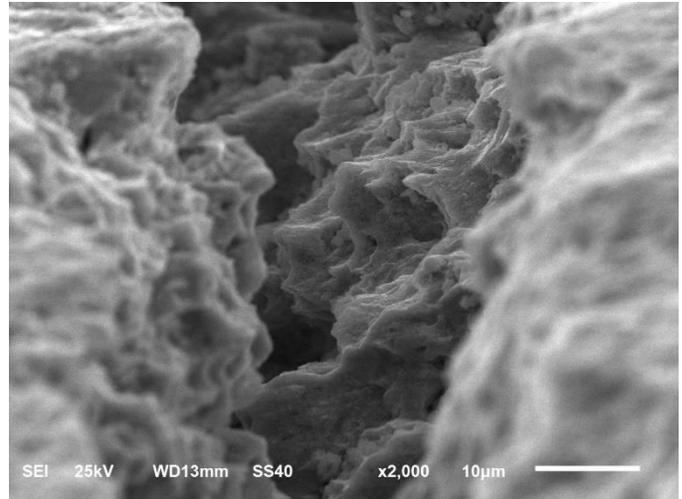
Figure 19 – 2000X Ductile Secondary Fracture, Ball Valve
