## Failure Analysis of Aluminum Condenser Coil

Merlin E. Williams, P.E.

### **Subject**

Examination of a Condenser Coil Large 38mm Header to determine the cause of failure of the header port cup. The header and header port cup were a brazed aluminum assembly. This aluminum condenser coil was used as part of a mobile refrigeration unit. The header port cup was examined by visual examination, hardness testing, scanning electron microscopic examination, fracture mechanics, and metallographic examination.

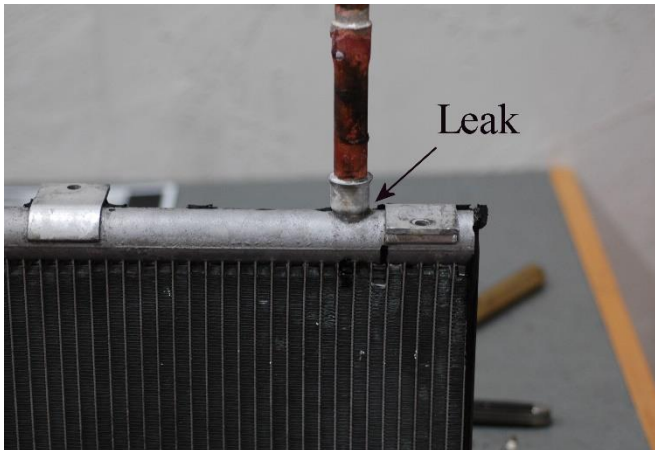
Figure 1 – Condenser Coil Leak Location

Figure 1 shows the location of the condenser coil leak. The leak was around the brazed base of the 23mm O.D. header port cup. Figures 2 and 3 show the leak locations.

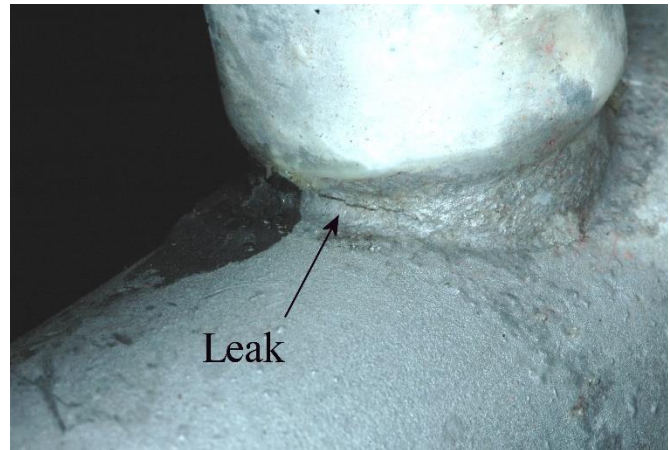
Figure 2 – Leak Location

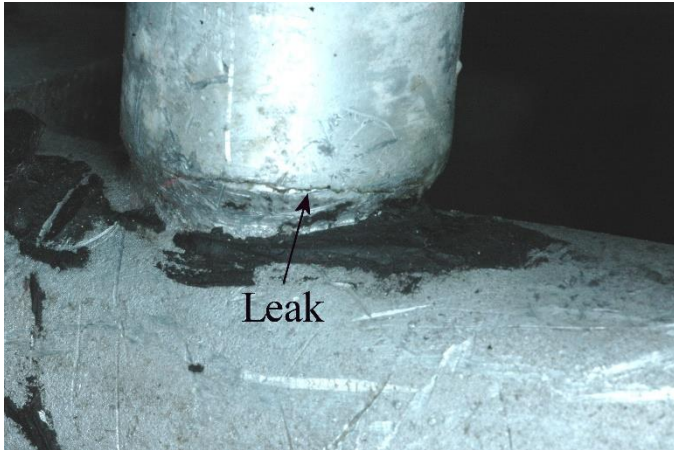
Figure 3 – Crack Associated with Leak

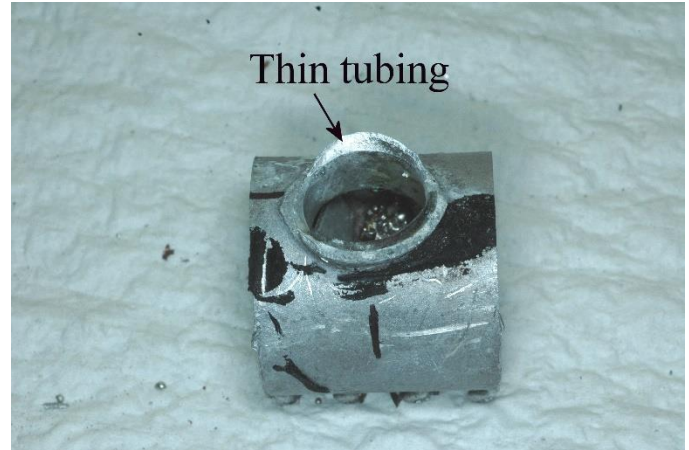
Figure 4 – Header Side of Crack

Figures 4 and 5 show the cracked port fitting opened up to show the fracture surfaces. Examination of the header port cup indicated that the tube was formed by expanding aluminum tubing from its original diameter to form a cup to accept the copper tubing. The expansion of the aluminum tubing did not appear to be uniform, and one side was thinner than the other. The thin area broke by ductile fracture.

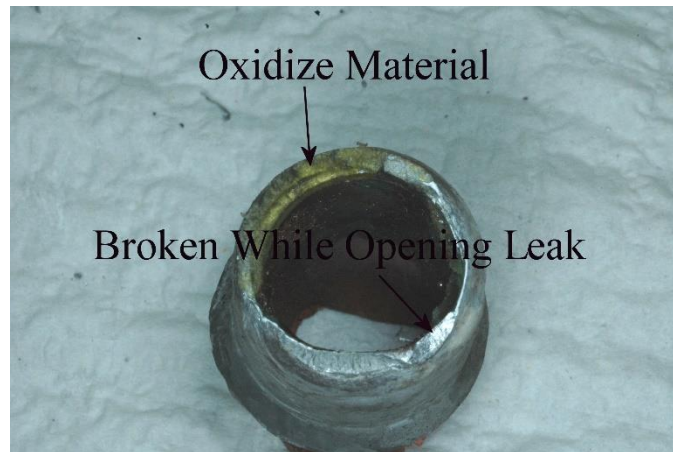
Figure 5 – Tube Side of Crack

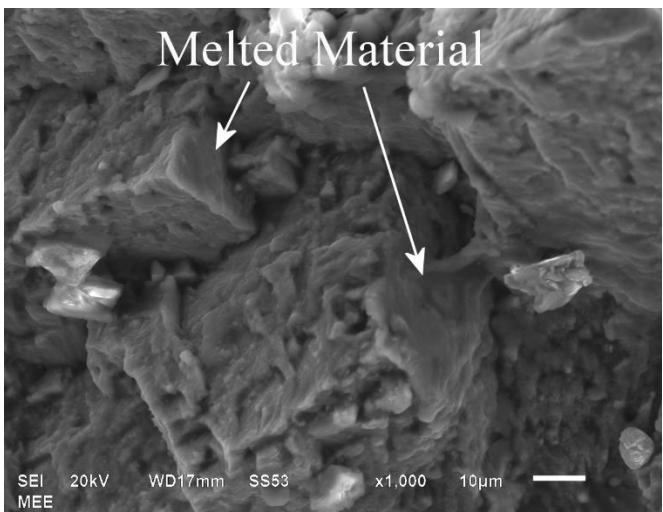
Figure 6 shows the intergranular fracture. The smoother faces appear to have been the result of localized melting. Localized intergranular melting would have reduced the strength of the header port cup even further. The presence of localized melting indicates that the brazing temperature was too high.

Figure 6 – 1000X Grain Boundary Melting and Intergranular Fracture

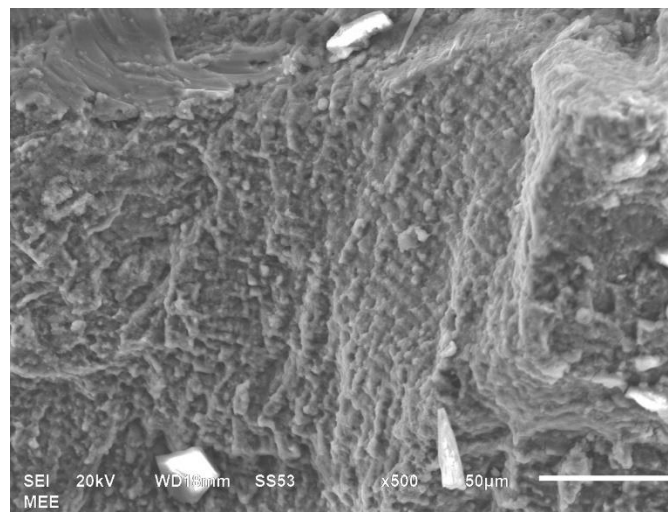
Figure 7 – 500X Fatigue Striations

Figure 7 shows fatigue striations. The spacing on the striations shown is  $1.30 \times 10^{-4}$  inches.

The estimated cyclic stress for the striations shown in Figure 7 is 54,300 psi. The aluminum used in this assembly cannot support this much cyclic stress. The actual applied stress was far in excess of the strength of the material used for the cup. Aluminum alloys are very sensitive to failure by fatigue and this sensitivity needs to be accounted for in the design and manufacturing of aluminum components.

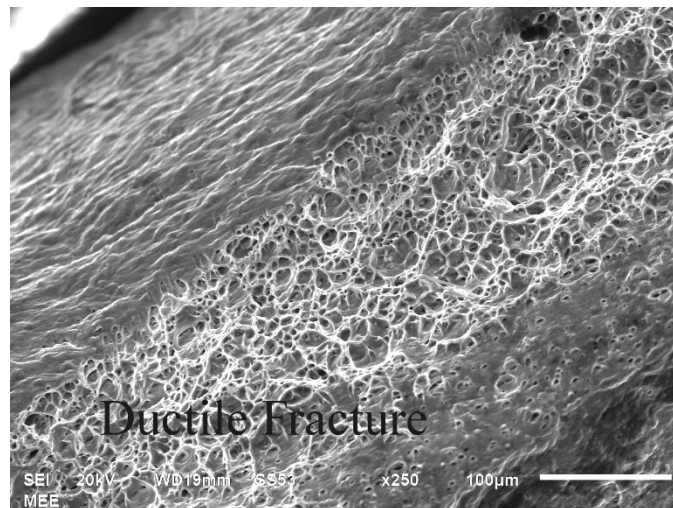
Figure 8 – 250X Ductile Fracture

The ductile fracture is shown in Figure 8. This is an excellent example of cup-cone fracture. This area was very clean, and the fracture, which occurred last, could have occurred during removal of the condenser.

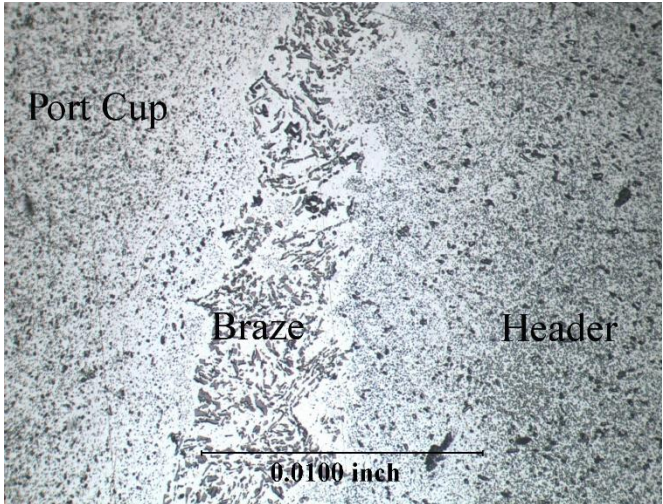
Figure 9 – 200X Braze Joint

Figure 9 shows the braze joint between the header port cup, to the left hand side, and the header, to the right hand side. There is a difference in alloys used for the header port cup and header tube. This is indicated by slight differences in the microstructure of the header tube and cup material.

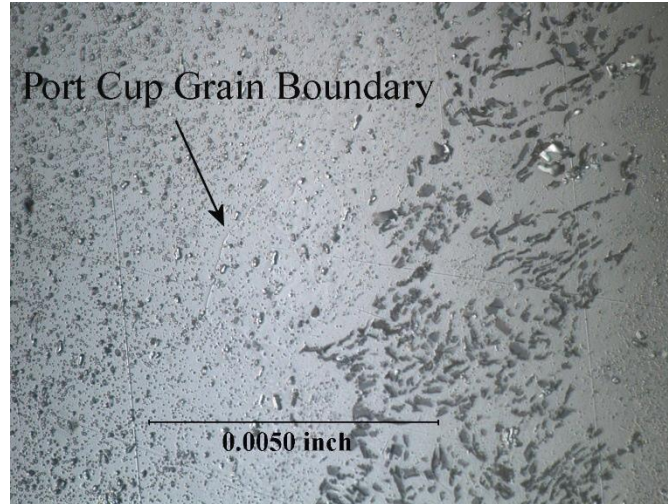
Figure 10 – 400X Port Cup Grain Boundary

The grain boundaries of the header port cup and header aluminum were enhanced in the area of the braze metal, Figure 10. The likely cause of the melting shown in Figure 10 was diffusion of alloying elements from the braze metal along the grain boundaries.

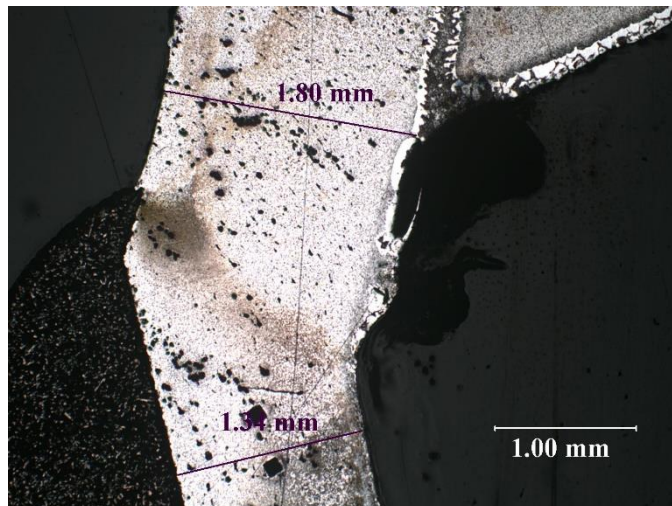
The minimum wall thickness of the header port cup is specified to be 1.65mm. The dimensions in each of the Figures are likely overstated because the cross sections were not exactly perpendicular to the cup port diameter. Figure 11 shows a variation of the thickness, between 1.80mm and 1.35mm, in the formed area. There was thinning of the header port cup that resulted during forming of the cup. Based on the hardness data and assuming 1100 aluminum alloy, the force required to cause failure of the header cup port was under 26 pounds.

Figure 11 – 25X Wall Thickness of Header Port Cup Intergranular Fracture Area
