## Welding Nightmare II – Case Study

Merlin E. Williams, P.E.

### **Introduction**

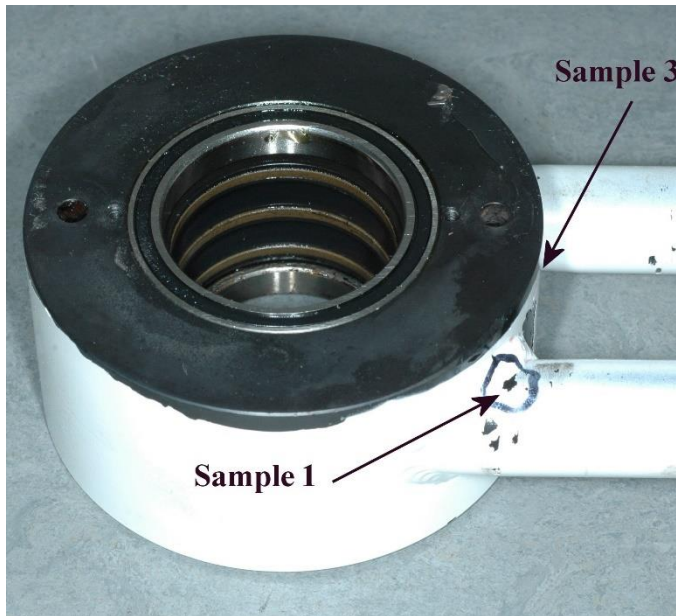
Figure 1 – Rotary Coupling

Figure 1 shows the Rotary Coupling. The locations of Samples 1 and 3 are indicated. Figure 2 shows a close-up of the Sample 1 location.

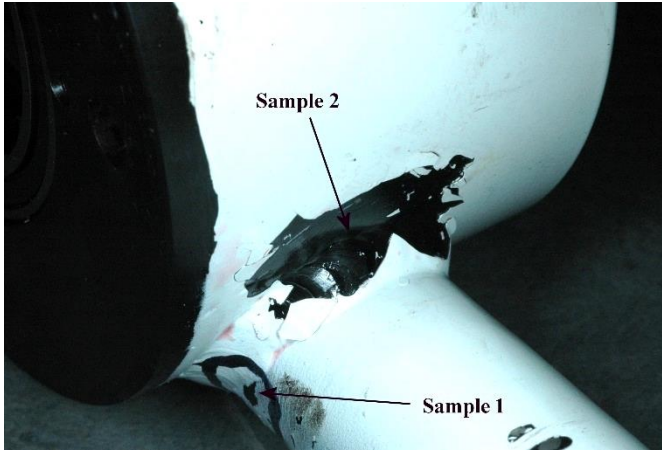
Figure 3 – Locations of Samples 1 and 2

The locations of Samples 1 and 2 are shown in Figure 3. These locations had been identified as places where hydraulic fluid had leaked.

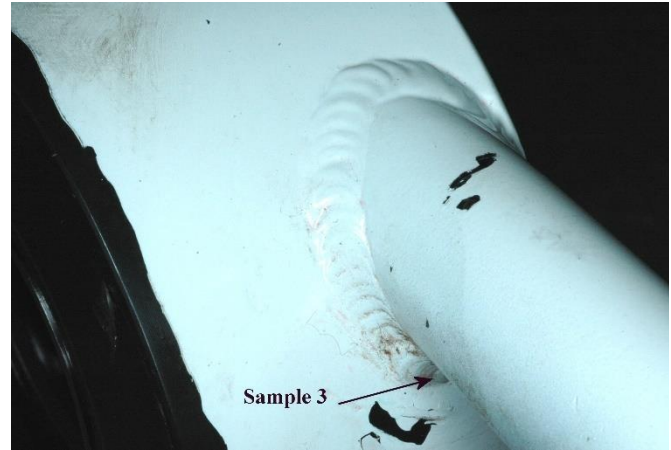
Figure 4 – Location of Sample 3

Sample 3 was chosen at a location where there was no leakage of hydraulic fluid, to be used as an exemplar, Figure 4.

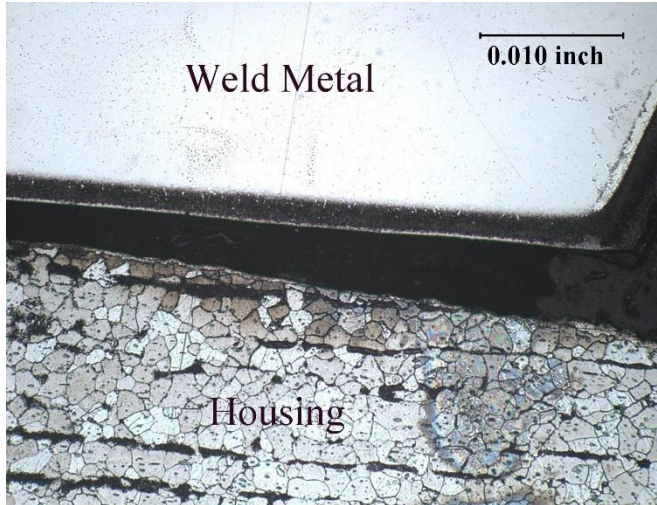
Figure 5 – 100X Weld Root

Figure 5 shows a significant lack of fusion in the weld root on the housing side of the weld. The lack of fusion extended for about 50% of the leg length on the housing side of the weld, indicating the weld operator was not qualified for these welds. The lack of fusion was the primary cause of leakage at this location. The weld metal was an austenitic stainless steel. The weld filler metal did not etch, the ferritic nitro-carburized layer did etch, and was found at any location where the weld metal had not bonded to the housing steel.

There were three major welding defects found with the Rotary Hydraulic Valve assembly: 1) The leaks were the result of lack of fusion between the 1215 steel valve body and the weld filler metal. This is strictly operator error and a clear indication that the weld operator was not qualified for this procedure. The other two major errors were design errors: 2) the valve body was machined from re-sulfurized and re-phosphatized 1215 steel, which is not weldable; and 3) austenitic stainless steel filler metal was used. These two errors would have eventually caused the valve to fail, even if the welding had been done correctly. 1215 Free Machining Steel has one purpose and that is high machinability and should never be considered as part of a welded assembly. The high machinability of 1215 is the result of the inherent brittleness caused by re-sulfurizing and re-phosphatizing of the steel to improve chip breakage during machining. Welding increases this brittleness in both the intermix and heat affected zones. The use of austenitic stainless steel filler metal with carbon or alloy steel requires a full metallographic evaluation of the procedure to determine the pre- and post-heating requirements. In some cases, the post-heating will be a full heat treatment prior to the welded assembly cooling to room temperature.

The Rotary Hydraulic Valve assembly should have been designed for copper brazing instead of welding.

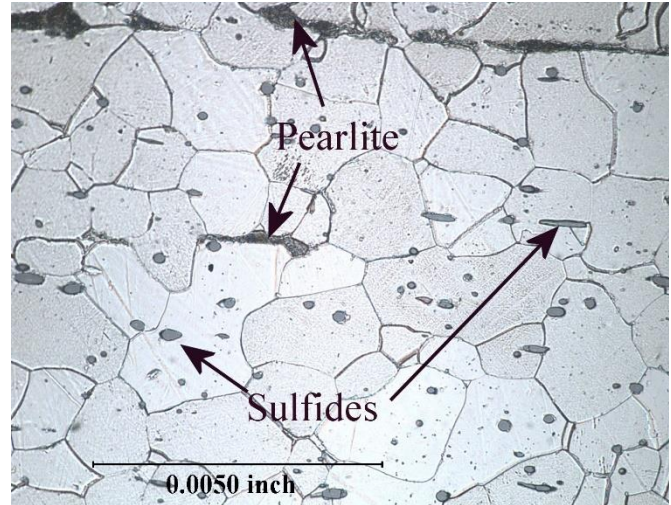
Figure 6 – 400X Microstructure of Housing

The microstructure of the housing steel was predominantly ferrite with small amounts of pearlite and manganese sulfides, Figure 6. The microstructure is typical of 1215. This grade of steel is not suitable for welding because of the high sulfur and phosphorous contents.

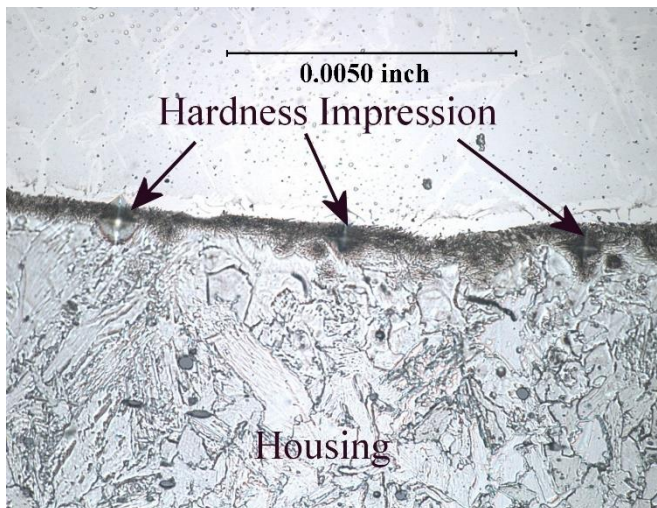
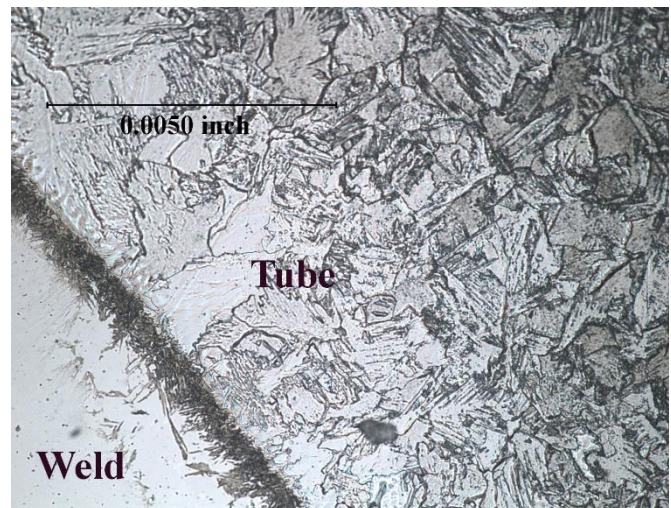
The hardness of the intermix zones 1 and 2, indicates that the steel is very brittle. The reason for this is pick-up of carbon by the austenitic stainless steel from the valve housing steel.

Figure 7 – 400X Interface between Housing and Weld Metal

Figure 8 – 400X Intermix Zone between Tube and Weld Metal

Figures 7 and 8 show the interfaces between the housing steel, hydraulic tubing, and the weld metal. Bands of tempered martensite were formed due to carbon being picked up by the weld metal. Martensitic intermix zones occur when carbon steels are welded with austenitic stainless steel. These zones are often quite brittle and are the weak location in the weld joint.

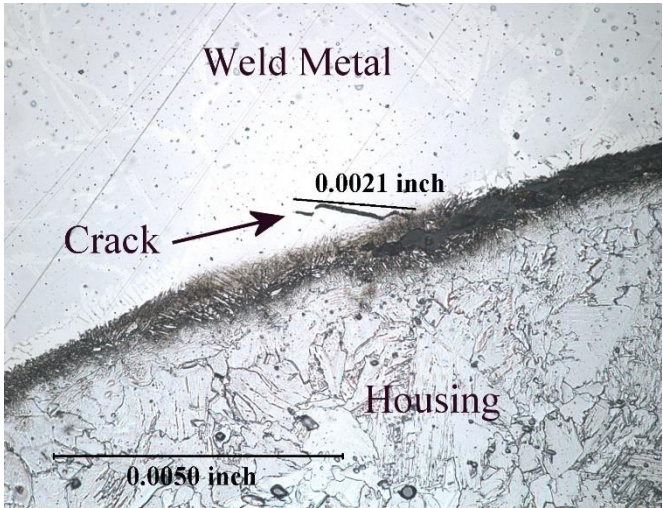
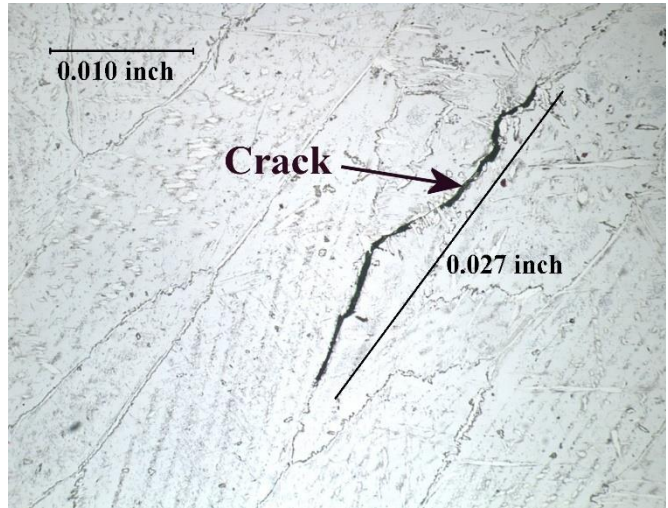
Figure 9 – 400X Crack in Weld Metal

Figure 10 – 100X Crack in Weld Metal

Figures 9 and 10 show cracks in the weld metal. Both of these cracks were hot cracks caused by phosphorous and sulfur pick-up from the housing steel. The etched microstructure of the weld metal, shown in Figure 10, indicates the weld metal was austenitic stainless steel.
