M. E. Williams and Associates, Inc.

Case Study: Erosion Corrosion

Failure analysis of a heat exchanger coil that had been in service for a short period of time to determine the cause of water leakage from the coil. The coil was examined by visual examination, scanning electron microscopic examination, energy dispersive x-ray analysis (EDS), and metallographic examination. A leaking coil from this system had been examined by another company and they concluded that the leaking was due to manufacturing defects and not caused by the water used in cooling the system. Our task was to identify any manufacturing defects, and to provide recommendations on how to prevent them.

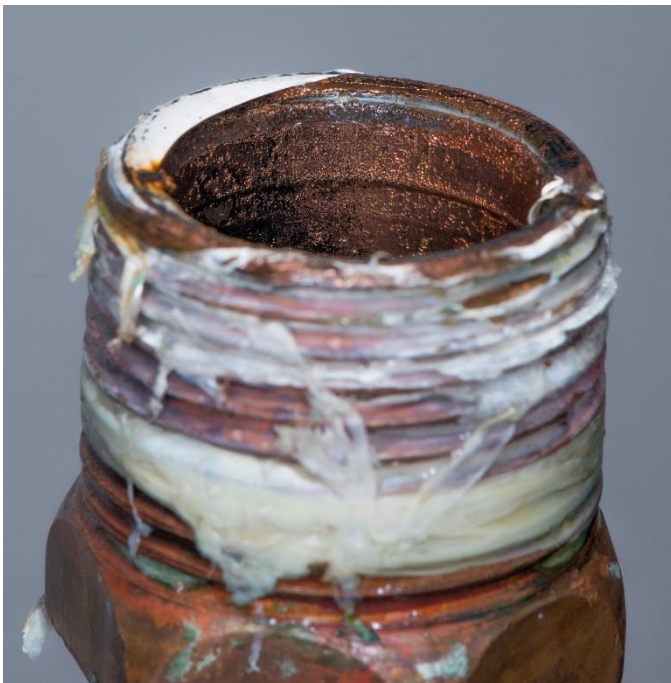
Figure 1 – Fitting

With just a preliminary macro examination, it was clear that this fitting showed evidence of erosion, and of having been chemically etched. The leaks in the system were obviously the result of problems with the cooling water. Figures 1 and 2 show the chemical and mechanical attack to the fitting.

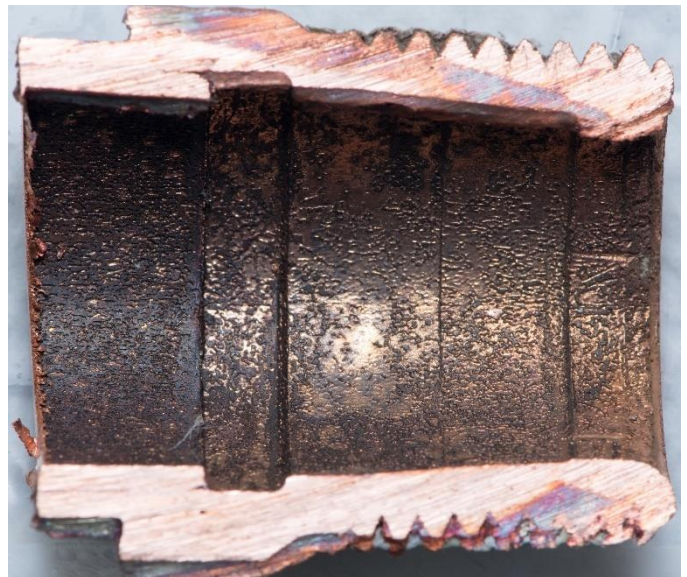
Figure 2 – Fitting after Sectioning

Figure 2 shows a fitting after sectioning. The inner surface of the fitting showed evidence of erosion, cavitation, and possible chemical etching. Erosion is caused by high velocity fluid flow. Cavitation occurs when there is a mixture of a gas and a liquid flowing over a metal surface. Some of the surfaces appeared to have been chemically etched. These surfaces were free of any deposits, and grain boundaries were visible.

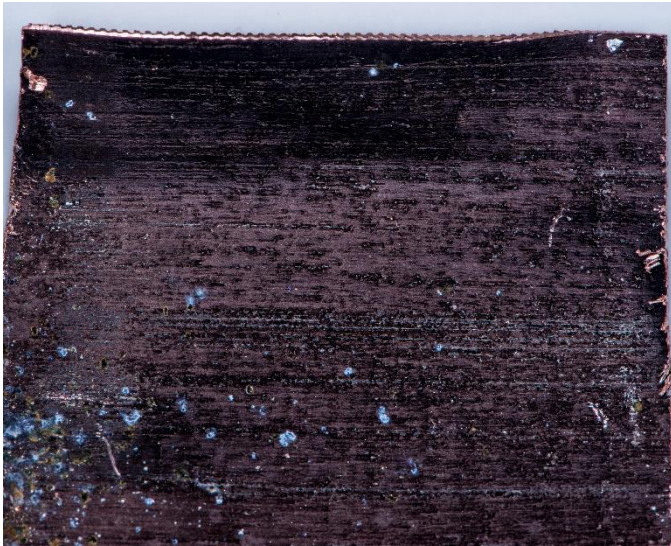
Figure 3 – Sheet Tube 1

Figure 3 shows black copper oxide scale and longitudinal striations on the inside diameter of a sheet tube removed from the coil. The tube showed evidence of erosion and cavitation beneath the black oxide layer. Figure 4 shows another sheet tube removed from the coil. There were clear indications of erosion and cavitation on this section of tubing.

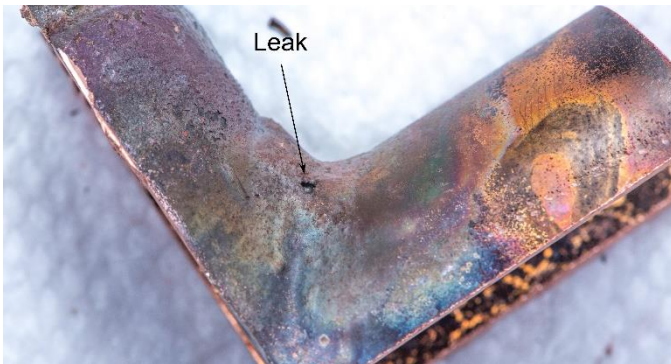
Figure 5 – Pinhole Leak

The location of a Pinhole Leak is shown in Figure 5. Figure 6 shows the inside diameter of the braze joint associated with the leak. There was no evidence of the leak's origin on the inside diameter. There was evidence of cavitation.

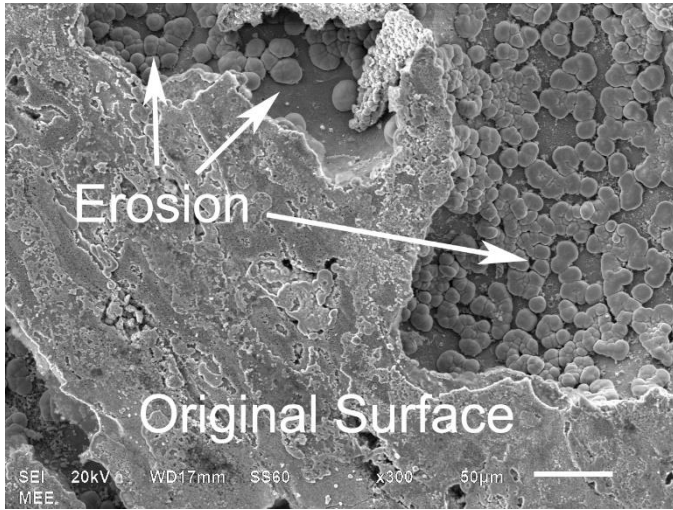
Figure 7 – 300X Fitting Surface

Figure 7 shows the inside diameter of the Fitting Surface using a Scanning Electron Microscope. The original surface is the smooth area. The locations of erosion are also indicated. The areas where erosion had occurred had copper oxide nodules forming on them, indicating that the conditions causing the erosion had stopped, and normal water circulation had resumed.

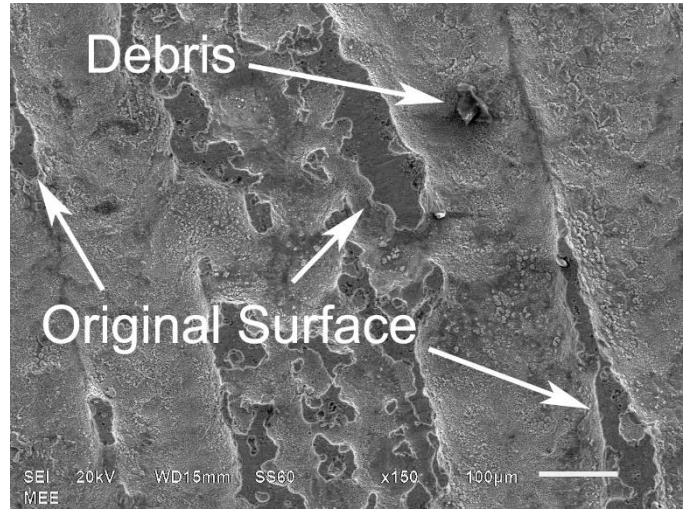
Figure 8 – 150X Tube 1 Surface

The inside diameter of Sheet Tube 1, from Figure 3, is shown in Figure 8 at a higher magnification using the SEM. The longitudinal ridges were formed by material having been eroded away. Copper oxide nodules were forming in the eroded areas, indicating that the condition that caused the erosion had ended. The debris particle indicated was less than 50 microns in size, and had been circulating in the water system. Figure 9 is the EDS spectrum of the debris particle. The two elements present that indicated possible corrosion problems were nitrogen and sulfur. Nitrogen compounds can cause stress corrosion in copper, and sulfur can cause pitting corrosion.

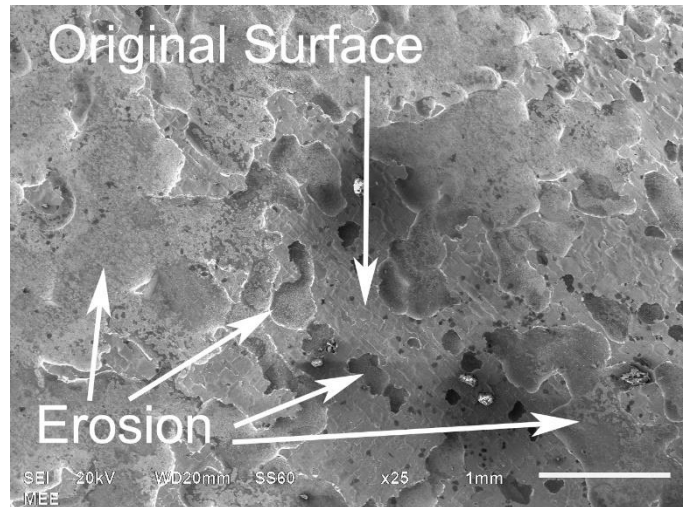
Figure 10 – 25X Tube 2 Surface

The surface on the inside diameter of Sheet Tube 2 shown in Figure 4, is shown at higher magnification in Figure 10. Figure 11 shows an eroded area at higher magnification. The EDS spectrum of one of the black spots on the original surface is shown in Figure 12. The spectrum shows that nitrogen was present.

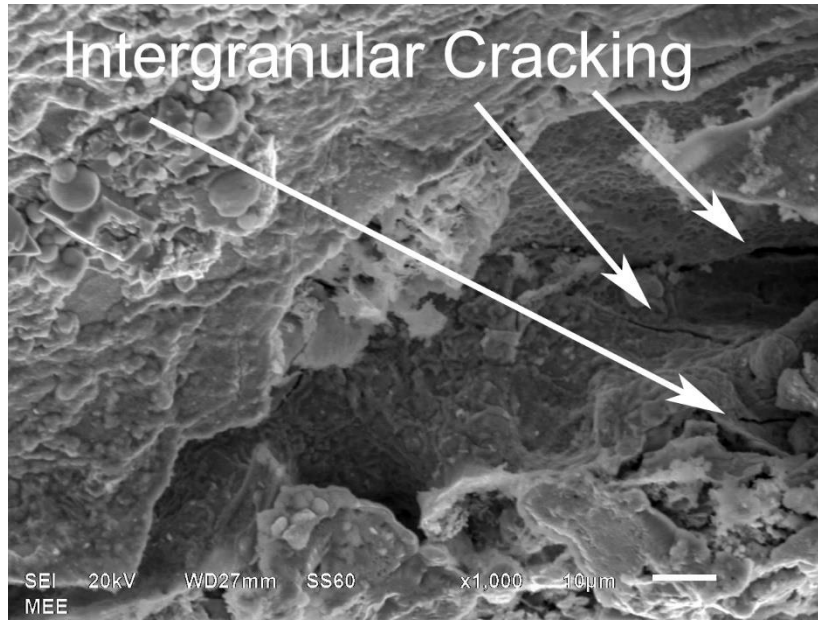
Figure 13 – 1000X I. D. Braze Joint

The Pinhole Leak location from Figure 5, and shown in the SEM photo in Figure 13, was likely the source of the leak in the braze joint. The opening shown was at the interface of the copper tubing and braze metal. There were indications of corrosion and of intergranular cracking. Nitrogen compounds cause intergranular cracking in copper and copper alloys. Sulfur compounds are associated with pitting corrosion of copper and copper alloys.

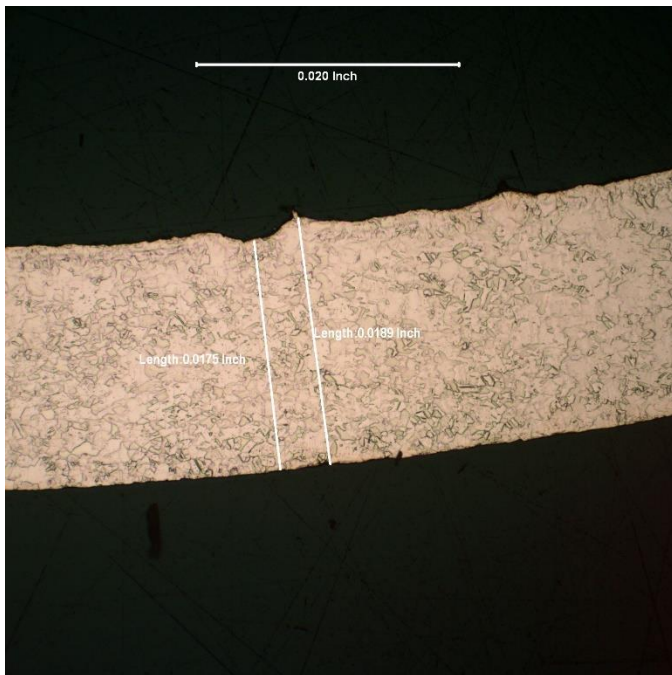
Figure 14 – 100X Sheet Tube

The thickness of the sheet tubes was 0.020 inches. Figure 14 shows the wall thickness of a sheet tube removed from the coil. The thickness of the ridge was 0.0189 inches, and the thickness of the eroded location was 0.0175 inches. This was a significant amount of erosion.

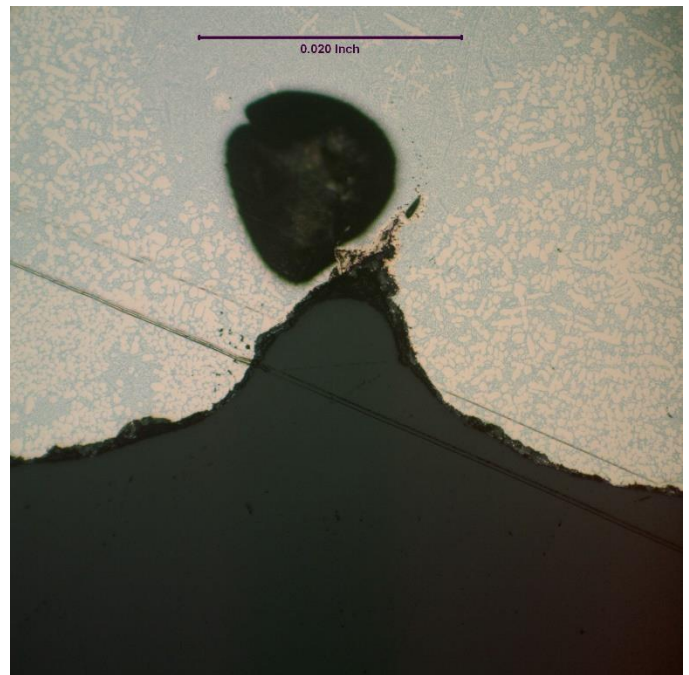
Figure 15 – 100X Pinhole Leak

Figure 15 shows the cross section of the Pinhole Leak shown in Figure 7. This leak is typical of many leaks found in heat exchangers and does not go straight through the metal, or, in this case, the braze joint. The large porosity next to the leak location is typical of braze material. Occasionally leaks will develop along lines of porosity, but that did not appear to be the case here.

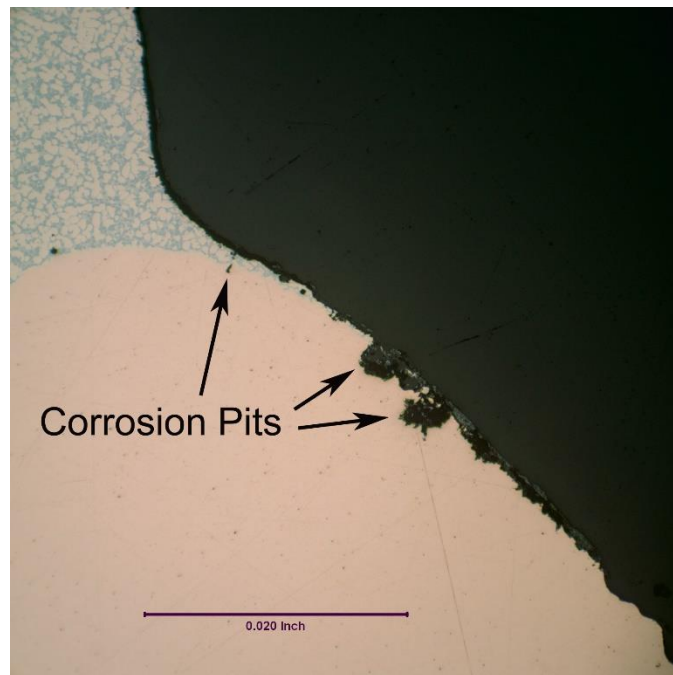
Figure 16 – 100X Corrosion Pits

The inside diameter of the braze tube section is shown in Figure 16. There were corrosion pits at the interface of the braze metal and copper tubing. These pits were likely the result of galvanic corrosion, where the copper is the anode to the cathodic braze metal. This means that the water in the system was electrically conductive, indicating that the water was very contaminated.
