M. E. Williams and Associates, Inc.

Case Study: Hurricane Damage to Hotel Computer System

Scope of Investigation

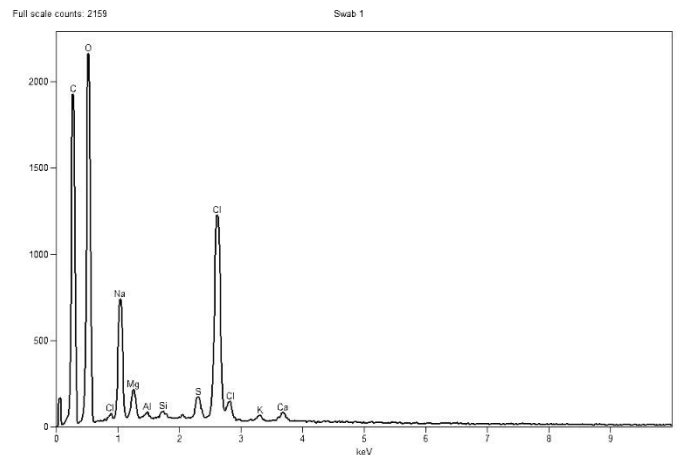
Figure 2 – Spectrum, Outdoor Grill IDF Sample

The Outdoor Grill IDF, (Intermediate Distribution Frame), was exposed directly to sea water during the hurricane. The spectrum of the sample taken from the equipment there, Figure 2, shows the presence of elements that would be expected from sea water: sodium, magnesium, silicon, sulfur, chlorine, potassium, and calcium. Aluminum, also present, indicates corrosion of the device’s housing. Figure 3 shows very fine particles collected on the surface of a sampling swab. The particles from two locations on the swab were analyzed. The presence of aluminum and iron, found in both Locations 1 and 2, indicates corrosion of the device’s cabinet and hardware.

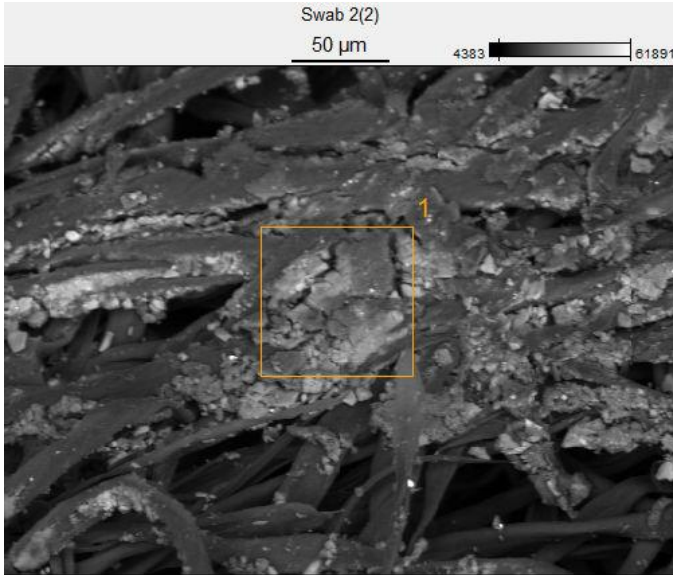
Figure 6 – 400X Spectrum Location on Main Server Sample

Figure 6 shows the material removed from the Main Server. The material appears to be gummy in nature. The spectrum is shown in Figure 7. The high levels of aluminum, iron, and phosphorous, along with sea salt, can explain this gummy condition. Phosphorous, in the form of iron phosphate, is often used as a primer for better paint adhesion on aluminum and would cause a gummy residue. There are clear indications of corrosion on this server housing.

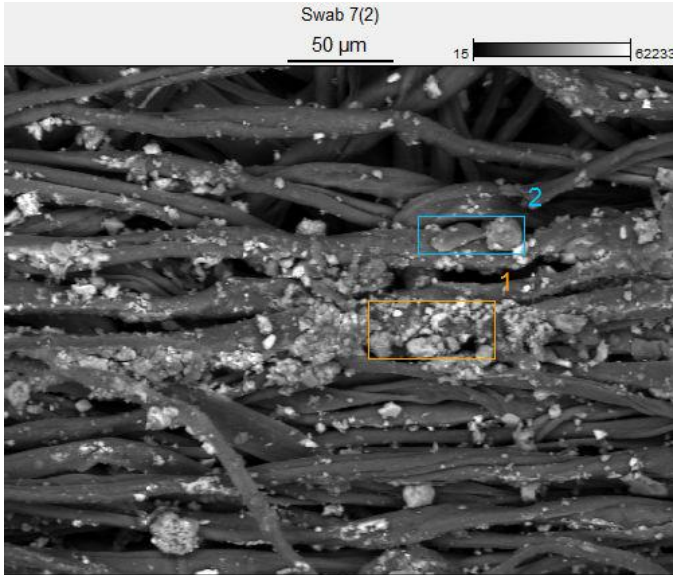
Figure 8 – 400X Spectra Locations, Guest MDF Sample

Figure 8 shows spectra locations for the Guest MDF, (Main Distribution Frame), Sample. The spectrum for Location 1 is shown in Figure 9. The high levels of magnesium, silicon, sulfur, and calcium are likely the result of sheet rock dust from repairs being done in the hotel when samples were taken. Figure 10, Location 2, shows the presence of sea salt, plus iron.

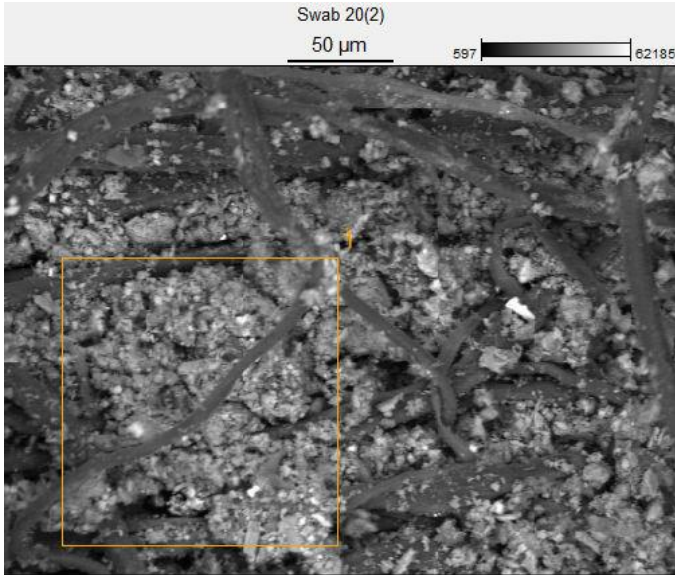
Figure 11 – 400X Spectrum Location, Electronics Closet IDF Sample

Figure 11 shows the general spectrum location for the Electronics Closet IDF Sample. The spectrum is shown in Figure 12, and indicates the presence of sea salt, sheet rock dust, and corrosion of cabinet materials. Figure 13 shows the lower right corner of Box 1 in Figure 11. The two crystals, Locations 1 and 2, were of interest. Location 1 is a sea salt crystal, and Location 2 appears to be a clay material, as indicated by high levels of aluminum and silicon.

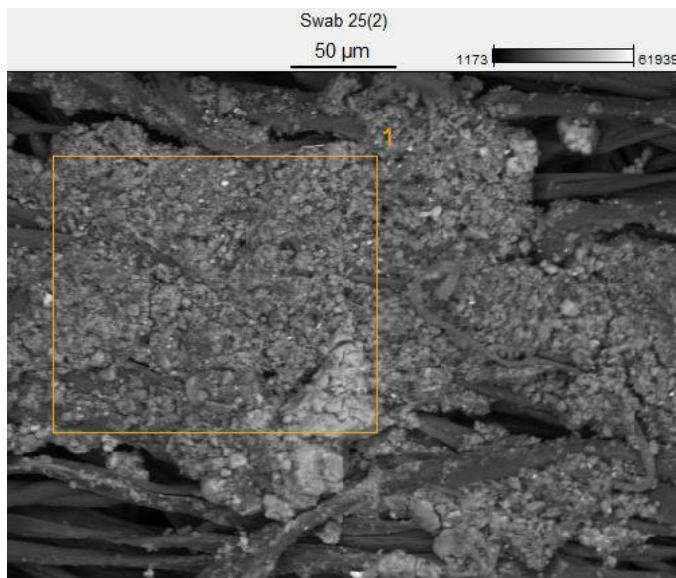
Figure 16 – 400X Spectrum Location, Outbuilding 2nd Floor IDF Sample

Figure 16 shows the spectrum location for the Outbuilding 2nd Floor IDF Sample. The spectrum, Figure 17, shows sea salt, and corrosion products from cabinet materials and hardware, as indicated by aluminum, iron, and zinc. The presence of titanium is likely due to paint pigment.
