New Supplier Approval

Evaluation of two (SJ) SAE Grade 8 Bolts to determine their suitability for use in equipment assembly. The bolts were examined by hardness testing and metallographic examination. The reason for this study was that there was a problem with Grade 8 bolts being sold in the United States at the time of this evaluation. There are many defects that affect the life of a product that are most easily identified by metallographic examination. These defects usually cannot be found by non-destructive testing methods.

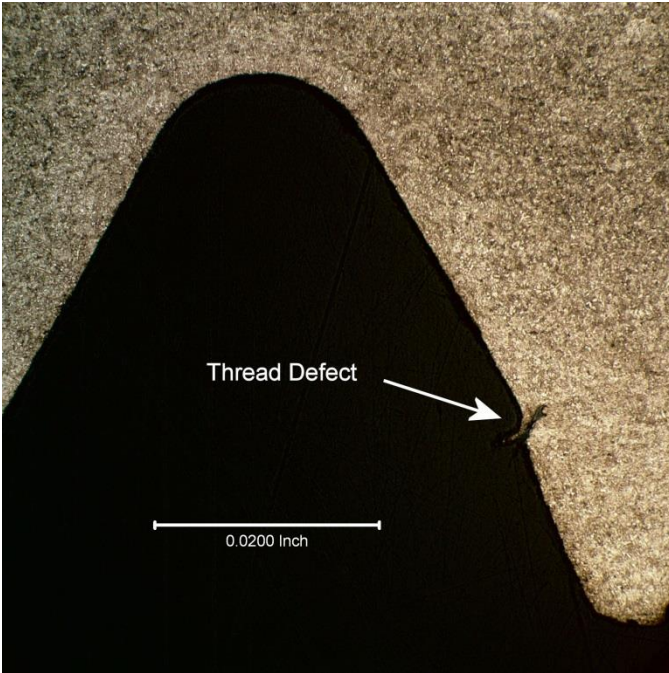
Figures 1 and 2 show thread defects found in Bolt 1. The defects were likely the result of seams on the steel bar or wire used to manufacture the bolts. Most of the threads examined had at least one surface defect. The defect in the right hand threads of Figures 1 and 2 were sharp, and could act as stress risers for fatigue. The large number of thread defects found on this bolt means that it was not suitable for use in dynamically loaded applications.

Figure 1 – 100X Thread Defect Bolt 1

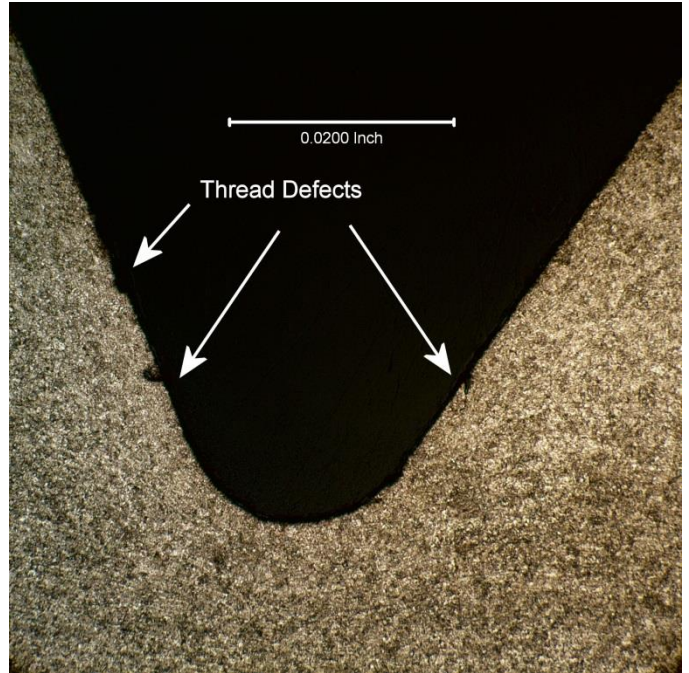
Figure 2 – 100X Thread Defects Bolt 1

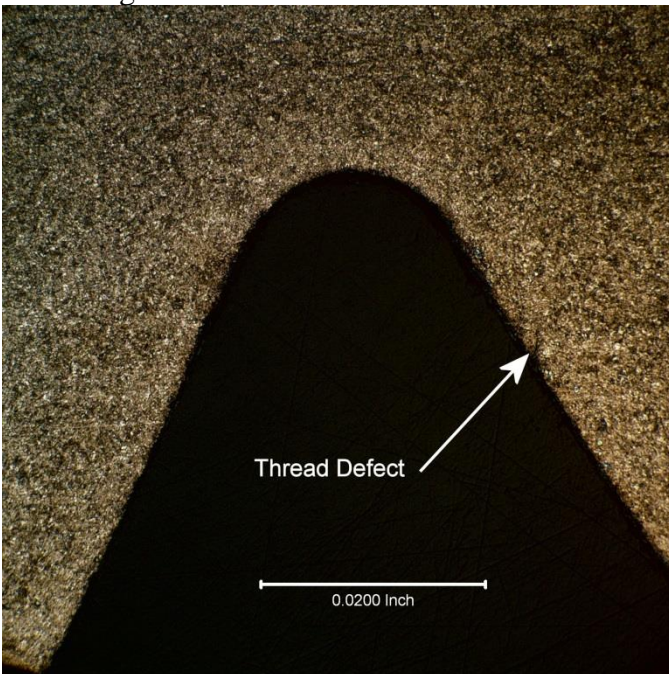
Figure 3 – 100X Thread Defect Bolt 2

Bolt 2, Figures 3 and 4, had the same type and similar number of defects found in Bolt 1. These defects were the result of defects in the steel used to produce the bolts.

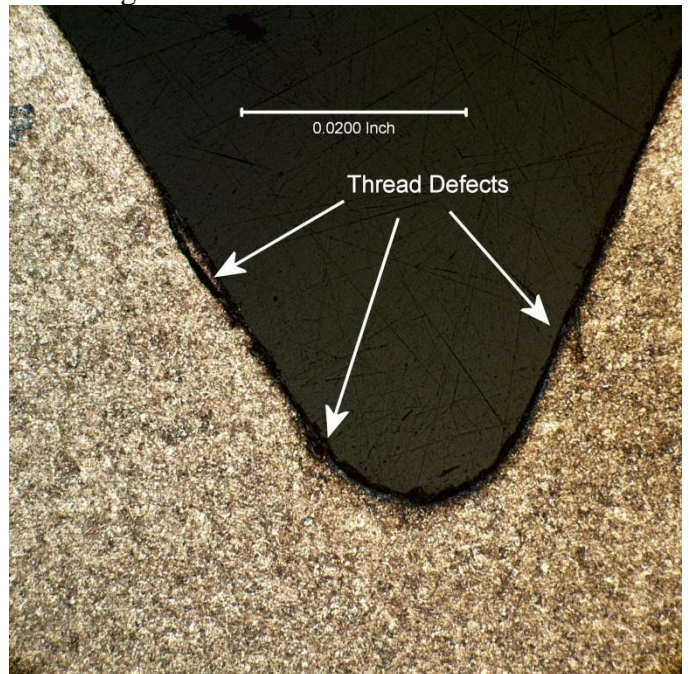
Figure 4 – 100X Thread Defects Bolt 2

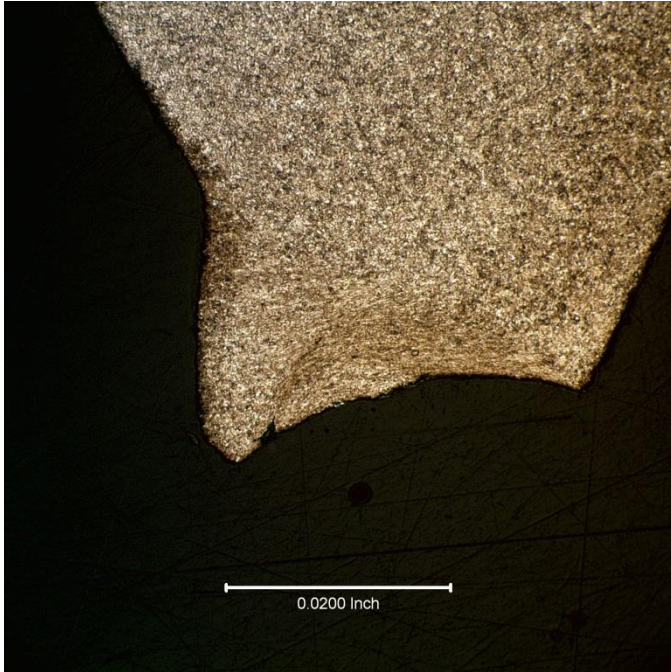
Two of the threads on Bolt 2 had defects that were the result of thread rolling, Figures 5 and 6. These defects could result in reduced clamping loads when the bolts are torqued, because of the misshaped threads increasing the friction between the bolt and nut.

Figure 5 – 100X Thread Rolling Defect Bolt 2

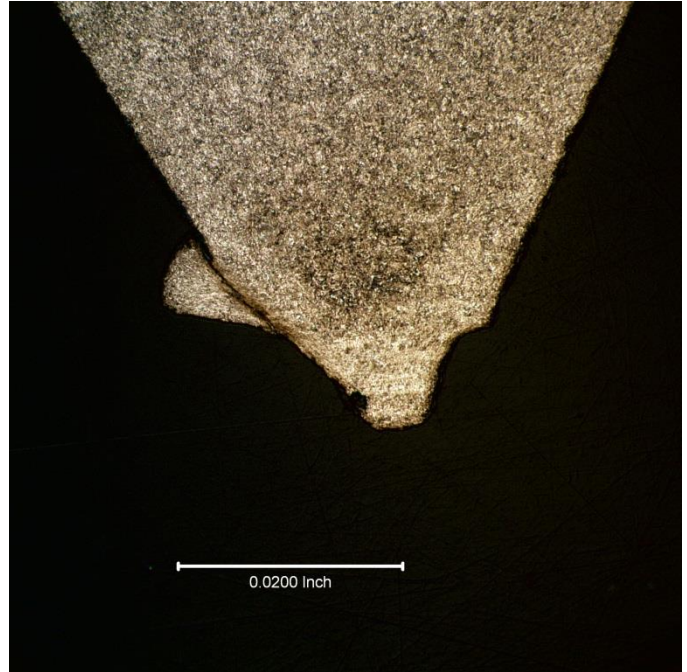
Figure 6 – 100X Thread Rolling Defect Bolt 2
