# *M. E. Williams and Associates, Inc.*

## Case Study: Paint Failure

Examination of paint from a small town Minnesota Water Tower to determine the cause of paint failure. Paint chips that had fallen from the tower were collected for examination, and other samples were removed from the tower structure. The samples were examined by visual examination, microscopic examination, scanning electron microscopic and energy dispersive x-ray analysis, and chemical analysis.

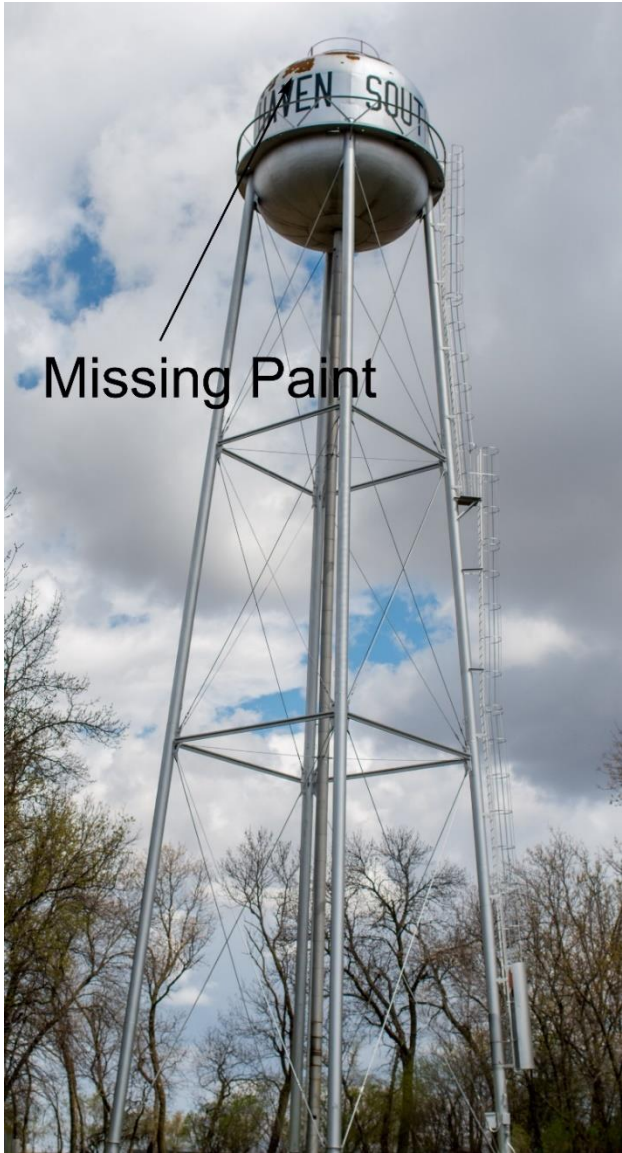
Figure 1 – Water Tower Overview

Visual examination of the Water Tower showed that large sections of paint were missing from the top of the tower, Figures 1 and 2. A Google Earth Satellite photo, which was taken one year earlier than our examination, shows some spots on top of the water tower that were likely bare of paint, but not to the extent shown in Figures 1 and 2.

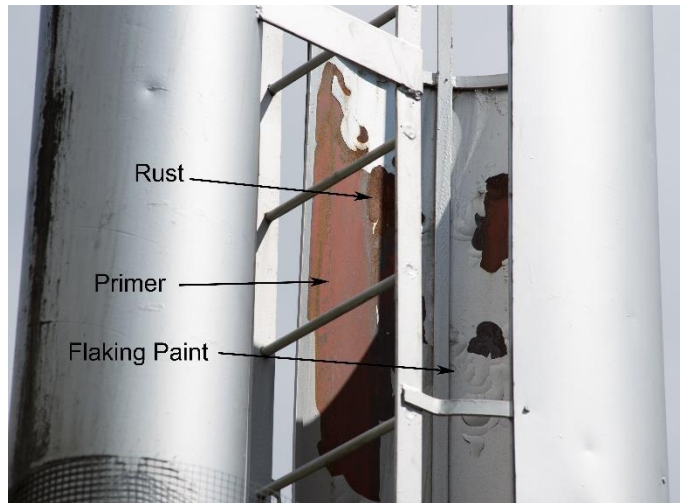
Figure 3 – Missing Paint on Personal Protection Cage

There were also large sections of paint missing from the personal protection cage at the bottom of the ladder running up a tower leg, Figure 3. The rusted locations indicated that the paint was missing prior to the date of loss. Cracking or chipping of the paint allowed moisture to be trapped beneath the paint layer, causing the paint to flake off. The paint chips found were fairly fine due to the grass around the tower having been mowed, Figure 4, but were still viable as samples.

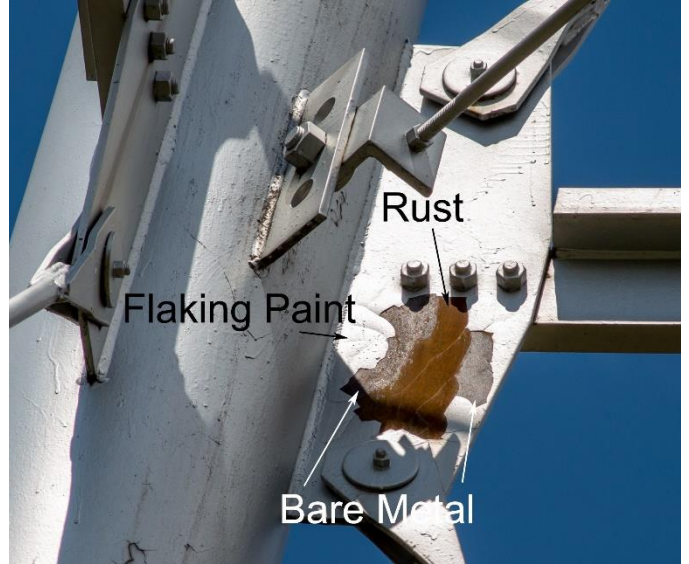
Figure 5 – Flaking Paint on Leg Tower Bracket

There was flaking and missing paint on a leg crossie bracket, Figure 5. The bracket showed both rusted steel and bare metal. The rusted steel indicated that the paint had been missing for a period of time, or water had gotten under the paint. Paint blisters similar to the one shown in Figure 6 allow water to get between the paint and steel on any steel structure, causing the paint to flake off, as shown in Figure 5.

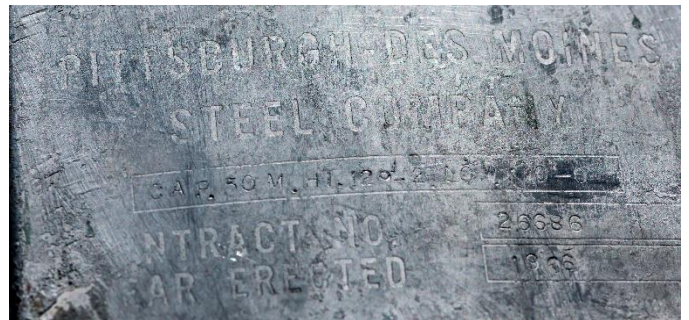
Figure 7 – Tower Manufacturer’s Label

Figure 7 shows the water tower’s manufacturer’s label, which showed it was erected in 1966. The tower was 52 years old at the time of examination.

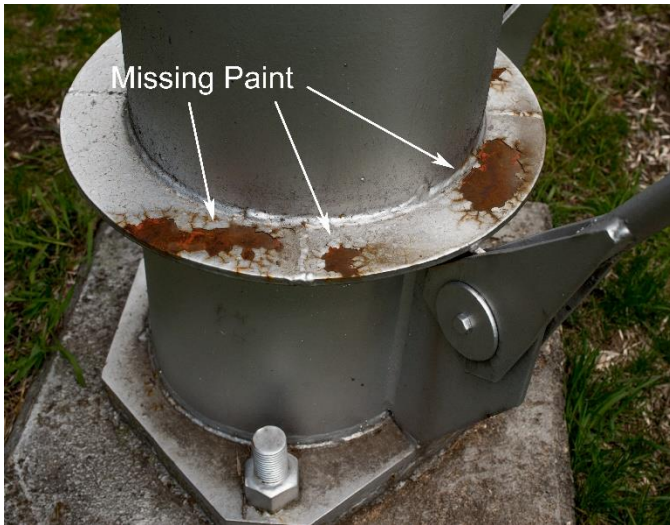
Figure 8 –Leg Base Flange

A Leg Base Flange is shown in Figure 8. The paint was flaking off the steel as shown. In the areas indicated, there was no paint adhesion to the underlying steel. A paint sample was removed for further testing.

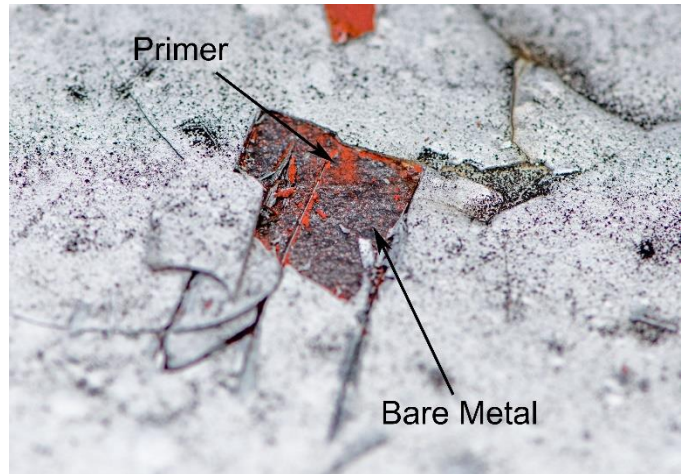
Figure 9 – Cross Hatch Paint Adhesion Test - Leg Base Flange

A cross hatch paint adhesion test was conducted on the paint on a Leg Tower Flange, Figure 9. There was very poor adhesion at this location. Some of the primer was still adhering, but for the most part, there was no adhesion. Paint samples were removed from the flange for further testing.

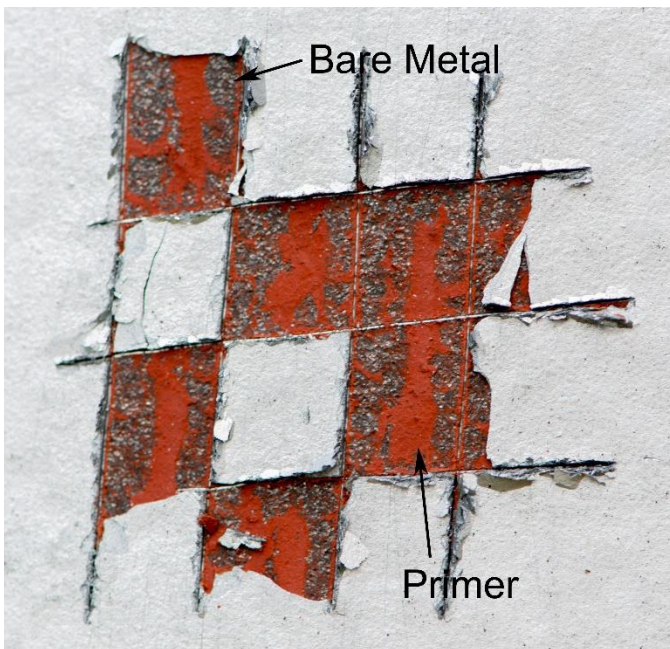
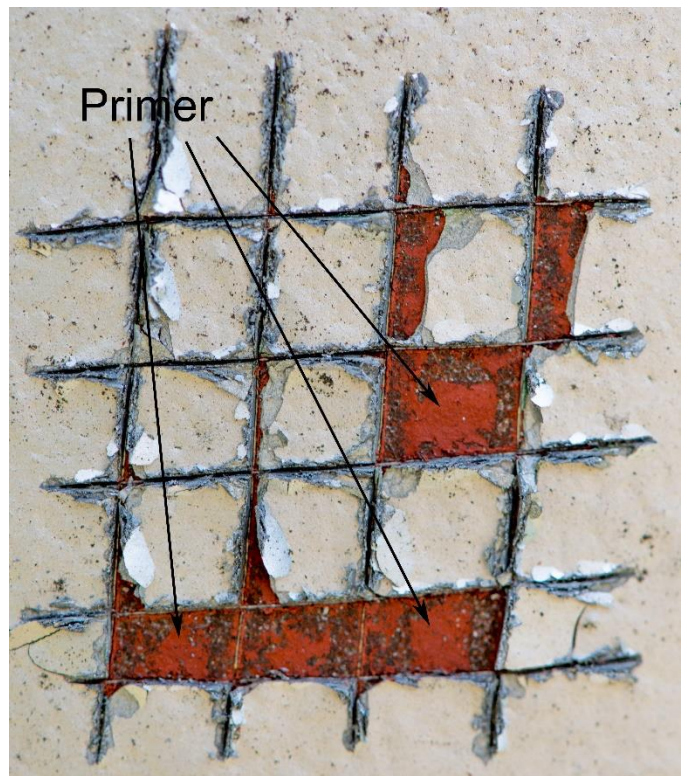
Figure 10 – Cross Hatch Paint Adhesion Test on Tower Leg

Figure 11 – Cross Hatch Paint Adhesion Test on Tower Leg

The paint adhesion on two different tower legs was poor, as shown in Figures 10 and 11. It appears that only about 50% of the primer was still adhering to the steel.

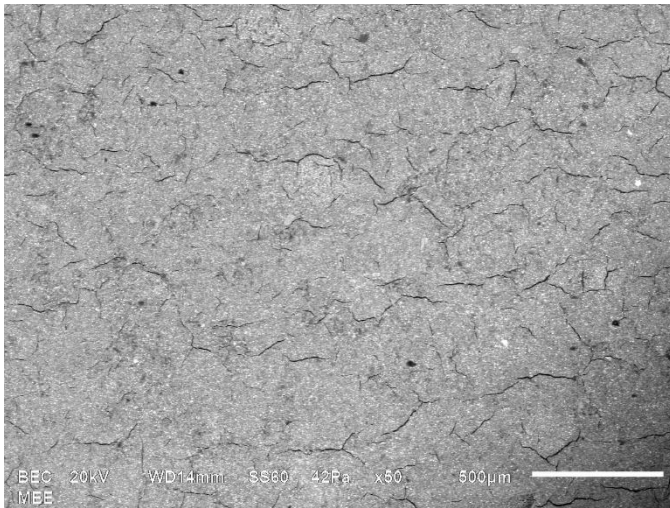
Figure 12 – 50X Primer Surface of Paint Sample 1

Paint Sample 1 was the paint material picked up from the ground around the east tower leg. The primer surface of the paint, Figure 12, was examined with a scanning electron microscope. The primer layer was cracked, indicating that the primer was brittle. The energy dispersive x-ray, EDX, spectrum of this surface is shown in Figure 13. The spectrum shows a significant quantity of lead present in the primer. Since the sale of lead based paints and primer has been banned since January 1, 1991, the presence of lead in the primer flakes means that the ground surrounding the water tower was contaminated with lead. The semi-quantitative analysis of the primer is given in the table that follows.

The cracking in the primer layer, shown in Figures 12 and 14, indicated that the primer had become brittle. All paints and primer continue to age and become brittle after many years.

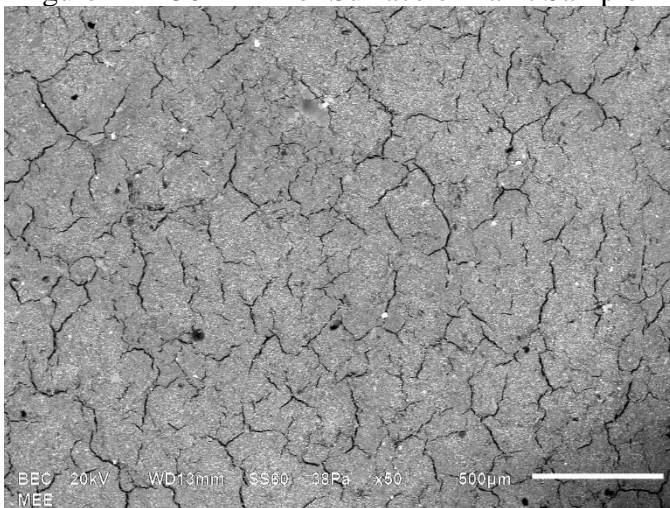
Figure 14 – 50X Primer Surface of Paint Sample 2

Paint Sample 2 was removed from another Leg Base Flange. Examination by the scanning electron microscope showed that the primer layer was cracked, Figure 12. The EDX spectrum shows the presence of lead, Figure 13. The semi-quantitative analysis of Sample 2 is given in the table that follows.

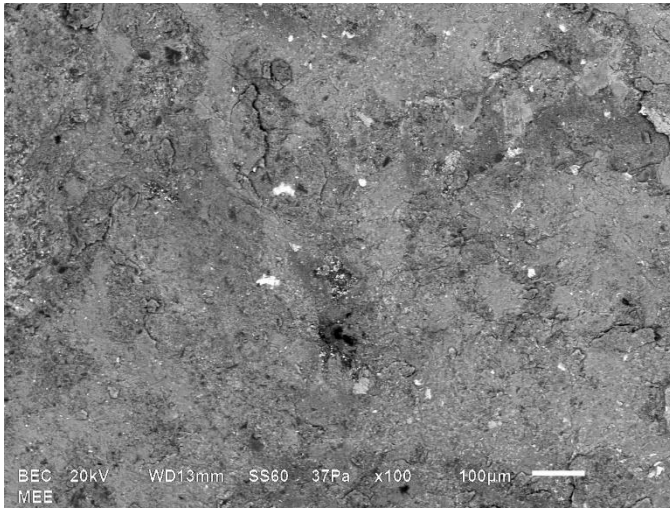
Figure 16 – 100X Primer Surface of Paint Sample 3

Paint Sample 3 was removed by the cross hatch test on a tower leg. The primer surface is shown in Figure 18. The EDX spectrum is shown in Figure 19. Lead was present at this location. The semi-quantitative analysis is given in the table that follows.

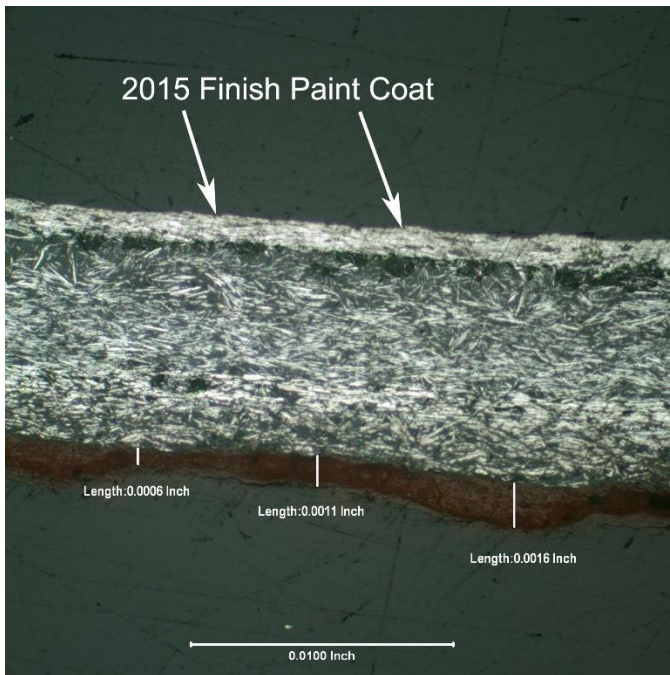
Figure 18 – 200X Cross Section - Paint Sample 1

The cross section of Paint Sample 1 is shown in Figure 18. The average thickness of the primer layer was 0.0011 inches. Typically, primer layers are at least 0.002 inches in thickness. There could have been three coats of aluminum paint present. There were definitely two coats present. City officials indicated that the tower was repainted in 2000, and again in 2015, for touch up and repair. At the writing of this report, there were no official records of the work being done in 2000.

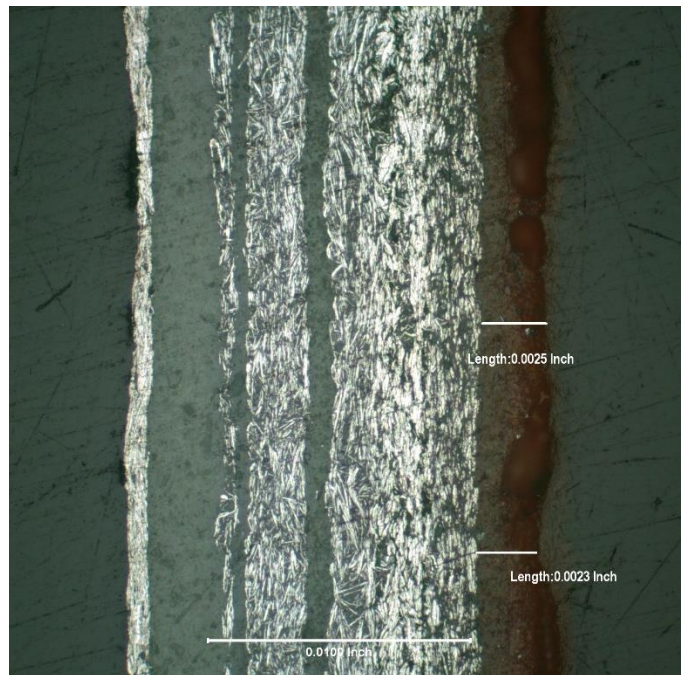
Figure 19 – 200X Cross Section - Paint Sample 2

Paint Sample 2 was much thicker than Paint Sample 1, Figures 18 and 19. The primer layer on Paint Sample 2 was over 0.002 inch thick, and there were two primer coats present. Each of the primer coats was approximately 0.001 inch thick. There could have been six or seven total coats of paint on this sample.
