M. E. Williams and Associates, Inc.

Case Study: Laser-cut Steel

Merlin E. Williams, P.E.

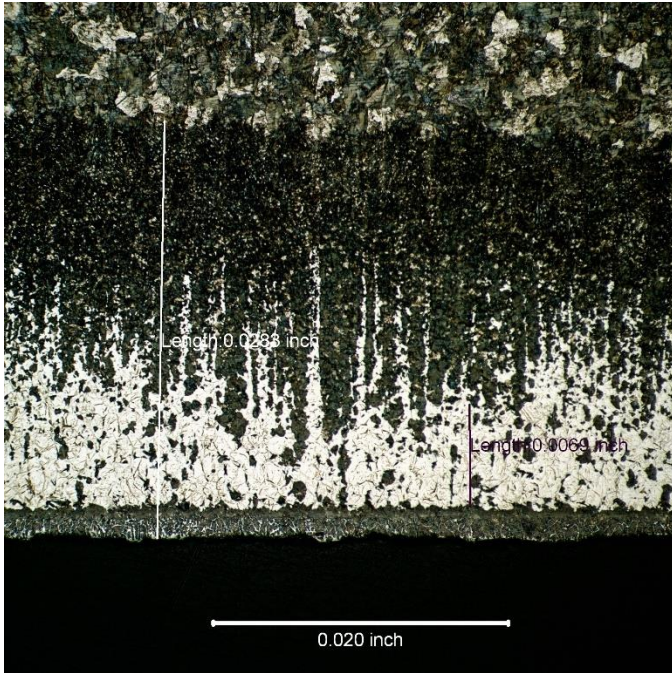
Figure 1 shows the microstructure affected by the laser cutting. There was a layer at the surface which consisted of bainite and bands of white martensite, Figure 2. This layer was between 0.002 and 0.003 inch thick, and was likely very brittle, even though the hardness was in the low 40's on the Rockwell C Scale. Figure 1 shows a layer of very fine grained bainite. The thickness of the combined layers was 0.025 to 0.030 inches.

Figure 1 – 100X Layers Caused by Cutting

- 1) Without pre-heating, laser cutting is not suitable for this part because it leaves a very brittle layer of untempered martensite.
- 2) Pre-heating to 200° F. would eliminate the formation of untempered martensite in this part.

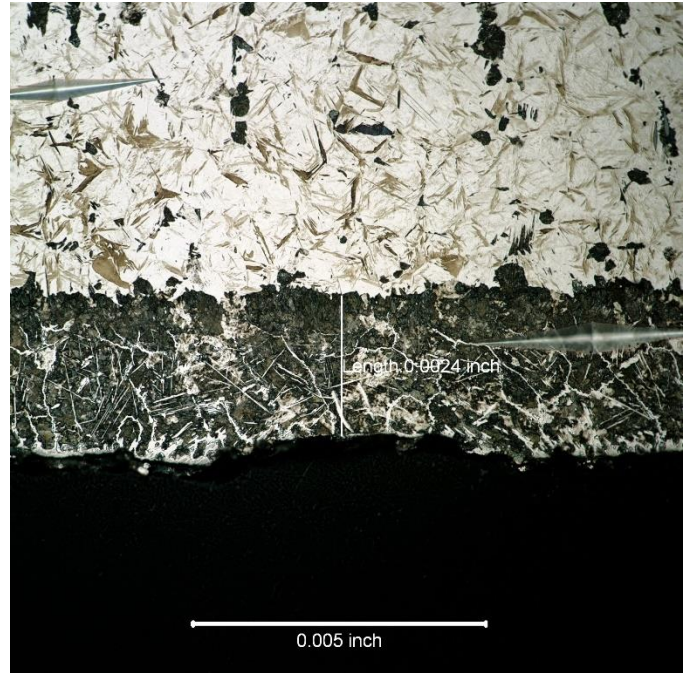
Figure 2 – 400X Surface Layer

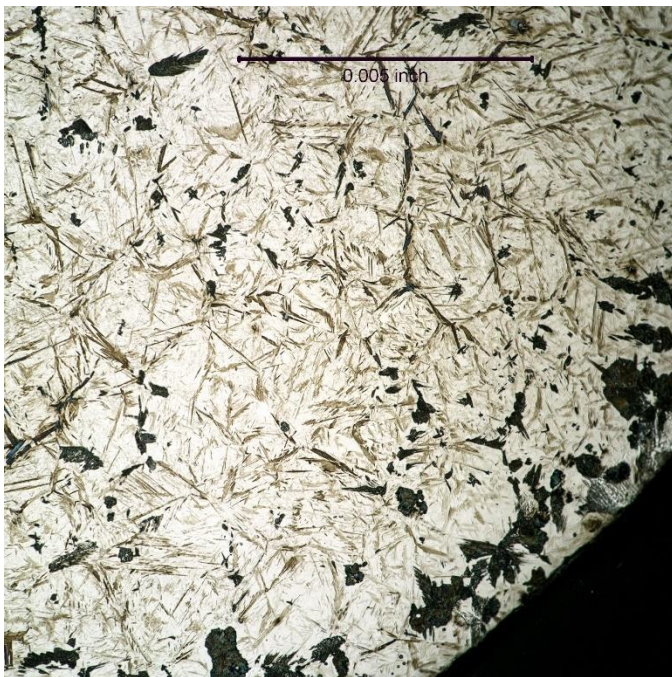
The layer that was of greatest concern was the white martensite layer that had a hardness of 61 on the Rockwell C Scale. This layer would be very brittle, and would likely result in premature failure of the part.

Figure 3 – 400X White Martensite at Corner

The white or untempered martensite layer was thickest at the corners of the part, and made up most of the heat affected zone, Figure 3. Untempered martensite has very poor fracture toughness and was not an acceptable microstructure for this application. The black areas are Bainite. The 1084 material core of the part is shown in Figure 4. The core consisted of fine grained bainite and pearlite.

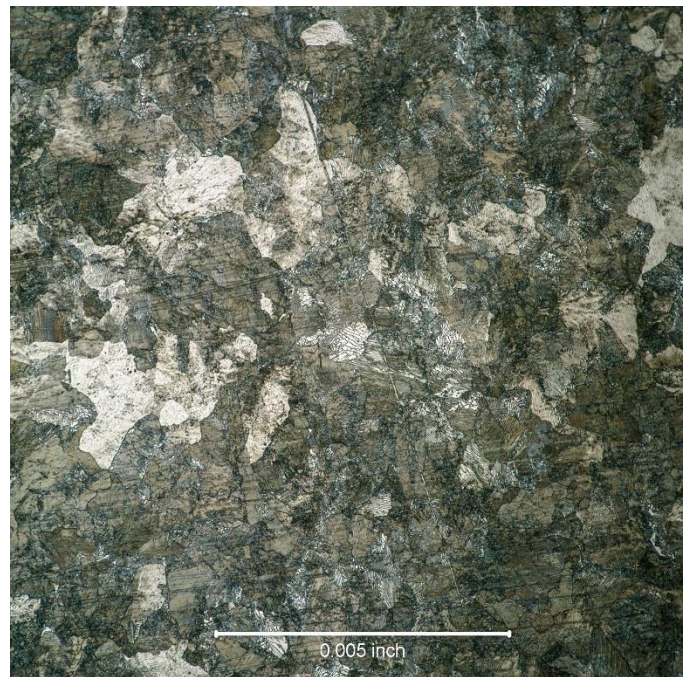
Figure 4 – 400X Core Microstructure
