<u>M. E. Williams and Associates, Inc.</u>

304L Stainless Steel Failures - Case Study

Merlin E. Williams, P.E.

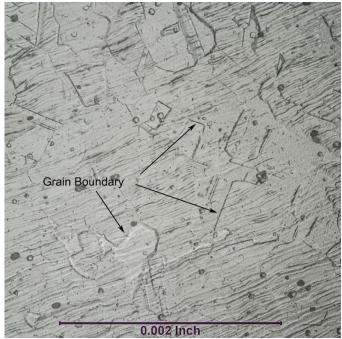
Figure 1 shows the etched microstructure of a sample of 304L stainless steel which had not been sensitized. This is a very good example of high quality 304L stainless steel.

Figure 1 – 1500X Grain Boundaries Free of Chromium Carbides

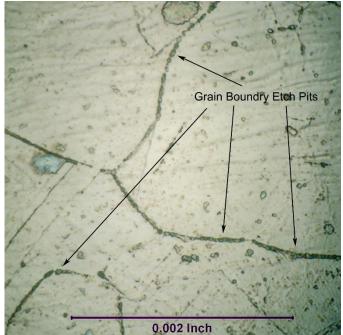
Figure 2 shows sensitized grain boundaries in 304L stainless steel. This sample was lightly electrolytically etched with saturated oxalic acid. The round and oval etch pits indicate the presence of chromium carbides. Tubing formed from this lot of 304L stainless steel failed by stress corrosion cracking after being in service for a few months.

Figure 2 – 1500X Sensitized Grain Boundaries with Chromium Carbides Present
