Case Study: Stainless Steel Ammonia Evaporator Coil

Merlin E. Williams, P.E.

Scope of Examination

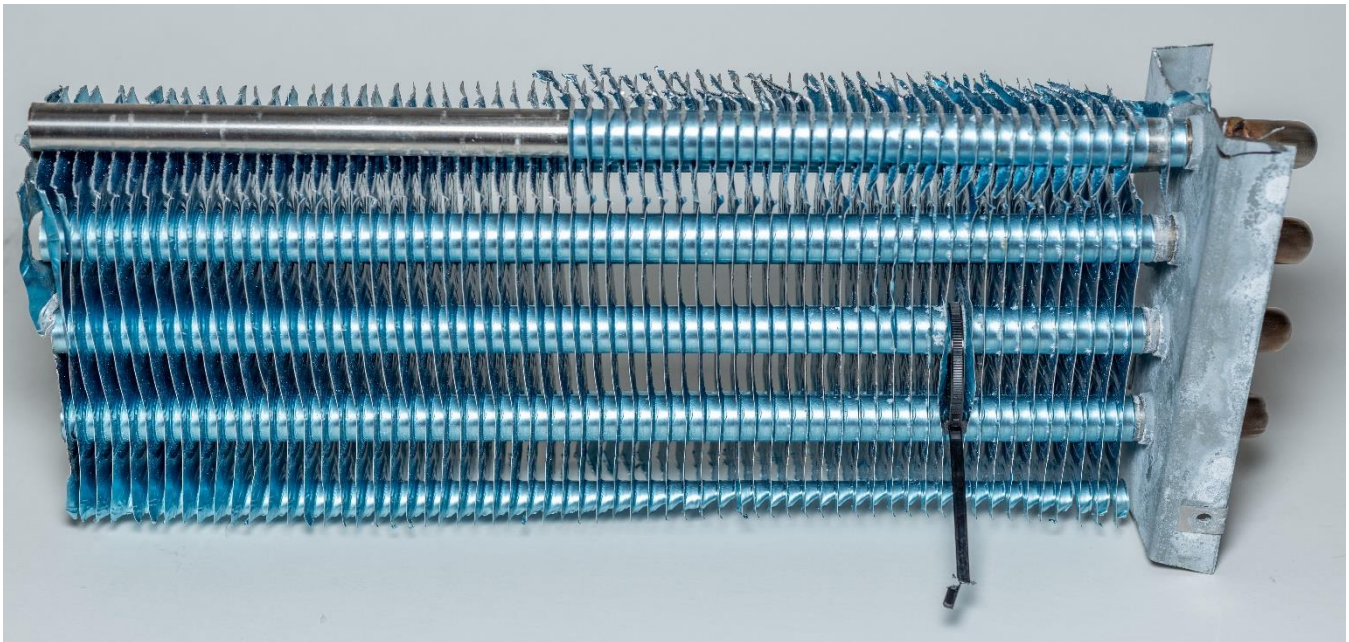
Figure 1 – Coil Sample As-Received

Figure 1 shows the section of the evaporator coil as-received. The leak location was marked with a black cable tie.

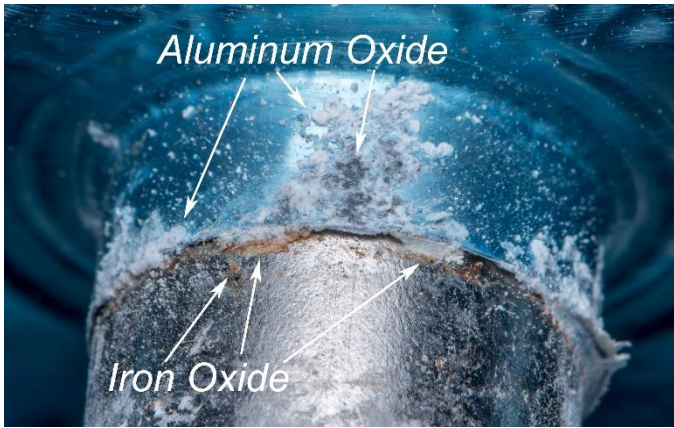
Figure 2 – Leak Location and Blue Fin Material

The red-brown material found, Figure 2, was primarily iron oxide, the source of which was unknown. Figure 3 shows the leak area after the fin was removed.

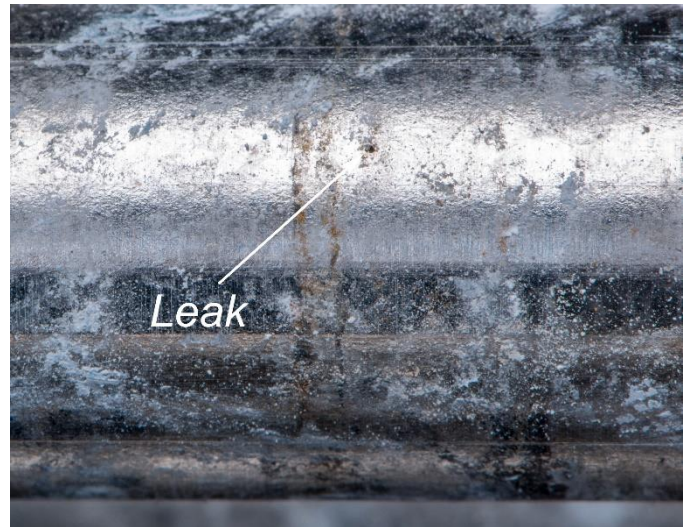
Figure 3 – Leak Location

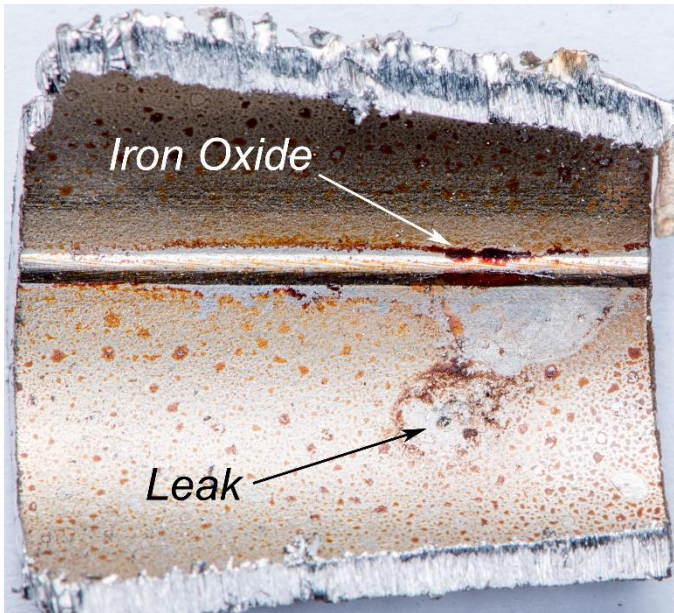
Figure 4 – Leak Location I.D.

The inside of the tube with the leak location indicated is shown in Figure 4. The red/brown material was mostly iron oxide. Figure 5 shows a location in the same tube where there was pitting corrosion, but no leak. The longitudinal ridge running the length of the tubing indicates that this was welded tubing.

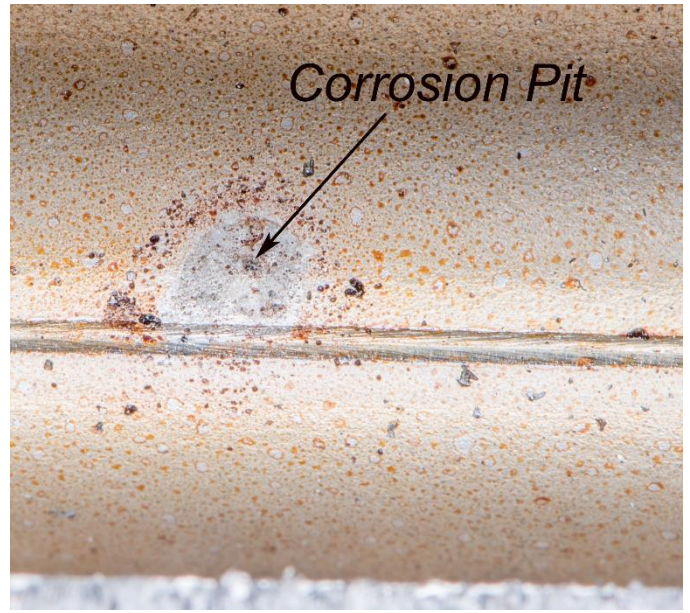
Figure 5 – Corrosion Pit on Sample 1 I.D.

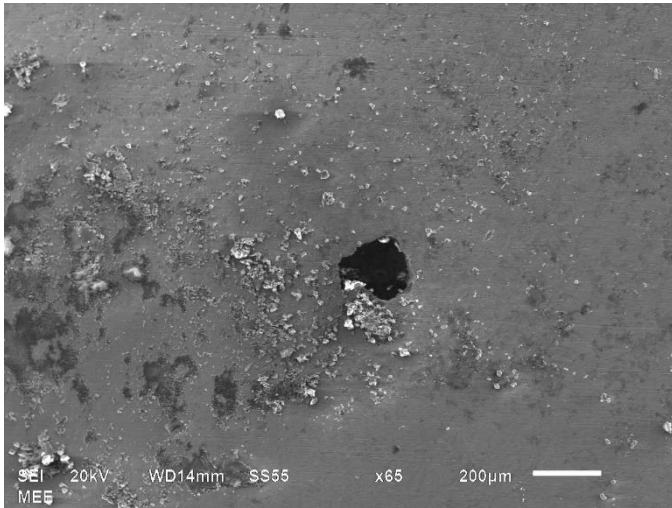
Figure 6 – 65X Leak O.D.

Figure 6 shows the leak on the outside diameter of the tube. Figure 7 shows pitting corrosion next to the hole. Pitting corrosion in 304 stainless steel is usually caused by wet chlorides.

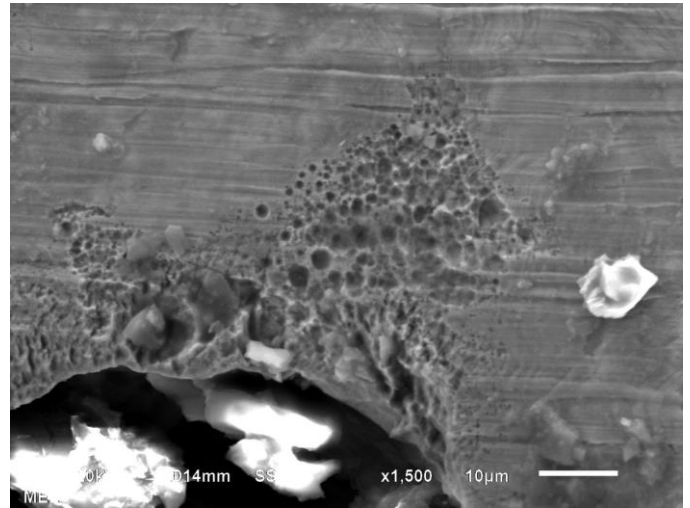
Figure 7 – 1500X Pitting Corrosion on Leak Periphery on Sample 1 O.D.

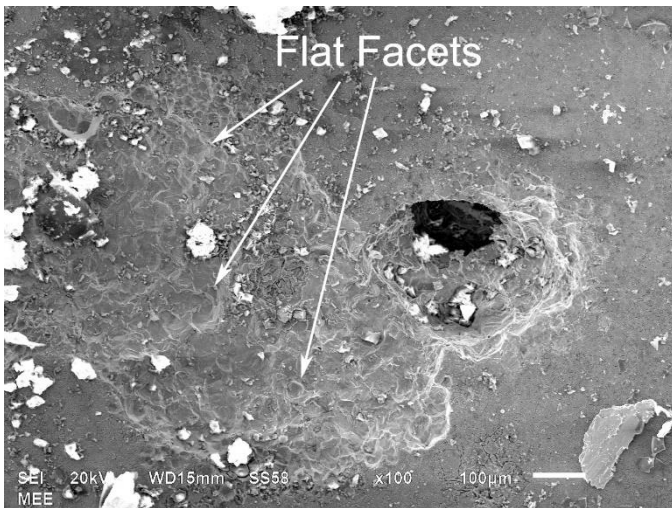
Figure 8 – 100X Corrosion and Leak Location Tube I.D.

Figure 8 shows the leak on the inside diameter of the tube. The flat facets in the area indicated that the corrosion was intergranular pitting corrosion. In order for intergranular pitting corrosion to occur, the stainless steel needs to be sensitized. Sensitization of austenitic stainless steels is caused by the formation of grain boundary chromium carbides when the material is heated during welding, or some other high temperature process, and the carbon content is 0.04% or greater.

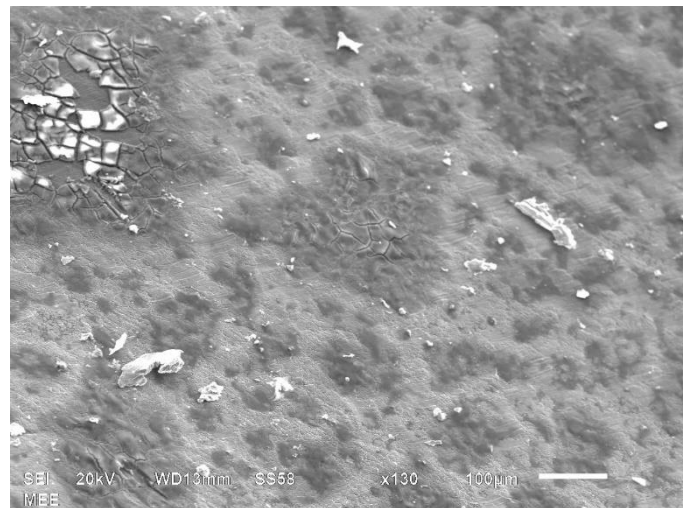
Figure 9 – 130X Deposits I.D.

Figure 9 shows deposits on the inside diameter of the tube.

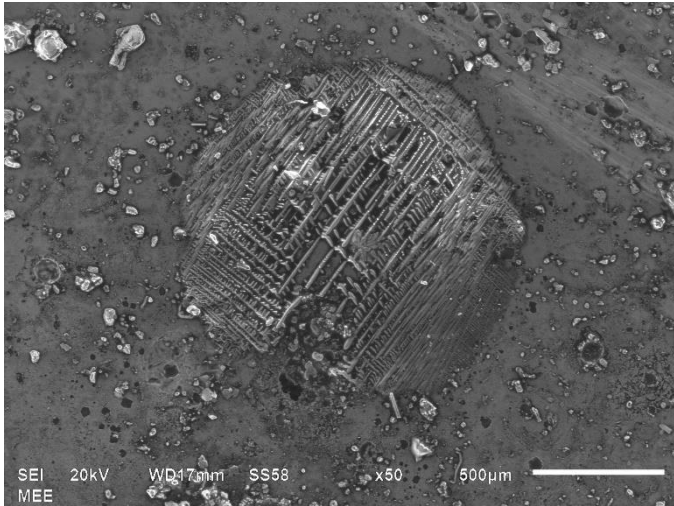
Figure 10 – 50X Crystalline Growth Tube I.D.

Figure 10 shows the beginning of growth of a crystalline material on the inside diameter of the tube.

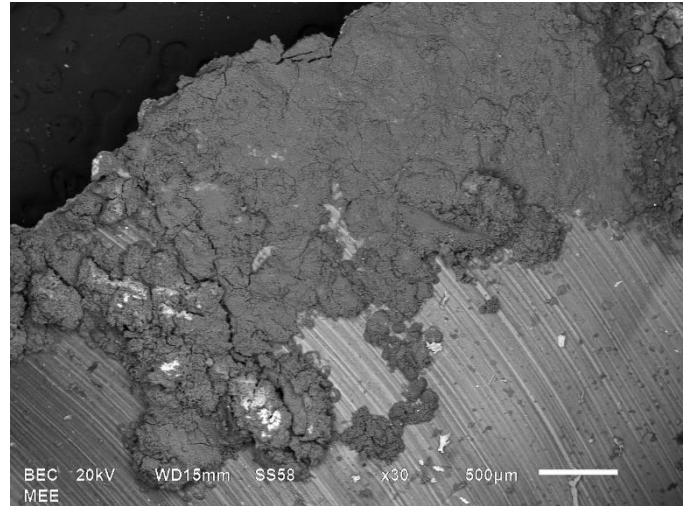
Figure 11 – 30X Corrosion Products on O.D. of Blue Fin Material

The corrosion products on the Blue Fin Material, Figure 2, are shown in Figure 11. This is typical of aluminum corrosion.

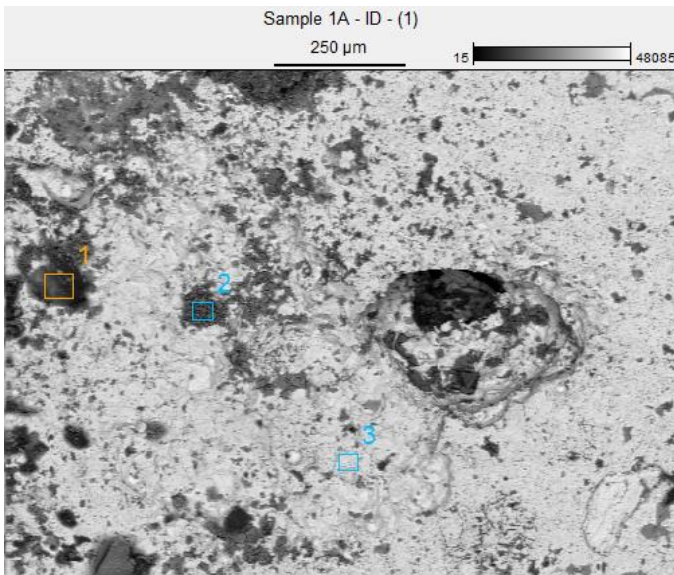
Figure 12 – Spectra Locations near Leak on I.D.

Figure 12 shows the locations where the debris was associated with the corrosion pit on the inside diameter of the tube. The SEM image was made in the back scatter mode; therefore, the darker material has the lowest atomic weight. Carbon based materials show up as black. The semi-quantitative analysis for the three locations is given in Table 1. The spectra shown in Figure 13 indicates the unusual presence of carbon, sodium, aluminum, phosphorous, sulfur, and chlorine. Chlorine in the form of chlorides is highly corrosive to 304 stainless steel. The spectra shown in Figure 14 indicates the presence of the same unexpected elements, plus calcium. Figure 15 is the spectra for an area of clean 304 stainless steel.

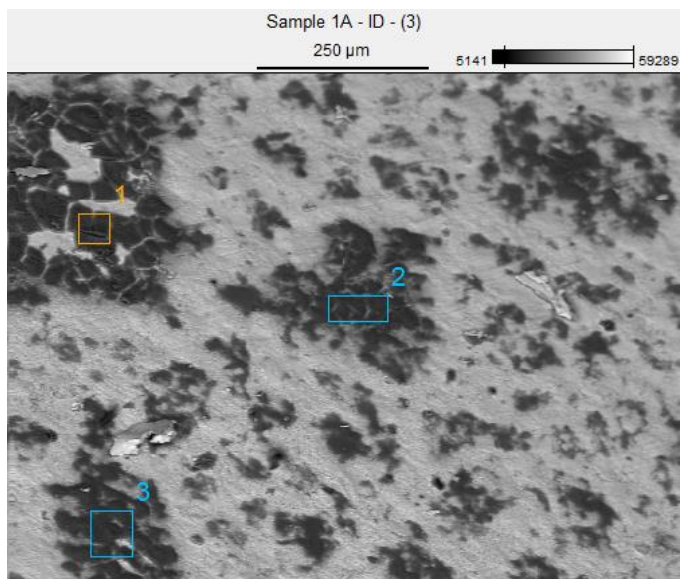
Figure 16 – Spectra Locations for Spots on Tube Wall

The three spots that were analyzed on the tube wall, Figure 16, were virtually identical. The three spectra, shown in Figures 17, 18, and 19, show the presence of iron oxide, organic material, sodium chloride, and stainless steel. The semi-quantitative analysis of these locations is given in Table 2.

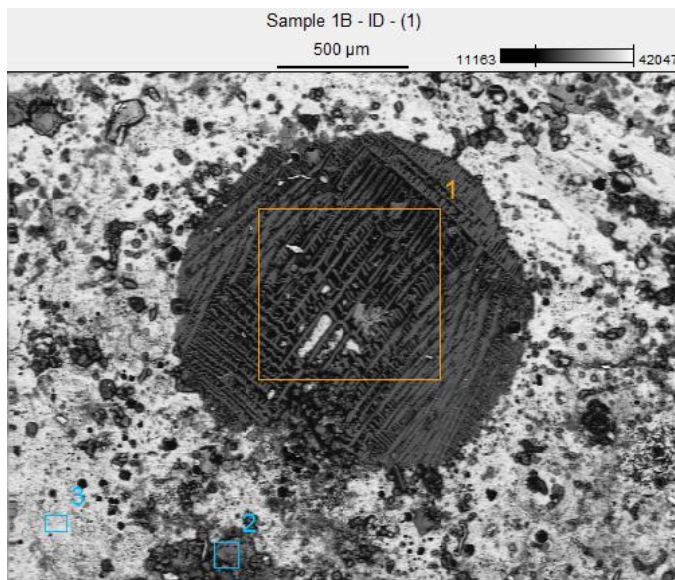
The large spot on the inside diameter of the tube, Figure 20, has a spectrum, Figure 21, that indicates that the crystalline material is likely a chlorinated amine salt. The remainder of the spectrum is from the underlying stainless steel.

Figure 20 – Spectra Location for Corrosion on Tube Wall

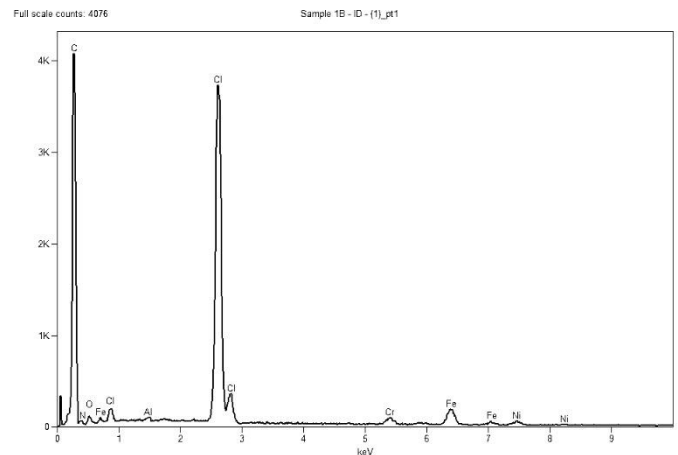
Figure 21 – Spectrum of Location 1 Corrosion on Tube Wall

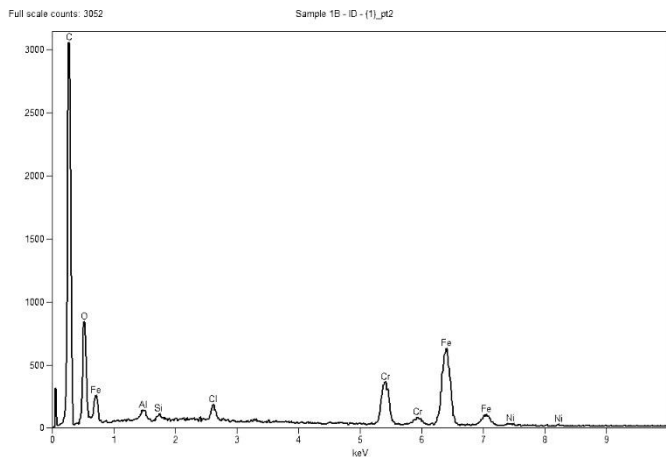
Figure 22 – Spectrum of Location 2 Deposit on Tube Wall

The spot analysis for Location 2, Figure 22, shows organic material, a chloride salt, and underlying stainless steel. Location 3 is similar, but the stainless steel is more prevalent. The semi-quantitative analysis is given in Table 3.

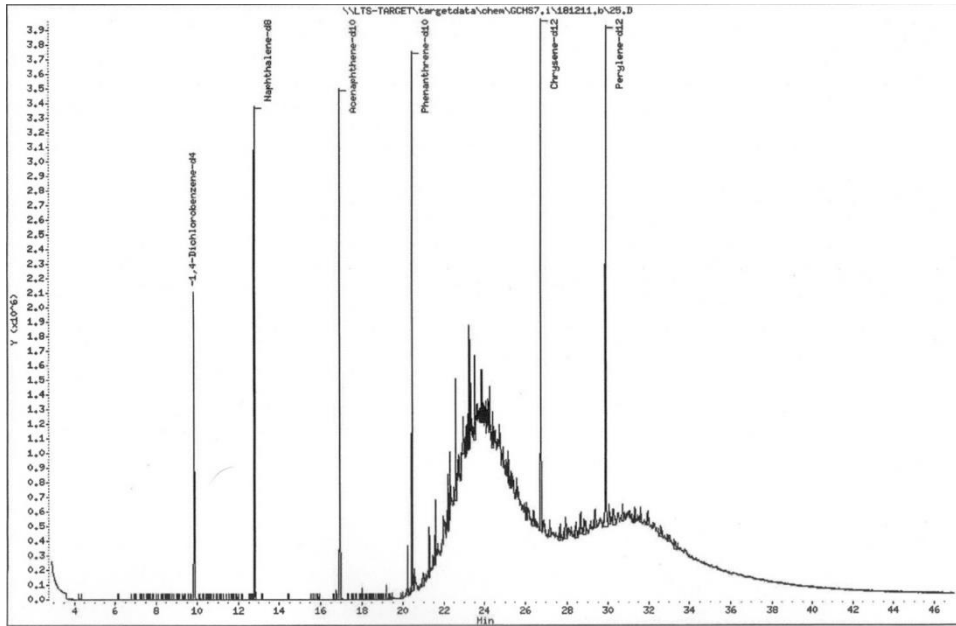
The scan indicates that the residual organic material was consistent with mineral oil, diesel oil, and Compressor Oil ISO 68, which is used with liquid ammonia and carbon dioxide systems.

The red/brown color of the residual oxidized oil is due to the presence of iron oxide. Red iron oxide, Fe_3O_4 , is a strong oxidizer which would oxidize the oil residue causing it to adhere to the tube inside diameter.

Figure 24 – CGMS Scan for Organic Material in Tube

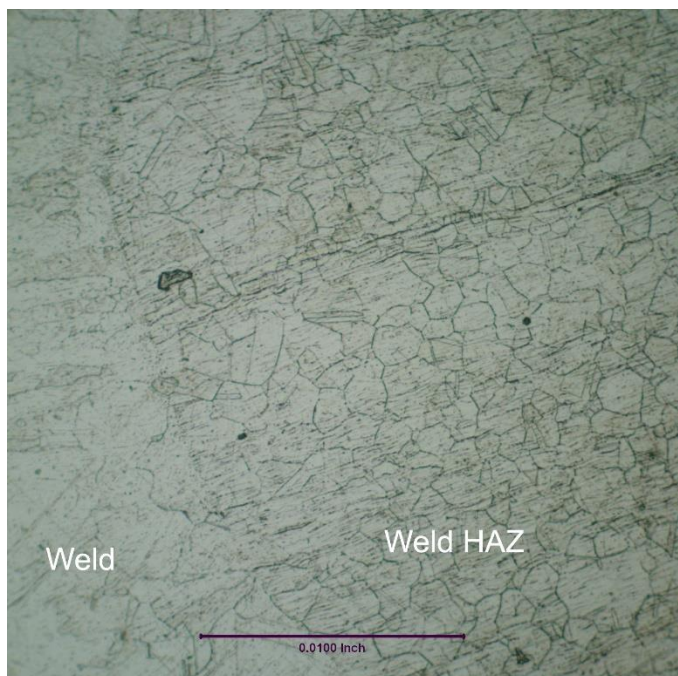
The weld and weld heat affected zones in the tube are shown in Figure 25. The grain boundaries in the heat affected zones were sensitized. Sensitized grain boundaries are caused by heating to between 1000 and 1550 degrees F. The sensitization was the result of formation of chromium carbides in the grain boundary. Chromium carbides have very poor corrosion resistance. The tubing used for this coil was not annealed after welding. Figure 26 shows sensitized grain boundaries.

Figure 25 – 200X Weld and Weld HAZ

The investigation showed that the 304 stainless steel tubing was sensitized, especially in the weld heat affected zone, making the tubing no more corrosion resistant than carbon steel tubing would have been. Sensitization of 304 stainless steel can be avoided by using 304L stainless steel. The tubing was certified by the tubing mill as being free of sensitization using one of the practices other than ASTM 262 Practice A. The sensitized weld heat affected zone was so small that it is not likely that these other practices would have detected the sensitized heat affected zone. Several other coil manufacturers experienced stainless steel coil failures due to sensitization during this time frame with tubing from different tube mills. Both 304 and 304L stainless steel are prone to pitting corrosion in the presence of chlorides and would eventually fail even without having been sensitized.

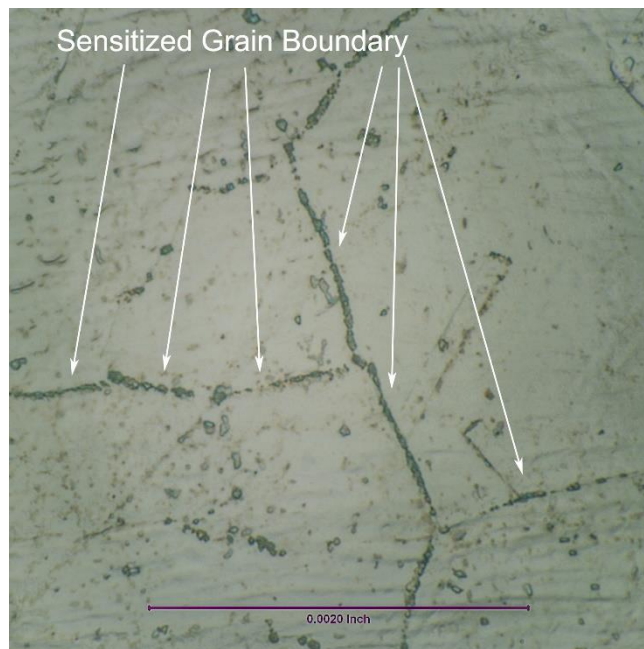
Figure 26 – 1500X Sensitized Grain Boundaries
