M. E. Williams and Associates, Inc.

Water Damage Inspection

Participation in a lawsuit inspection involving all contractors of a six year old home that had water damage in the daylight basement level. The purpose of the inspection was to verify the cause of water damage and determine the likely contribution resulting from the installation of insulation by the insulation contractor.

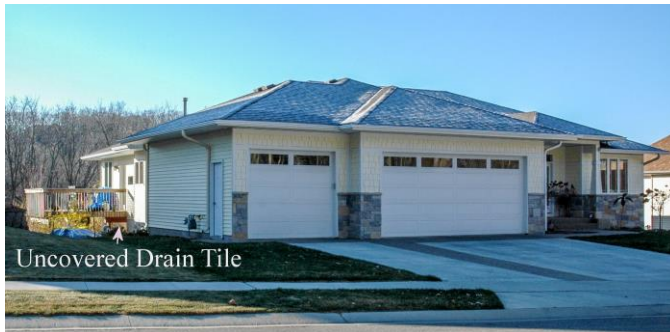
Figure 1 – North and East Side of the Home

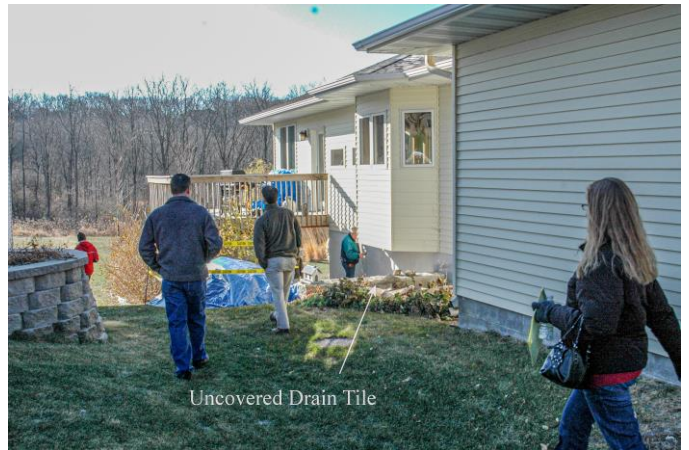
Figure 2 – East Side of the Home

Two excavation pits had been made on the east side of the home to uncover the exterior drain tile. The first was in the area of the bay window, Figure 2. Figure 3 shows the tile, and the gravel that was put into the bottom of the trench and over the tile. The tile had been covered with a fabric material to prevent silting into the tile. The fill over the gravel was most likely heavy clay soil from the basement excavation.

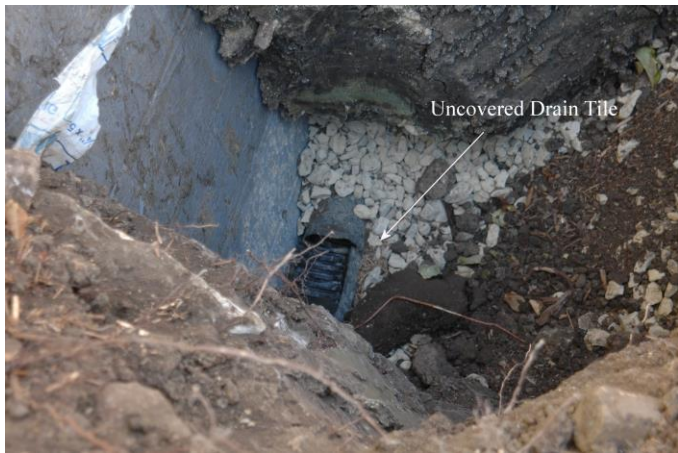
Figure 3 – Drain Tile, East Side of the Home

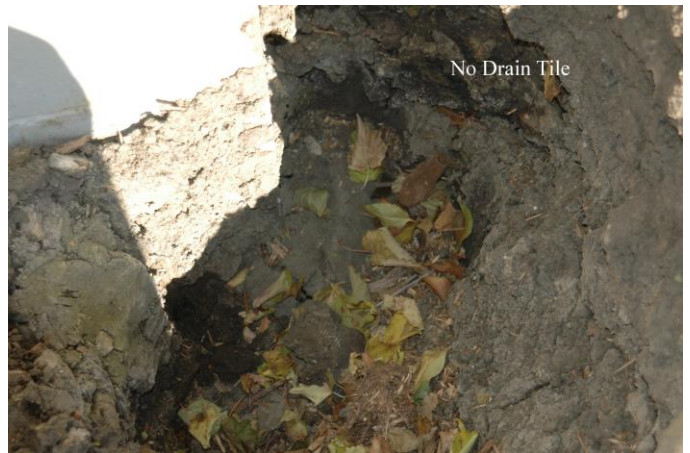
Figure 4 – Pit, Southeast Corner of the Home

Figure 4 shows the second pit which was at the southeast corner of the home. There was no evidence of any tile or gravel fill at this location. This pit was shallow, only about a foot deep, but down to the level of the tile shown in Figure 3.

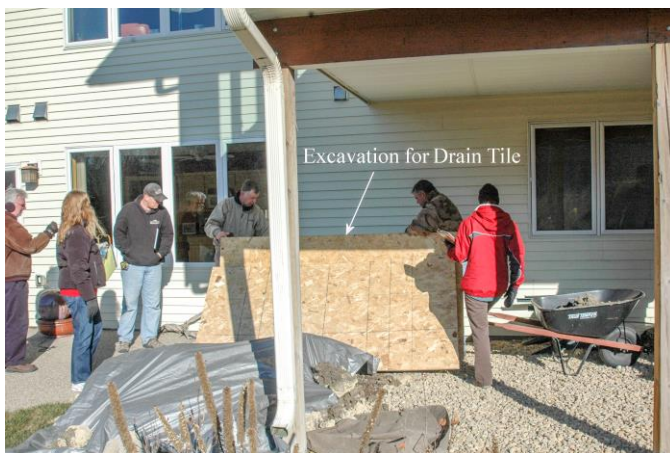
Figure 5 – Excavation Pit Location, South Side of the Home

An excavation pit was dug on the south side of the home to uncover the drain tile. Figure 5 shows the location of the excavation pit, and Figure 6 shows the pit. There was no tile was found at this location.

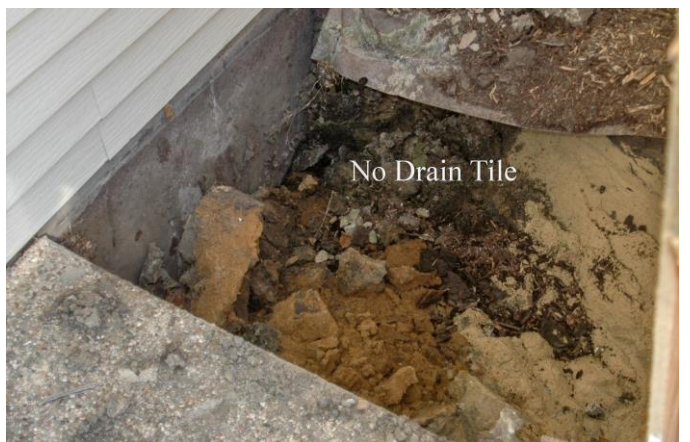
Figure 6 – Excavation Pit South Side of the Home

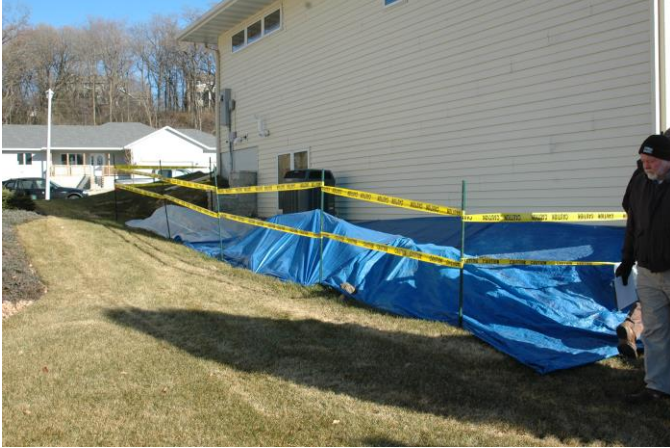
There was a large excavation on the west side of the home, Figure 7. Figure 8 shows the end of the drain tile at the southwest corner of the home. The drain tile appears to have been about one foot below grade at the southwest corner. The tile ended at the corner and there was no evidence as to where the tile drained, or of provision for water drainage from the tile.

Figure 7 – Excavated Area West Side of the Home

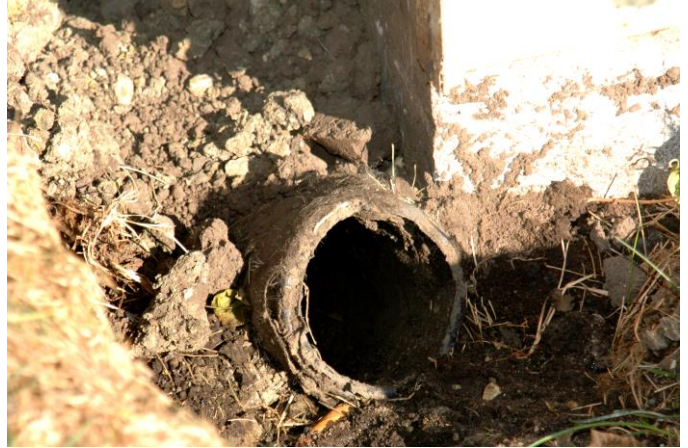
Figure 8 – End of Drain Tile Southwest Corner of the Home

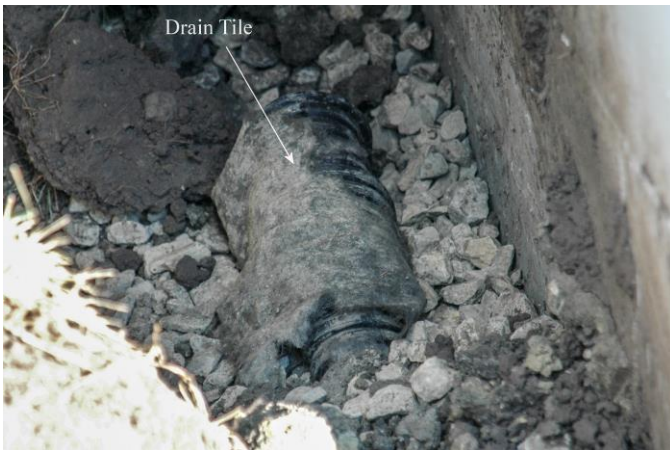
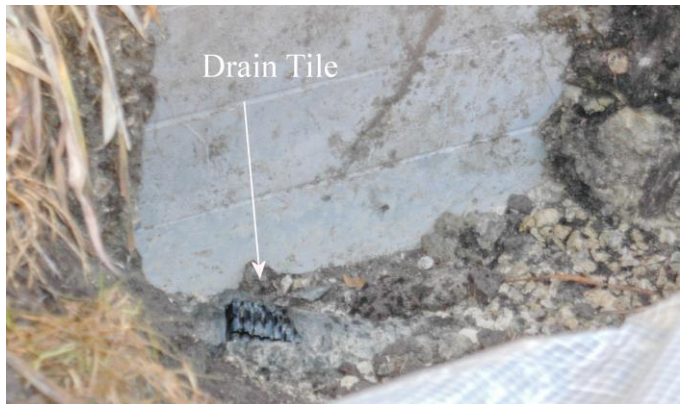
Figure 9 – Drain Tile West Side of the Home

Figure 10 – Drain Tile West Side of the Home

Figures 9 and 10 show where the drain tile had been uncovered along the west side of the home. There did not appear to be any problems with the tile installation at these two locations.

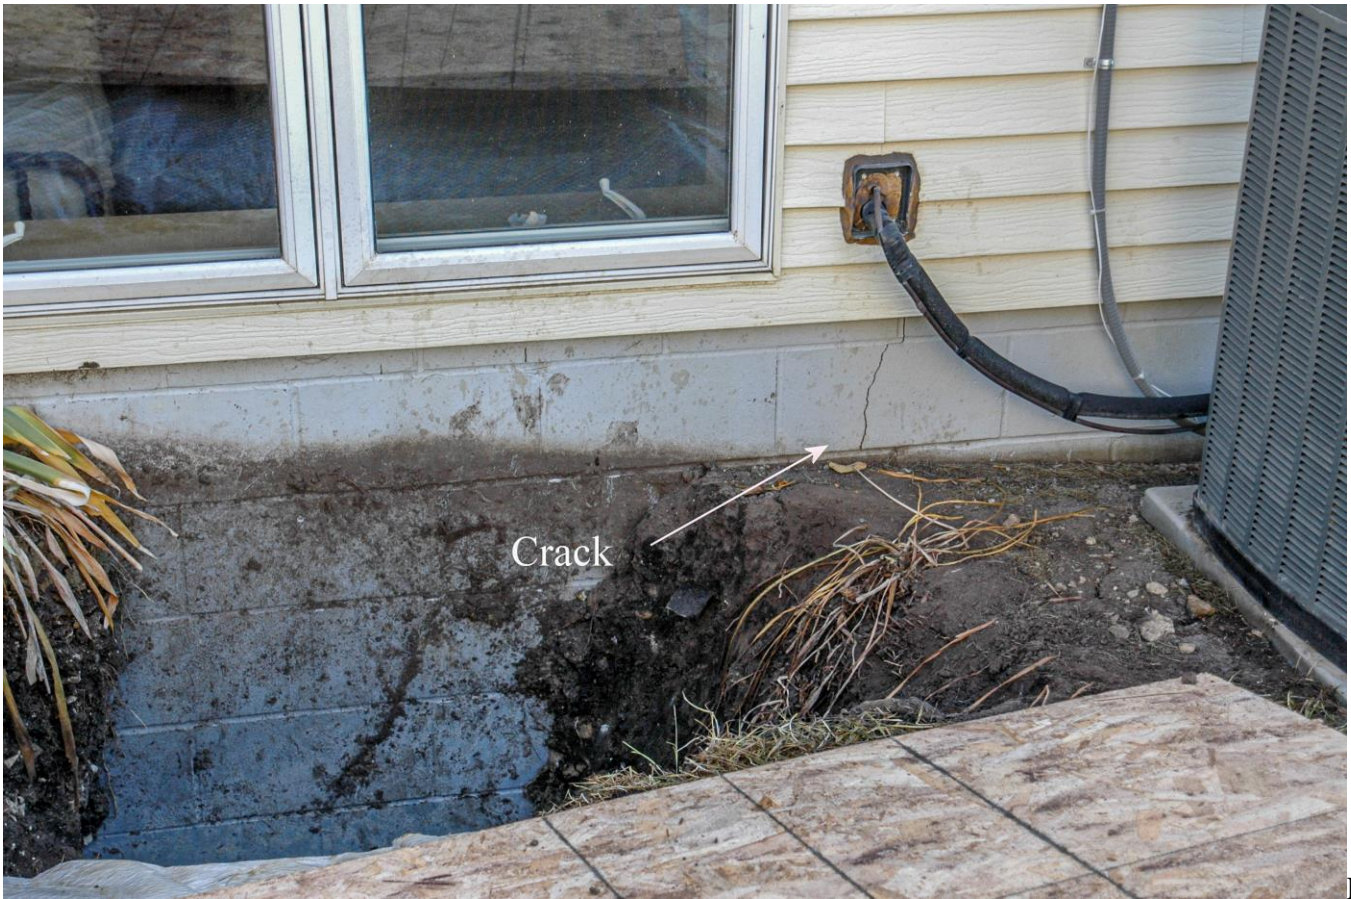
11 – Crack in Block Foundation West Side of the Home

Figure 11 shows a crack in the block foundation. The tubing hole for the air conditioning unit may have contributed to the block cracking. There was evidence of water leakage in the northwest bedroom on the inside of the foundation wall at this location

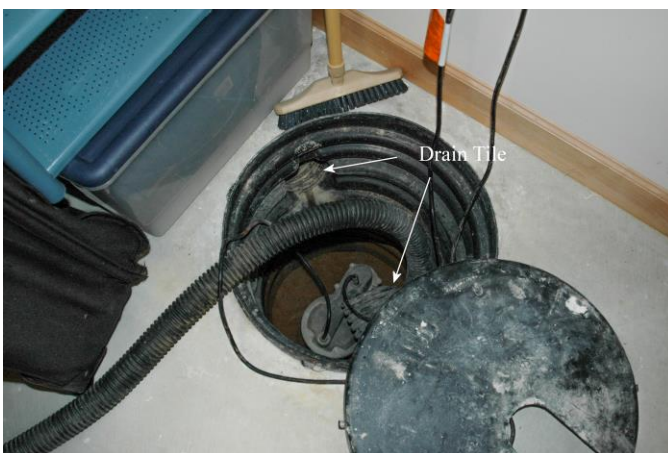
Figure 12 – Sump and Sump Pump

Figure 12 shows the interior sump and sump pump. There are two tiles entering the sump. The upper left-hand tile apparently runs along the north side of the house to the west, and the lower right-hand tile

apparently runs along the north side of the house to the east. The sump pump was added this year. The home's owner said that they had been told that they would not need a sump pump, because the tiling was so good. The sump was present, but there was no discharge provided for the pump.

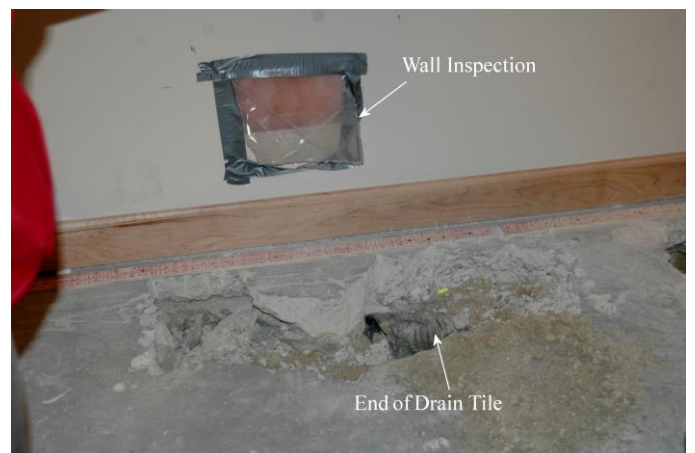
Figure 13 – West Drain Tile along Inner West Wall in Northwest Bedroom

Figure 13 shows the end of the drain tile in the northwest basement bedroom along the inner west wall of the foundation. This location was approximately the center of the window shown in Figure 11. The sheet rock had been cut to inspect the vapor barrier and insulation, which appeared to be in order.

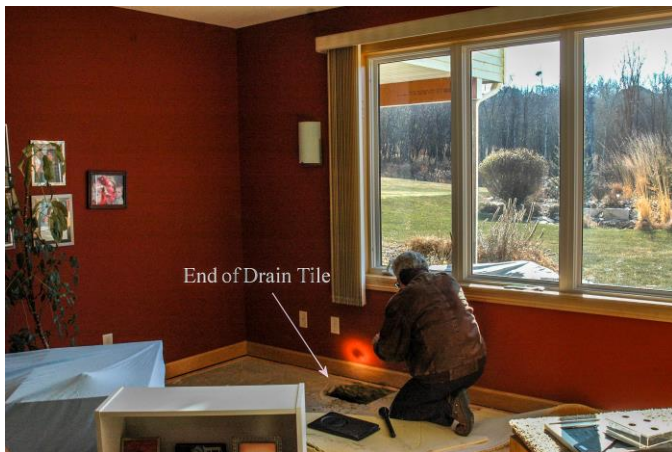
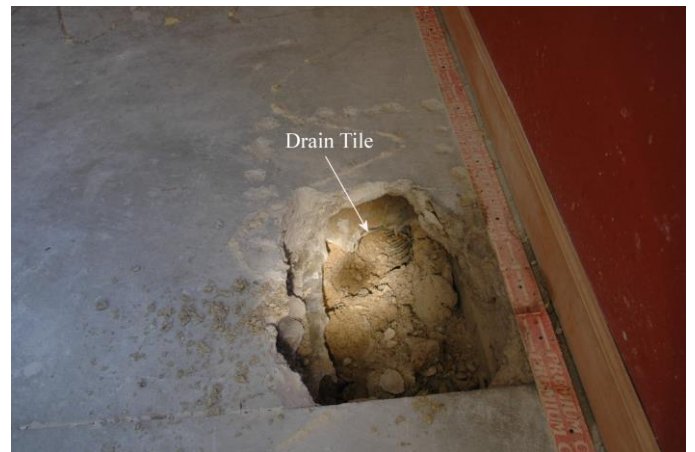
Figure 14 – East Drain Tile, South Wall

Figure 15 – End of East Drain Tile, South Wall

The drain tile running from the east end along the south wall in the family room is shown in Figures 14 and 15. The drain tile ended about 4 feet from the southeast corner.

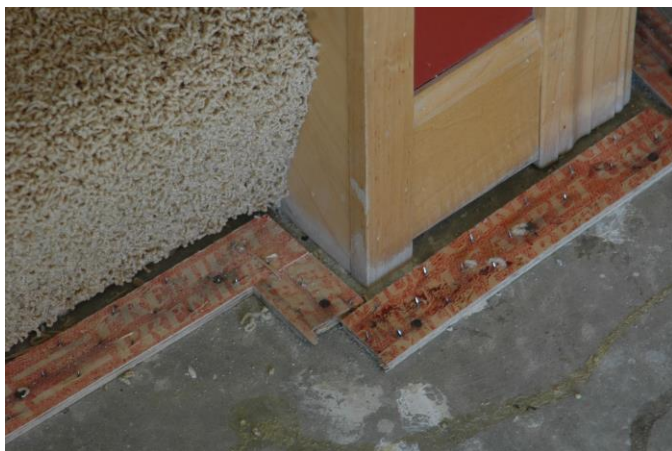
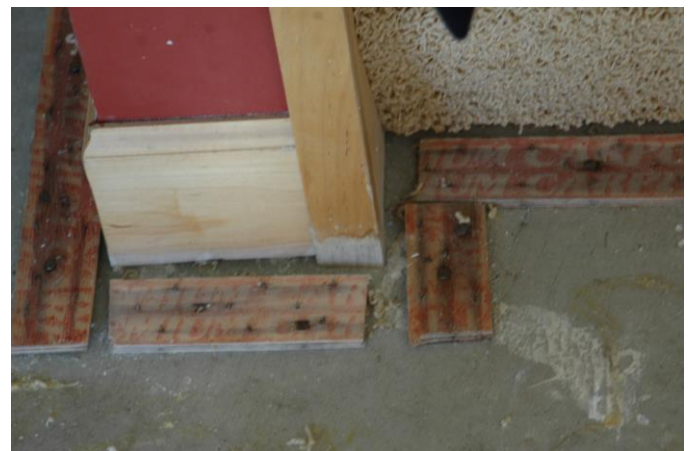
Figure 16 – Water Damage to Basement Woodwork

Figure 17 – Water Damage to Basement Woodwork

The water damage in the basement appears to be very limited, Figures 16 and 17 showing typical staining of the woodwork.

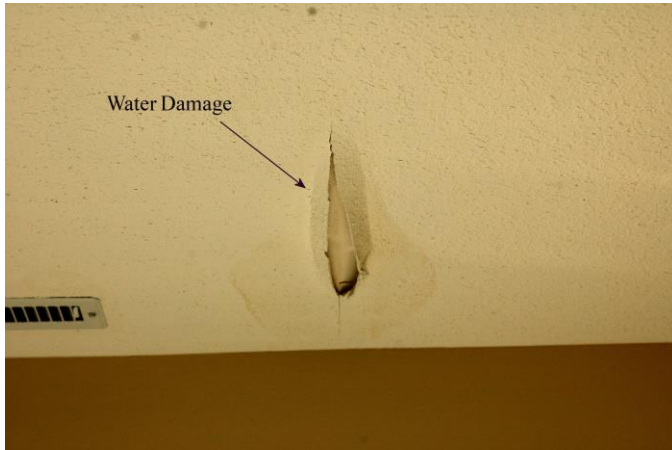
There was water damage to the ceiling in the southwest basement bedroom, Figure 18. The master bathroom is located above the southwest basement bedroom. There was clear evidence of cracking in the shower floor tile grout lines, Figure 19. The shower in the master bathroom is very likely the source of water in the ceiling in the basement southwest bedroom. Cracking along the grout lines was the result of improper installation of the shower by the plumbing and tiling contractor.

Figure 18 – Water Damage Ceiling, Southwest Basement Bedroom

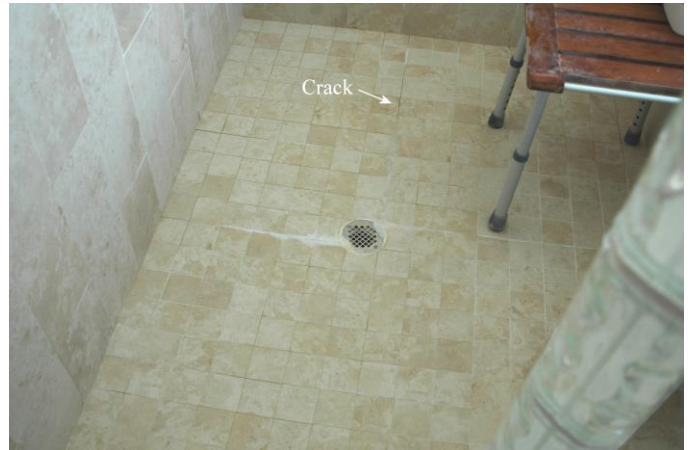
Figure 19 – Cracks in Grout, Master Bathroom Shower, Main Level
