# M. E. Williams and Associates, Inc.

## Wind Turbine Gearbox Failure

A 500KW wind turbine gearbox, identified as LK15, No. 421 104 802 – 001 – 1, was examined to determine the cause of failure. This was one of three gearboxes that failed within a 30 day period. The three turbine gearboxes had been in operation for 17 years, and were installed at approximately the same time. Each gearbox was inspected during tear-down at a maintenance facility. The maintenance personnel made measurements of gear end-play and back-lash during disassembly, and bearing race diameters after disassembly.

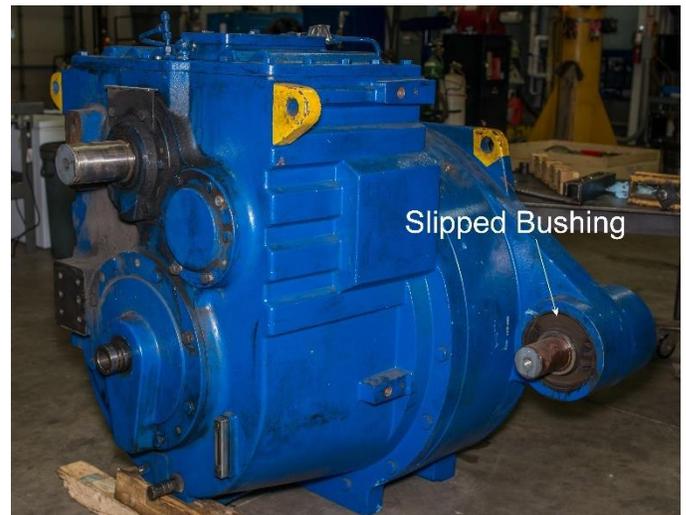
Figure 2 – LK 15 Gearbox

The gearbox is shown in Figure 2. The bushing around the mounting pin had slipped about ½ inch. The slippage of this bushing could have resulted in unexpected stress in the gearbox. Figure 3 shows the slipped bushing from the low speed side of the gearbox. Figure 4 is a closeup of the bushing. The shock absorbing rubber around the mounting pin had been torn. The tear in the rubber likely compensated for any misalignment caused by the shifting of the bushing.

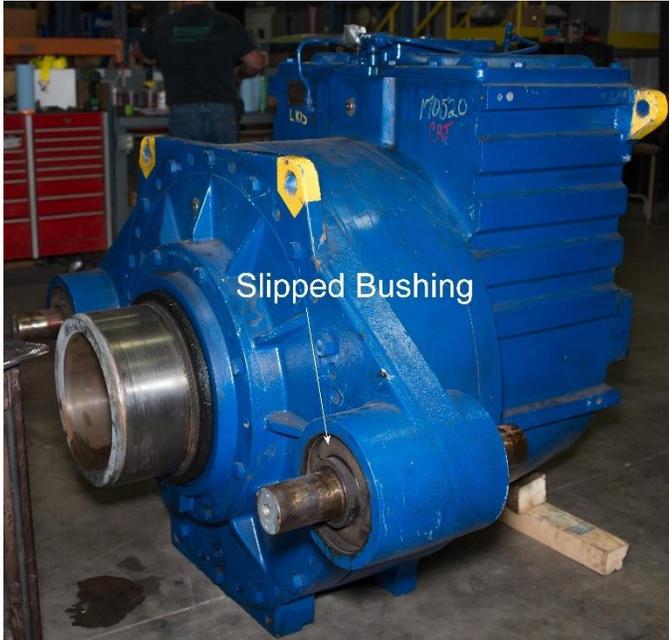
Figure 3 – Location of Slipped Bushing

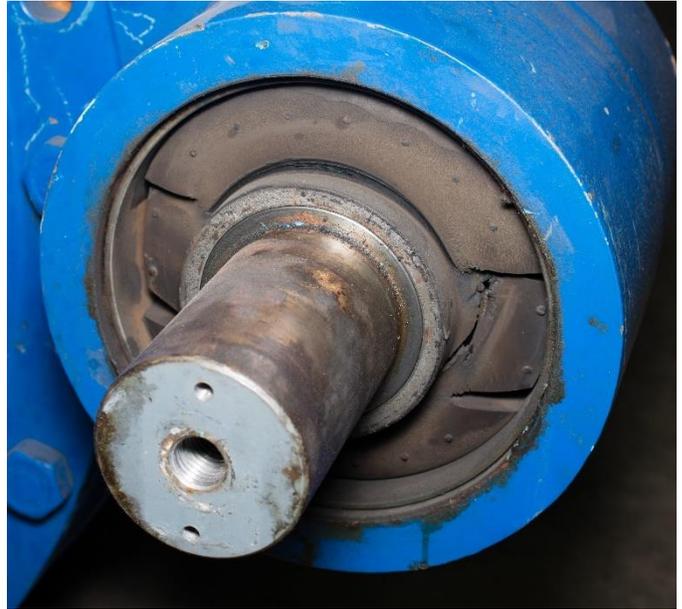
Figure 4 – Slipped Bushing

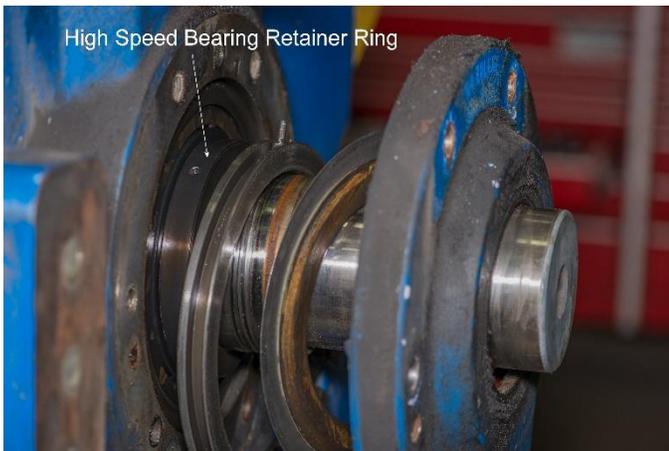
Figure 5 – In-place Highspeed Shaft Bearing Retainer

The highspeed shaft bearing retainer on the LK 15 unit was in place, Figure 5. Figure 6 shows that the set screw was properly seated. The retainer ring needed to be heated in order to loosen the set screw. There are indications of Locktite being on the set screw.

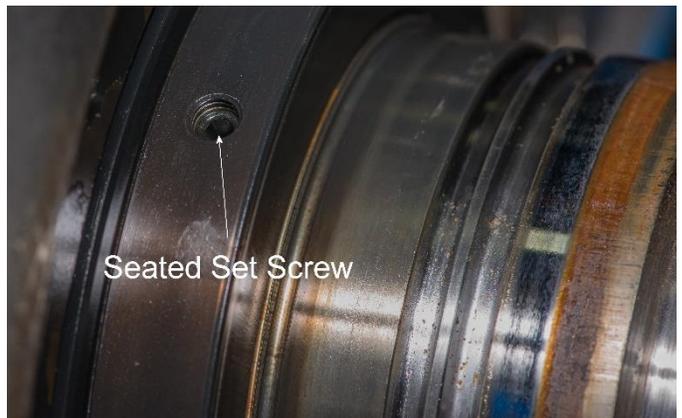
Figure 6 – Properly Seated Set Screw on Highspeed Shaft Bearing Retainer

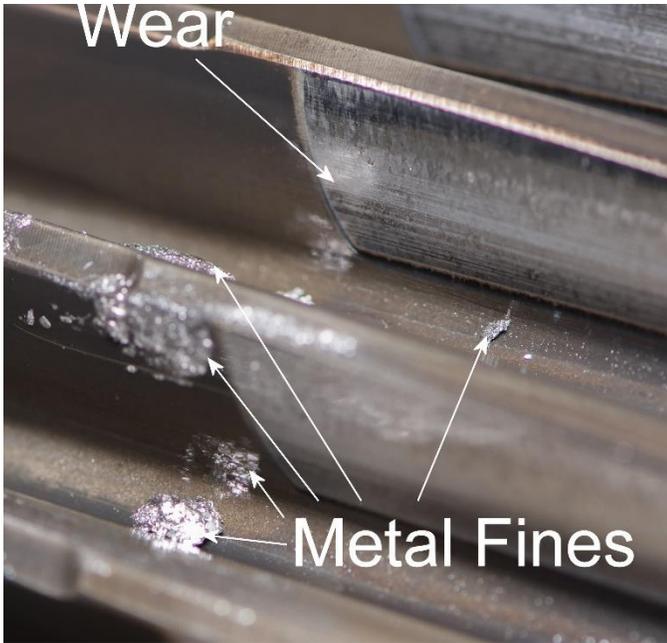
Figure 7 – Wear and Metal Fines on Highspeed Shaft Gear

The insides of the LK 15 gearbox and components were covered with metal fines. Figure 7 is an example of the metal fines buildup on the highspeed gear shaft. The photo also shows abrasive wear on the gear teeth. The cause of the abrasive wear is most likely the metal fines in the gearbox.

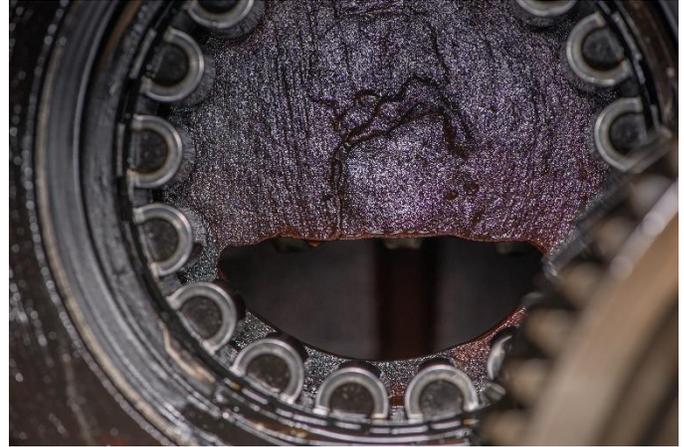
Figure 8 – Highspeed Shaft Roller Bearings and Gearbox Housing

Figure 8 shows the roller bearings at the end of the highspeed shaft. There was no wear on the LK 15 gearbox housing that would have been caused by lateral movement of the highspeed shaft.

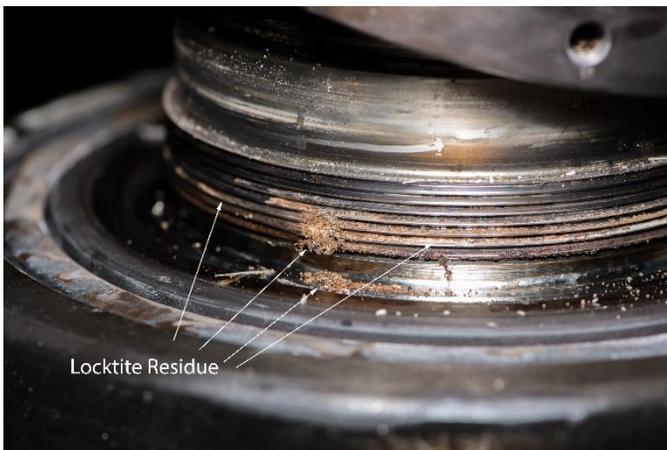
Figure 9 – Locktite Residue on Highspeed Shaft

The highspeed shaft bearing retainer ring was removed after the highspeed shaft had been pulled from the gearbox. Figure 9 shows Locktite residue in the set screw hole and in the threads of the LK 15 highspeed shaft. Figure 10 shows Locktite residue on the bearing retainer ring.

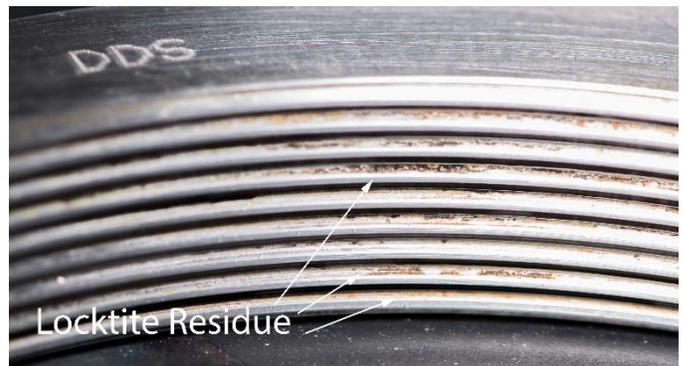
Figure 10 – Locktite Residue on Highspeed Shaft Bearing Retainer Ring

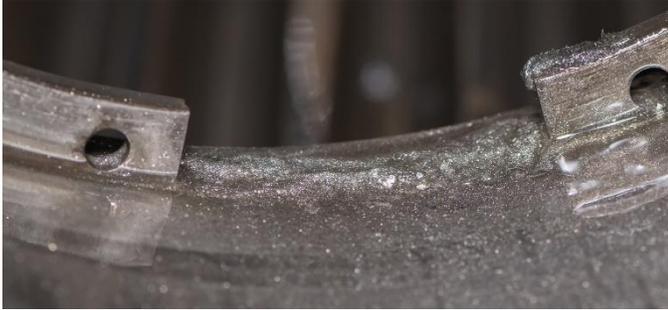
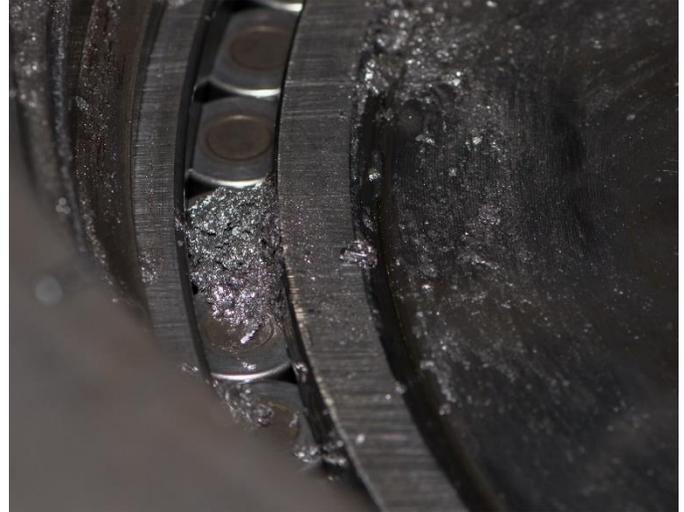
Figure 11 – Metal Fines

Figure 12 – Metal Fines

Figures 11 and 12 are examples of the large quantities of metal fines distributed throughout the interior of the LK 15 gearbox.

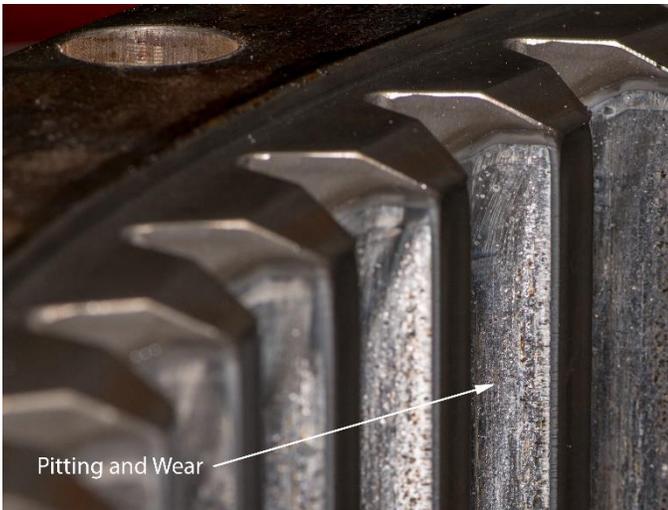
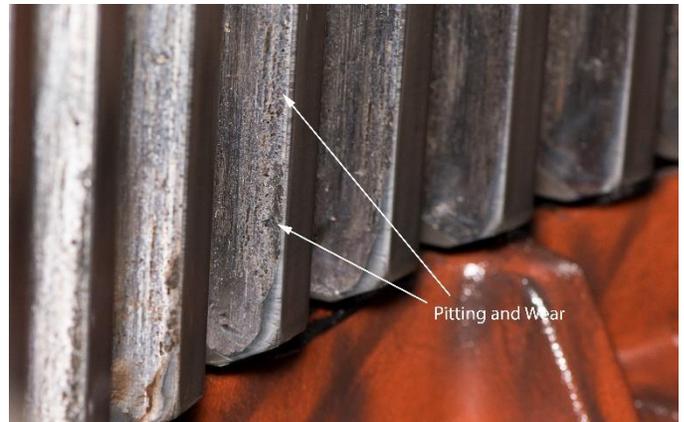
Figure 13 – Pitting and Wear on Ring Gear Teeth

Figure 14 – Pitting and Wear on Ring Gear Teeth

The ring gear is a low speed gear, but it showed a considerable amount of pitting and wear; the wear was uniform on the teeth all the way around the circumference of the gear. Figures 13 and 14 are examples of the wear. This wear was likely the result of lubrication failure.

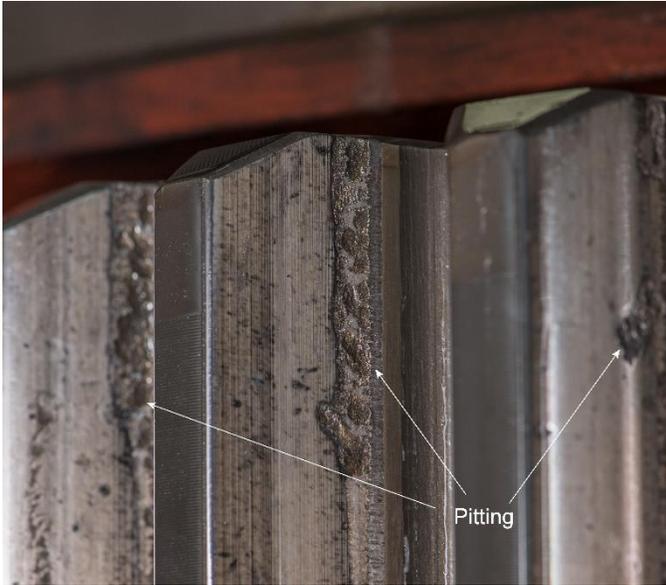
Wear consisted of extensive pitting of the gear teeth on the planetary gear, Figure 15. This pitting was the result of sliding contact fatigue resulting from gear overloading.

Figure 15 – Pitting on Planetary Gear Teeth

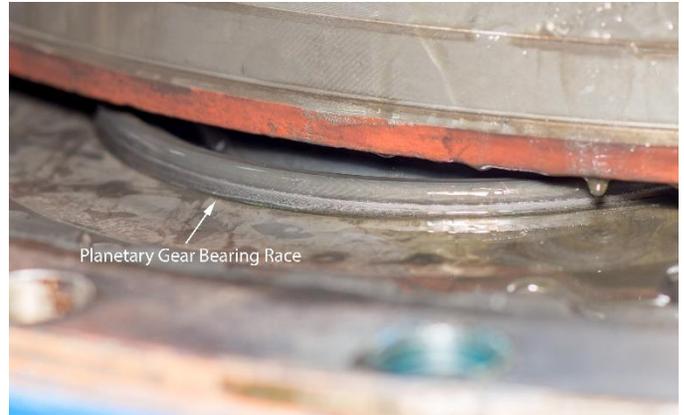
Figure 16 shows one of the bearing races. The bearing race appears to have spun in the planetary gear. This is indicated by the wear on the outside diameter of the bearing race.

Figure 16 – Planetary Gear Bearing Race

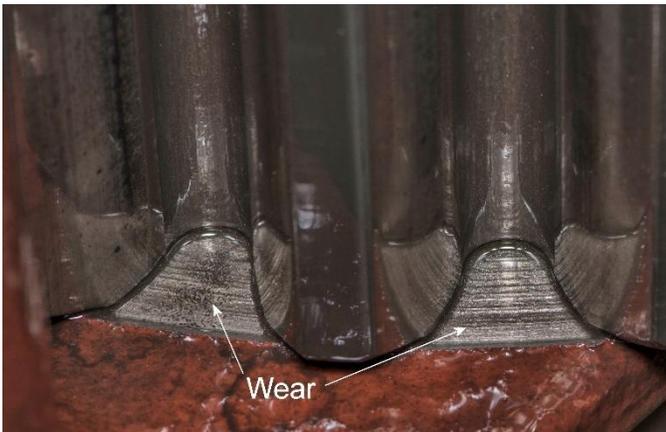
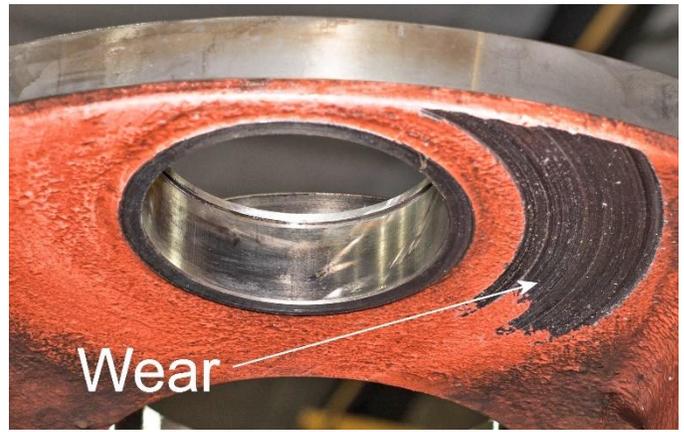
Figure 17 – Wear on the Planetary Gear Carrier

Figure 18 – Wear on the Planetary Gear Carrier

There was wear on the planetary gear carrier. The wear is shown in Figures 17 and 18. The wear corresponds to the planetary gear labeled 2 during the disassembly of the gearbox. The wear of the bearing carrier was most likely the source of all the metal fines in the gearbox, resulting in the failure of the gearbox. It is my understanding that the shifting of the planetary gear bearing races is a typical problem with these gearboxes, therefore, this is normal wear and tear for this equipment.

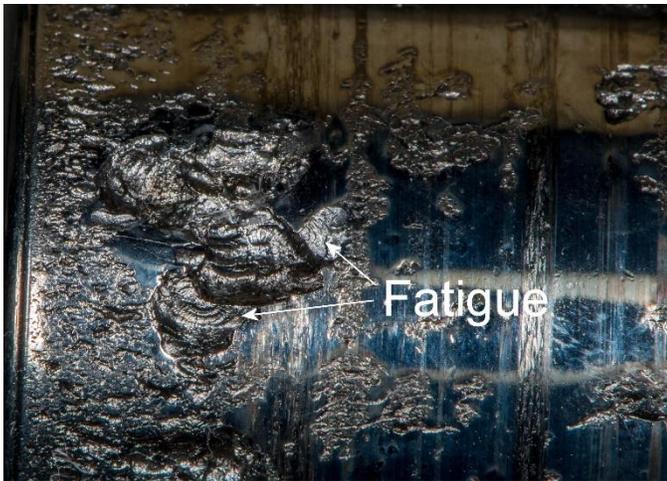
Figures 19 and 20 show sliding/rolling contact fatigue on two of the bearing rollers removed from planetary gear #2. These two rollers were examined metallographically to verify the presence and extent of the fatigue. The conditions found on the bearing rollers are similar to the conditions on the gear faces. The presence of surface fatigue was caused by overloading and the presence of debris, namely metal fines, inside the gearbox.

Figure 19 – Fatigue Failure Bearing Roller #1

The hardness of 59 on the Rockwell C scale on the bearing rollers, Table 2, is within the expected range for bearing rollers.

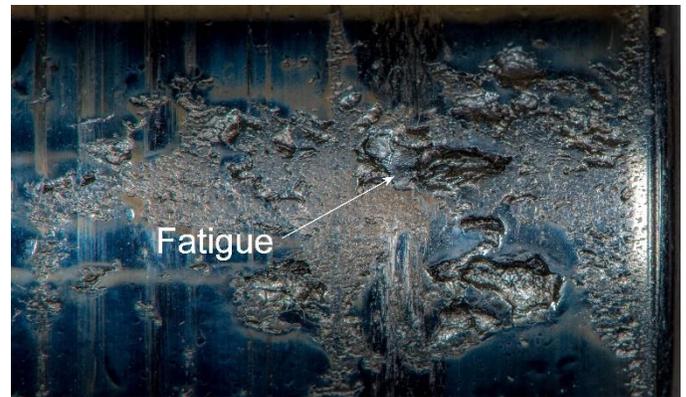
Figure 20 – Fatigue Failure Bearing Roller #2

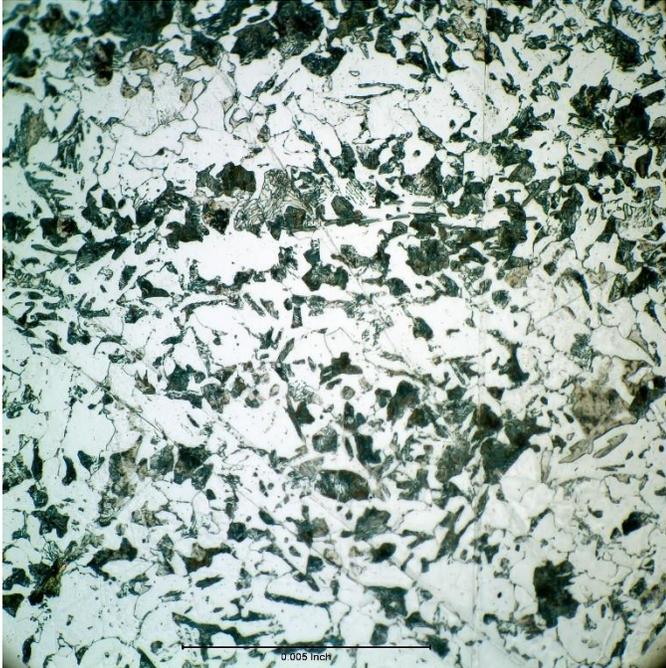
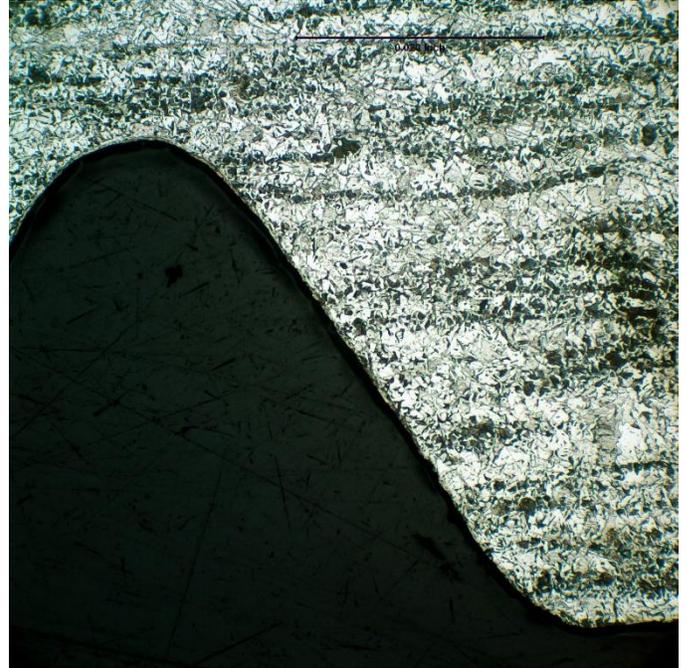
Figure 21 – 400X LK15 Retainer Ring Microstructure

Figure 22 – 100X Retainer Ring Thread Form

The microstructure of the LK15 retainer ring is shown in Figure 21 and consists of very fine pearlite, the dark areas, and fine grained ferrite, the white areas. Figure 22 shows the retainer ring thread form.

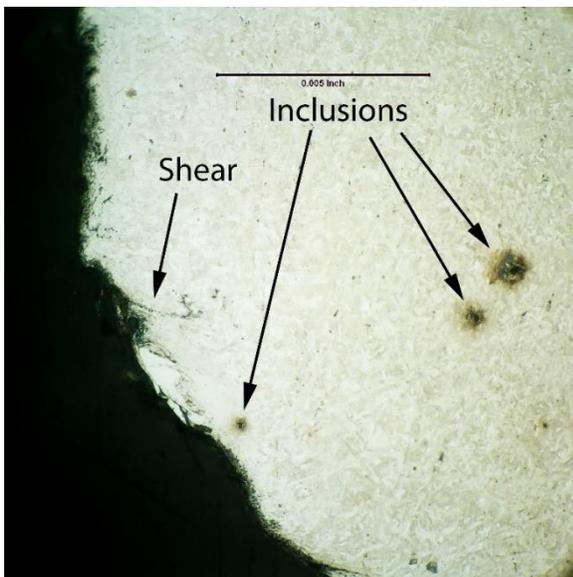
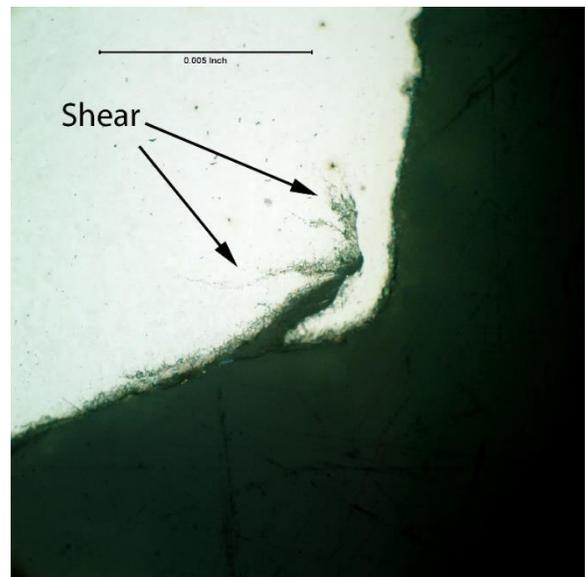
Figure 23 – 400X Tip of Set Screw

Figure 24 – 400X Tip of Set Screw

Figures 23 and 24 show the tip of the set screw. The shear cracking was likely the result of forming of the tip of the set screw. Inclusions, Figure 23, are typical in the steels used to fabricate set screws.

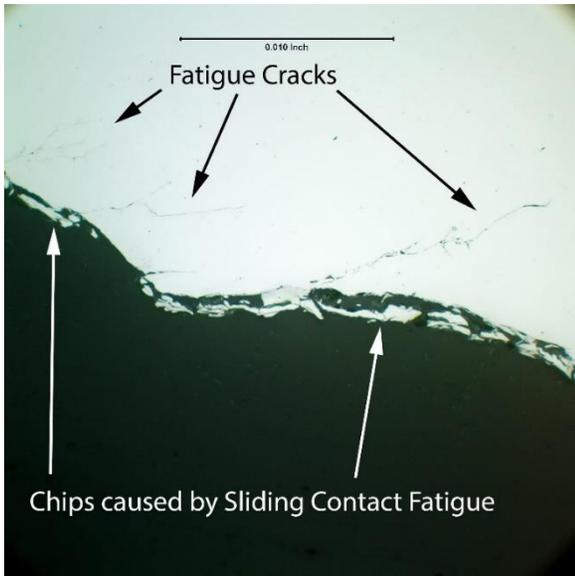
Figure 25 – 200X Fatigue Cracks in Bearing Roller #1

Figure 25 shows a considerable number of fatigue cracks in a location where chips had formed in the bearing surface, similar to the locations indicated in Figure 19. Figure 26 shows a fatigue crack running perpendicular to the roller surface. The crack had penetrated 0.004 inches into the roller.

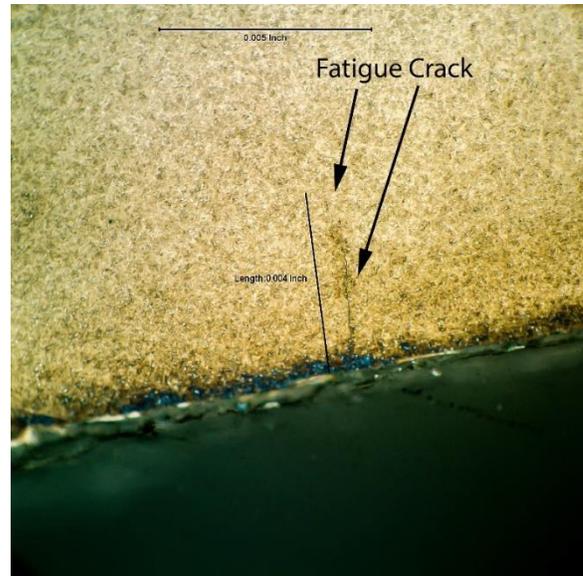
Figure 26 – 400X Fatigue Crack Perpendicular to the Roller Surface, Roller #1
