M. E. Williams and Associates, Inc.

Case Study: Aluminum Fin Corrosion

Merlin E. Williams, P.E.

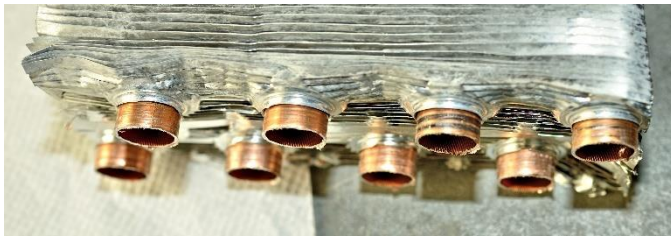
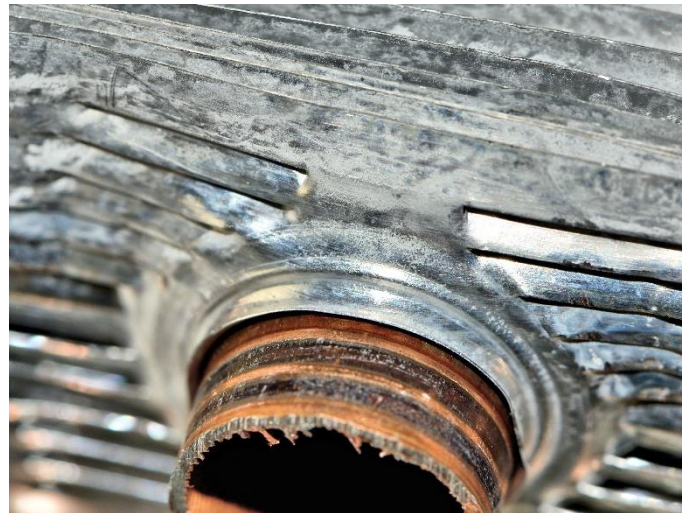
Figure 1 – Coil End

Figure 2 – White Deposits and Discolored Copper

Figures 1 and 2 show the end of the coil section with two rows of fins removed. Besides the white deposits on the fins, there was discoloration of the copper tubing associated with the contact area between the fin collar and the tubing.

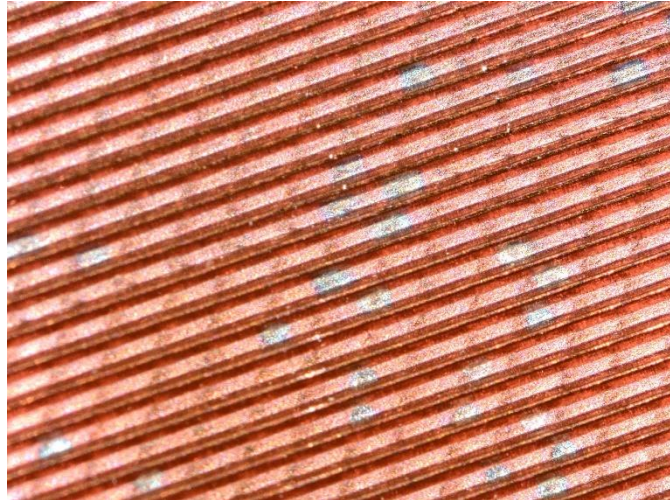
Figure 3 – Corrosion on Copper Tubing I.D.

In preparation for examination of the coil section, one of the tubes had been cut open, Figure 3. Indications of the beginnings of corrosion were found on the inside diameter of the tubing.

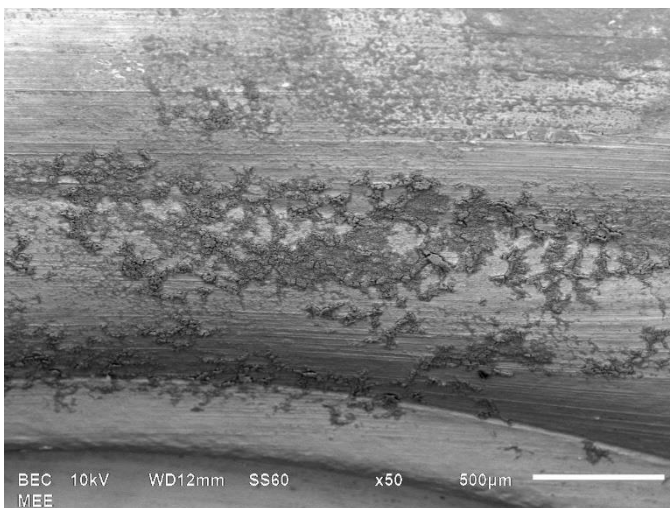
Figures 4 and 5 show the location of a white deposit on a fin. The location was near the collar associated with the installation hole in the fin material. Figure 6 shows the locations where the three analyses were done. Figures 7, 8, and 9 are the spectra for these locations. Table 1 gives the semi-quantitative analysis for these three locations.

Figure 4 – 50X White Deposit on Fin

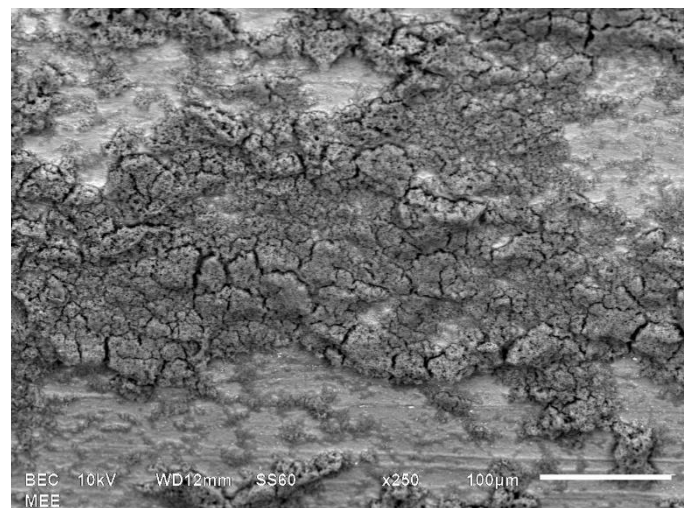
Figure 5 – 250X White Deposit on Fin

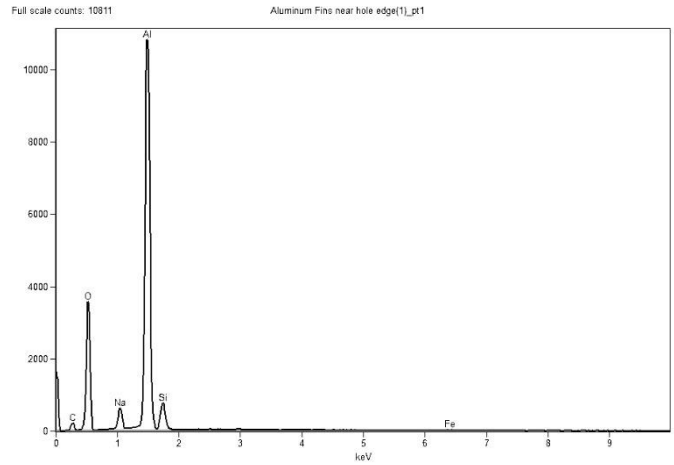
Figure 7 – Spectrum Location 1

The analysis showed the presence of sodium and silicon, indicating contamination of the fins by sodium metasilicate and sodium hydroxide from the parts degreaser. Sodium metasilicate and sodium hydroxide are very corrosive in aluminum and were major ingredients in the degreasing solution.

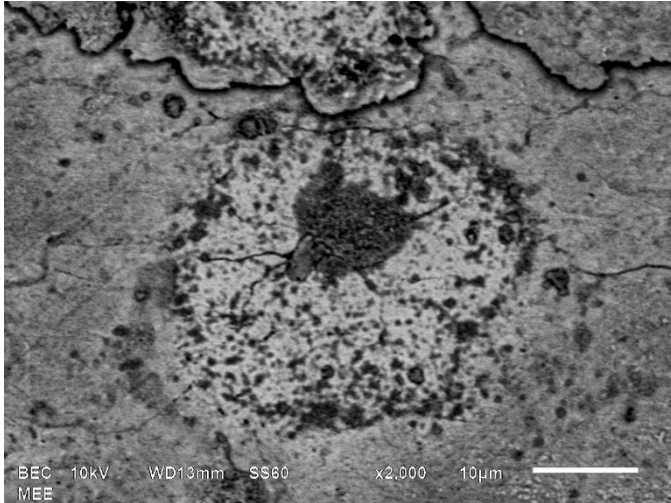
Figure 10 – 2000X Dark Spot in Copper Tube

Figure 10 shows a dark spot found on the inside diameter of the copper tubing. The presence of sodium in the Dark Spot, Table 2, indicated that the solution containing sodium hydroxide had been present on the inside diameter of the copper tubing. The copper oxide that formed was likely the result of highly alkaline conditions associated with the sodium hydroxide. Figure 10 also shows the beginning of intergranular corrosion of the copper tubing which resulted from being exposed to sodium hydroxide.

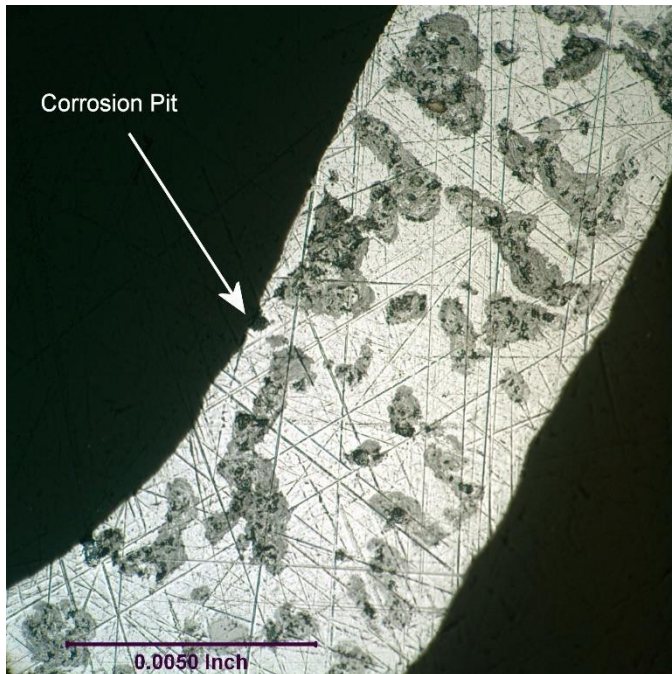
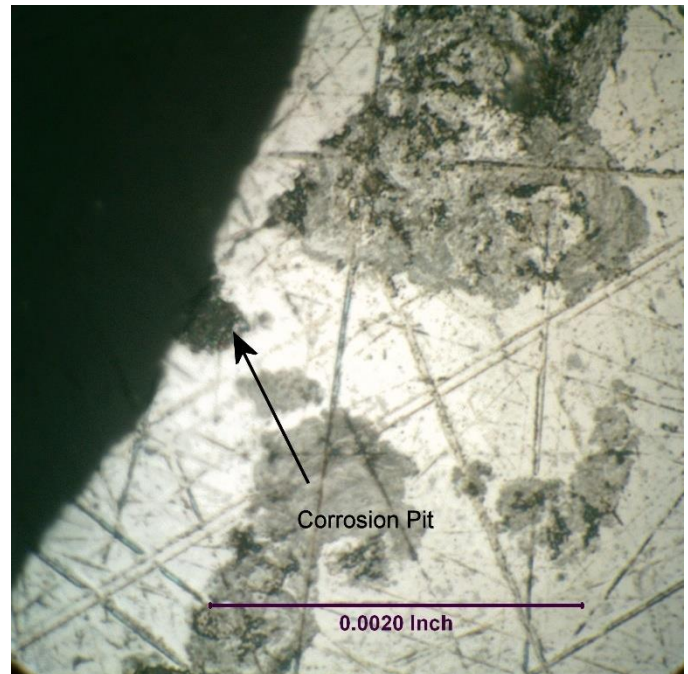
Figure 12 – 400X Corrosion Pit in Fin

Figure 13 – 1500X Corrosion Pit in Fin

Figures 12 and 13 show a corrosion pit in the fin collar material near the tube. After the fins were cleaned with the degreaser, white deposits were noticed. This is again attributable to the sodium metasilicate and sodium hydroxide contained in the degreaser, which are both very corrosive to aluminum. These two materials will cause pitting and general corrosion of aluminum. This type of degreaser should not be used near or around any type of assembly containing aluminum or copper.
