Case Study: Broken Water Valve

Examination of a Viega ASTM F877 dahl NO76 water valve to determine the cause of failure. The examination was limited to non-destructive testing due to a class action lawsuit involving similar valves from this manufacturer. A partial water analysis was provided. The broken valve was examined by visual and microscopic examination. This is a good example of restraints being put on the scope of examination, but the likely cause of failure may still be determined within those restraints.

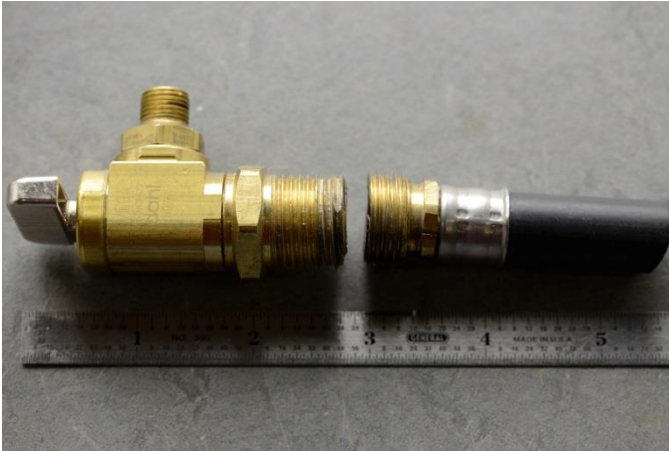
Figure 1 – Viega ASTM F877 dahl NO76 Valve

Figure 1 shows the broken valve. There was no visual evidence of any mechanical damage that would have led to the valve failure.

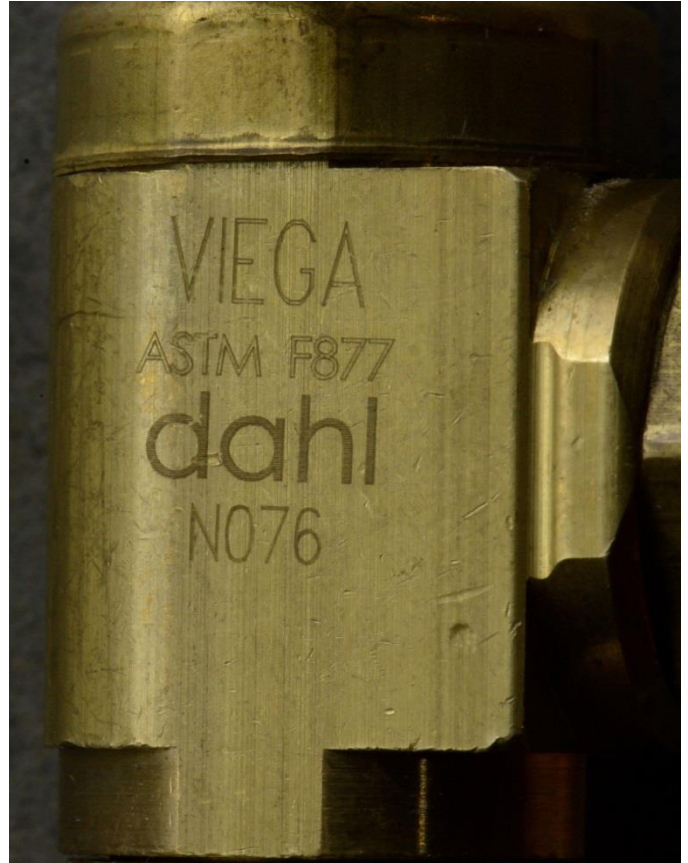
Figure 2 – Viega ASTM F877 dahl NO76 Valve

Figure 2 shows the identification on the valve.

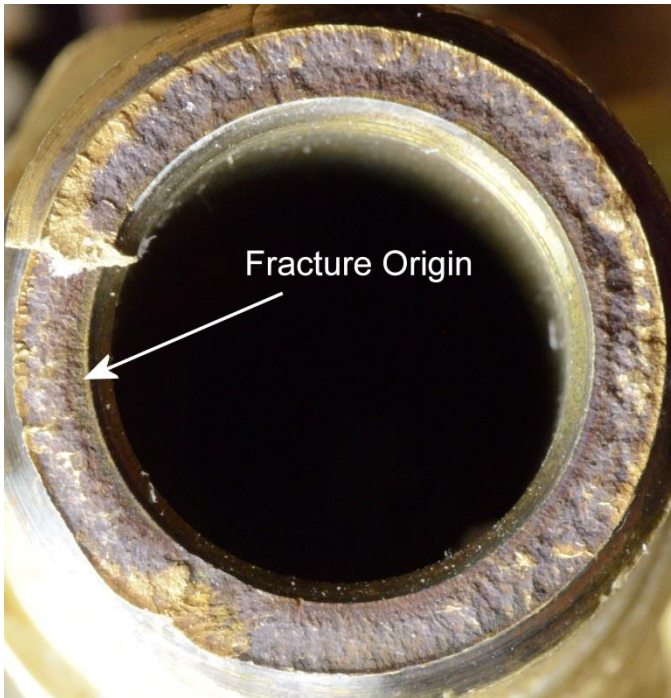
Figure 3 – Fracture, Valve Body Side

Figures 3 and 4 show the fracture surfaces, and the location of the fracture origin. Figure 4 shows an orange-brown stain, which is shown in Figure 6 at higher magnification. The fracture characteristics shown in these two photos are typical of de-alloying, dezincification, fatigue, and stress corrosion. The orange and red-to-purple colors indicate the presence of dezincification.

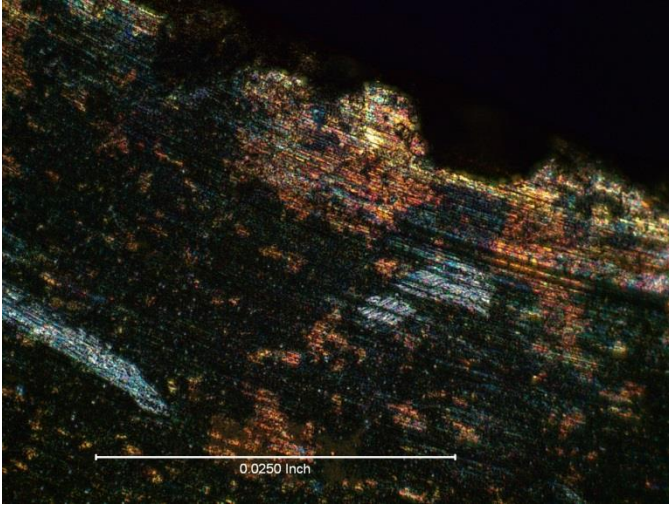
Figure 5 – 100X Fracture Surface

Figure 5 is an optical photo of the fracture surface. The yellow areas are brass. The pink and salmon colored areas are copper, indicating dezincification. The black areas are copper oxide.

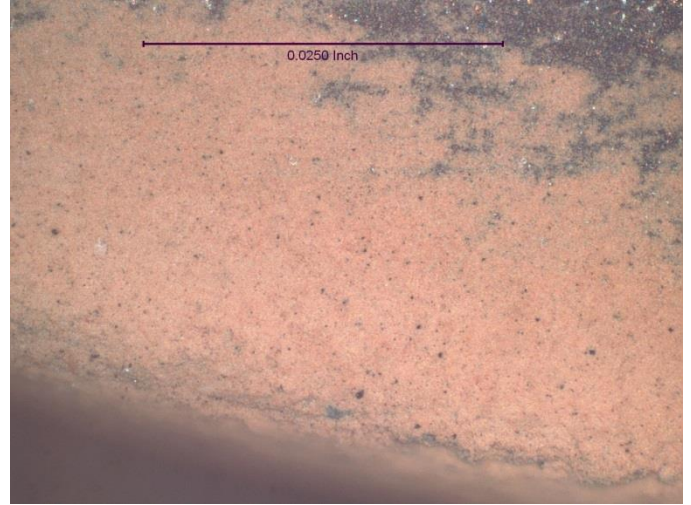
Figure 6 – 100X Copper Deposit

Figure 6 is a microscopic photo of the deposit shown in Figure 4. The salmon color indicated the presence of pure copper. Viewing at much higher magnification showed the presence of very fine copper flakes. These flakes are characteristic of dezincification of the brass valve. The dezincification was the primary cause of failure of the valve.
