Case Study: Aluminum Sand Casting Failure

Merlin E. Williams, P.E.
President
M. E. Williams and Associates, Inc.

A clamp made from an aluminum sand casting was examined to determine the cause of breakage. These castings failed shortly after the equipment on which they were installed was put into service. The sand castings were produced by a new supplier and were put into service without undergoing rigorous inspection. They were only inspected for dimensional tolerances.

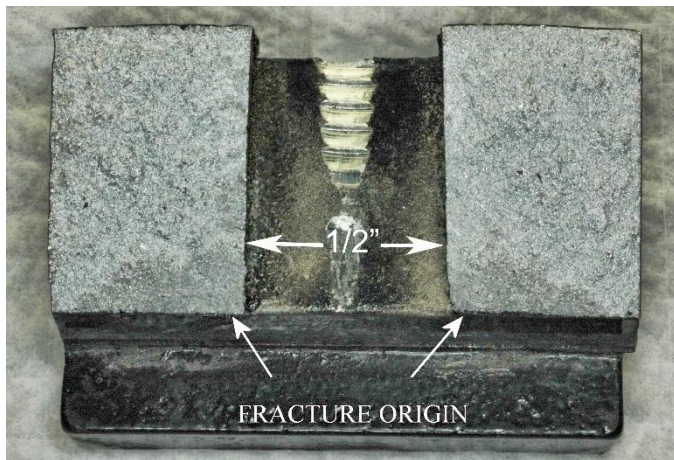
Figure 1 – Fractures in Sand Casting

Figures 1 shows the fractures in the clamp sand casting and the fracture origins. The fracture origin is shown at higher magnification in Figure 2. There was a pre-existing crack at the fracture origin of this sand casting, Figure 2. Figure 2 also shows a casting defect that was caused by the sand mold being broken while the aluminum was still liquid.

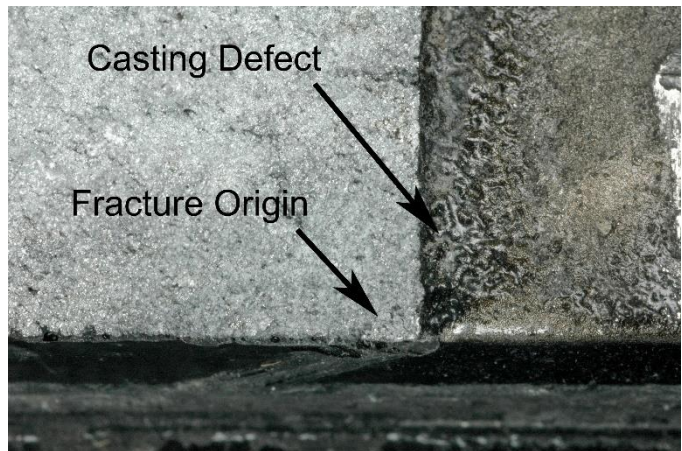
Figure 2 – Fracture Origin in Sand Casting

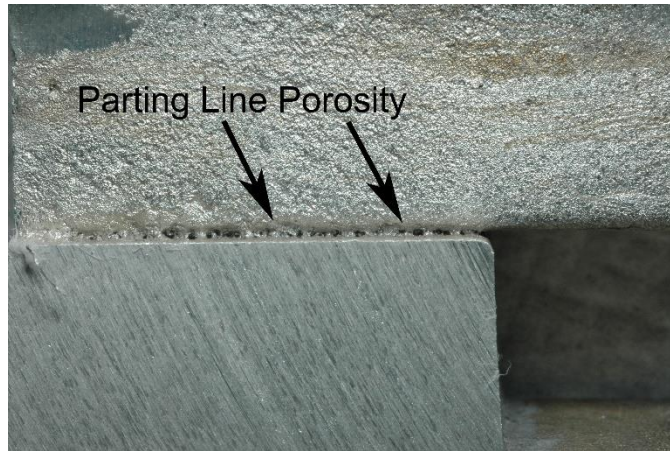
Figure 3 – Internal Parting Line Porosity

The parting line on all the castings were very poor due to the presence of porosity, shown in Figure 3. Parting lines are supposed to be free of porosity.

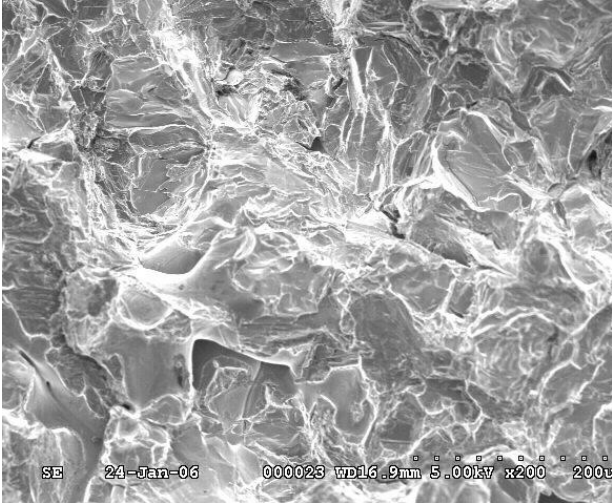
Figure 4 – 200X Brittle Fracture, Cleavage, near Fracture Origin

Figure 4 shows cleavage fracture near the fracture origin. Throughout the rest of the fracture surface the brittle fracture was a mixed mode of cleavage and intergranular, Figure 5. The sand casting had no ductility. The elongation for 713 alloy is 4%, which is enough to show ductile fracture characteristics.

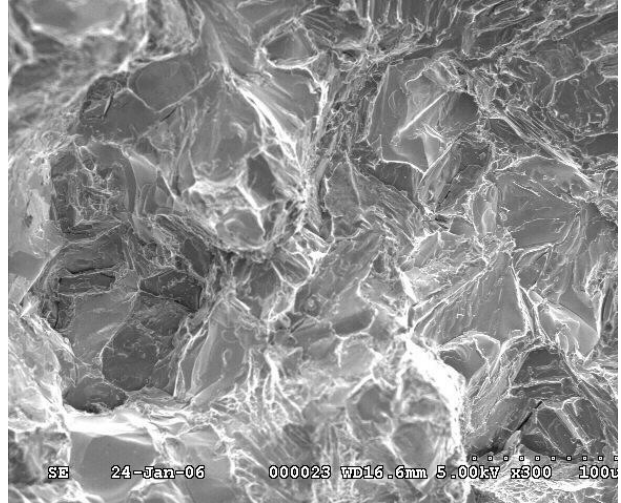
Figure 5 – 200X Brittle Fracture, Intergranular

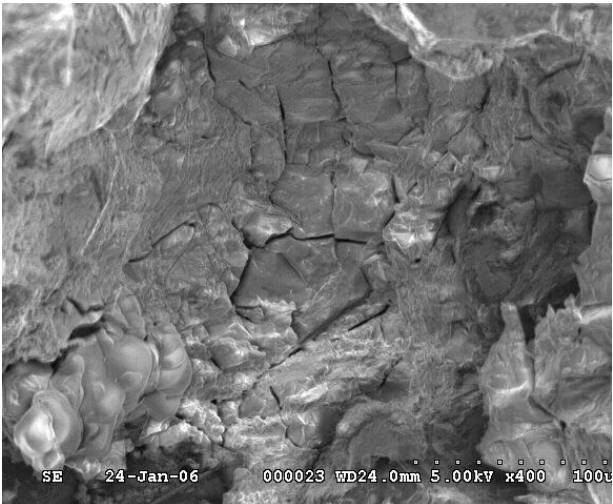
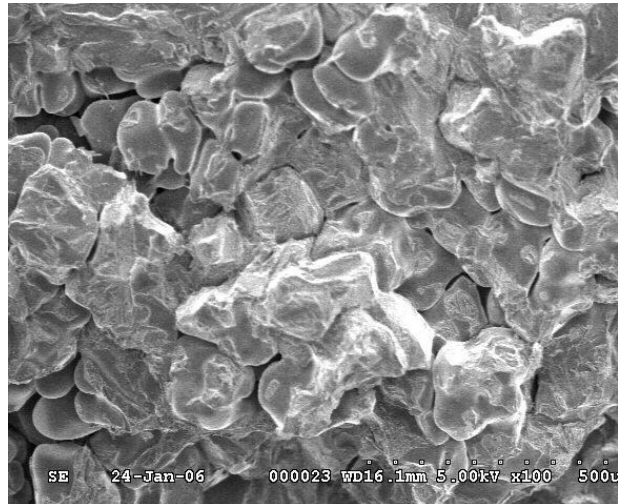
Figure 6 – 400X Intergranular Porosity

Figure 7 – 100X Intergranular Porosity

The dominant feature of the fracture surface of the sand casting was intergranular porosity, indicated by the angular and nodular features, Figures 6 and 7. Intergranular porosity in sand cast aluminum is due to trapped hydrogen gas, which is the result of not properly fluxing the molten aluminum just prior to casting. The condition shown in this sand casting is a very serious defect.

These castings should be recalled and removed from service as soon as possible.

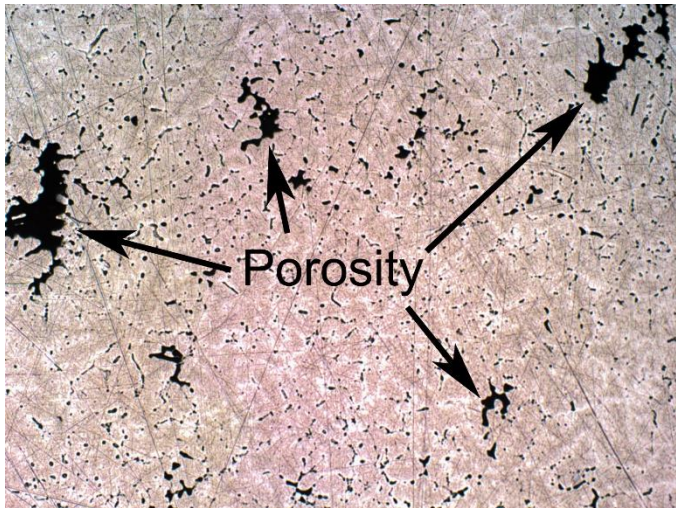
Figure 8 – 25X Porosity in Grain Boundaries

Figure 8 shows a cross section through the parting line. There was grain boundary porosity present, as indicated by the black areas within the casting. The presence of porosity to this extent is the result of trapped hydrogen gas. There were copper and silicate precipitates in the grain boundaries, Figure 9. The presence of these precipitates in the grain boundaries is the cause of the intergranular fracture found on this casting. The precipitates are the result of the higher-than-specified concentrations of copper and silicon in the sand casting, and therefore are the cause of brittle failure.

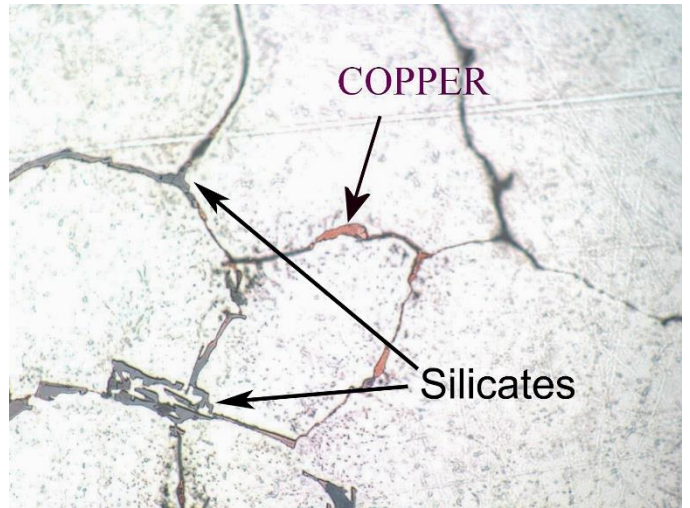
Figure 9 – 400X Copper and Silicate Precipitate in Grain Boundary
