Failure of a Dynamically Loaded Welded Assembly – Case Study

Merlin E. Williams, P.E.

This case study involves the examination of dynamically loaded welded axle housing assemblies to determine the cause of failure. The axle housings cracked in the rectangular structural tubing. They were examined by visual examination, scanning electron microscopic examination, hardness testing, and metallographic examination.

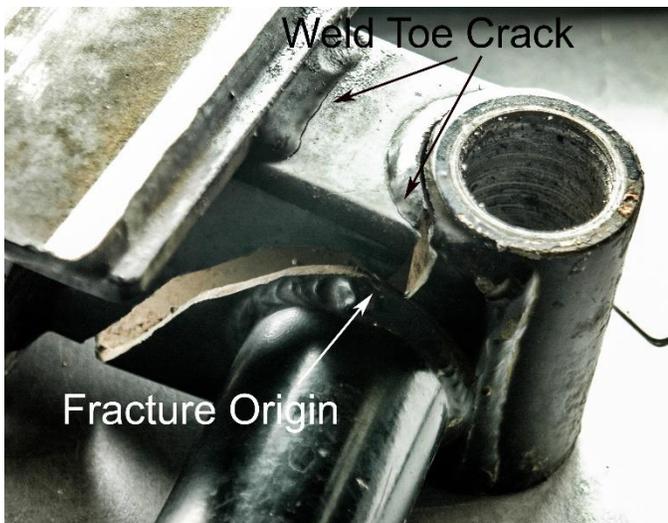
Figure 1 – Axle Housing Segment

Figure 1 shows the axle housing segment which was the worst of the housing assemblies examined. There was significant cracking associated with the welds. One of the fractures originated near the weld start-stop location of the circumferential weld. Figure 2 shows the location of the fracture origin near the circumferential weld start/stop. It is difficult to make a weld start/stop that is defect free. To do so requires a highly skilled weld operator.

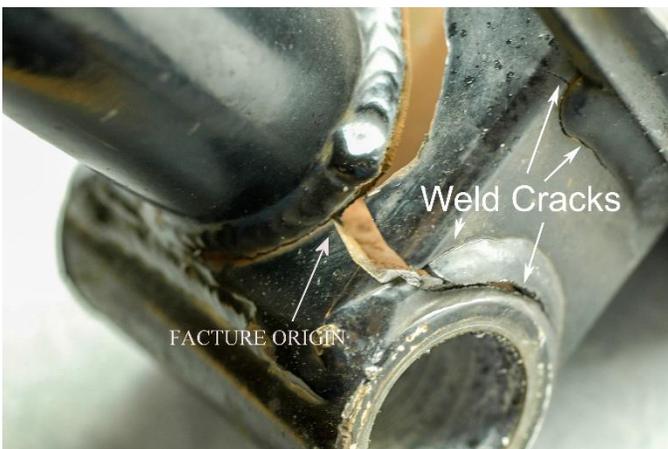
Figure 3 – Fracture Origin - Axle Housing Segment

Figure 3 shows additional weld cracking. There were a number of cracks originating from the weld toes, indicating the weld operator insufficiently skilled for those particular weld types.

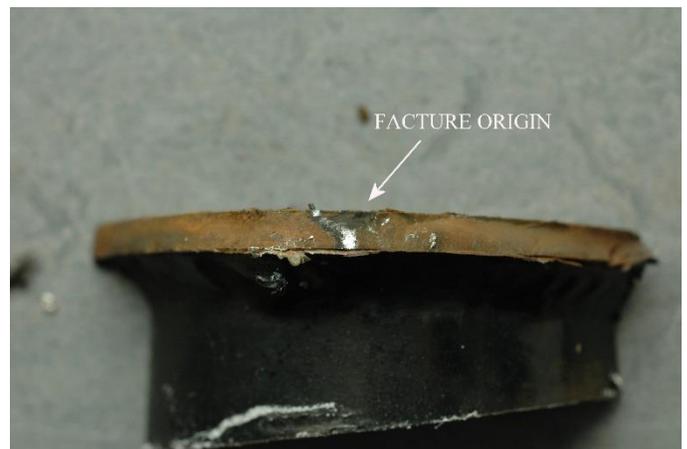
Figure 4 – Fracture Origin

Figure 4 shows the fracture origin after removal from the axle housing segment. To the left side of the fracture origin was a fatigue crack, and to the right side the fracture mode was unknown.

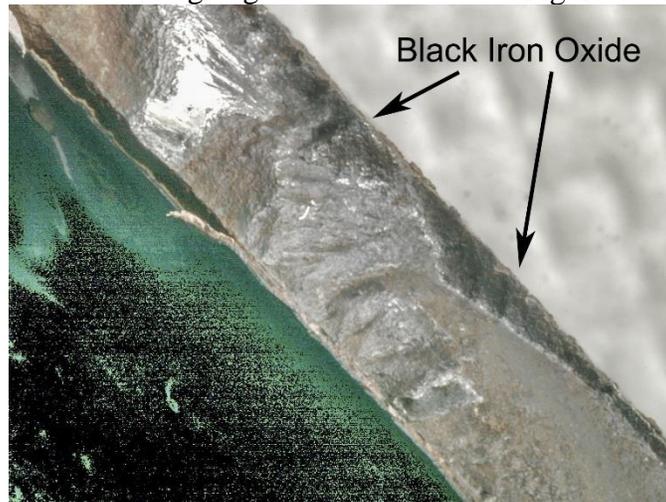
Figure 5 – Fracture Origin after Cleaning

The fracture origin is shown after cleaning was done prior to scanning electron microscopic examination, Figure 5. The presence of black iron oxide reveals an area where there was a lack of root fusion during welding. Black iron oxide forms at temperatures greater than 900° F.

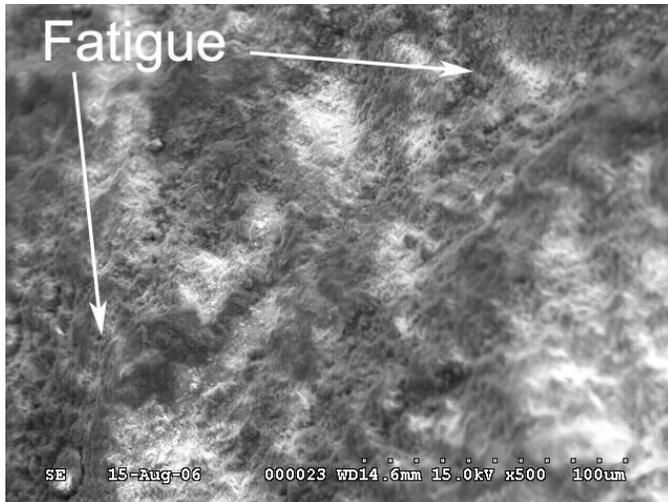
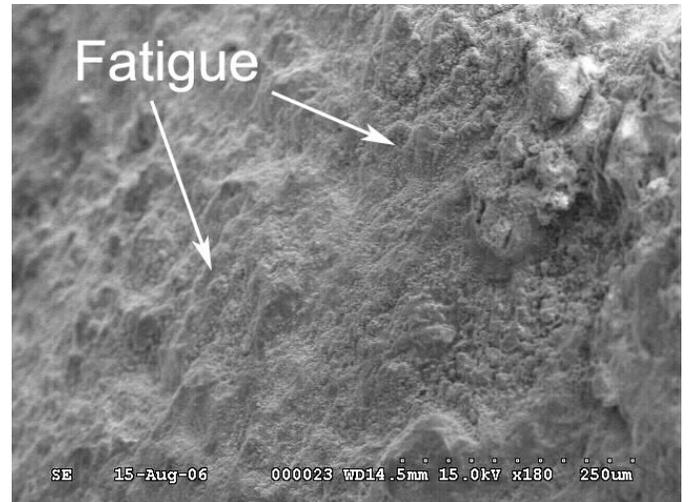
The fatigue section of the fracture in the axle housing segment was so badly corroded that the only information that could be obtained from the scanning electron microscopic examination was that the fracture was actually fatigue, Figures 6 and 7. The amount of corrosion prevented the measuring of the fatigue striation spacing, which is necessary in estimating the applied cyclic stress.

Figure 6 – 500X Fatigue Fracture - Axle Housing Segment

Figure 7 – 180X Fatigue Fracture - Axle Housing Segment

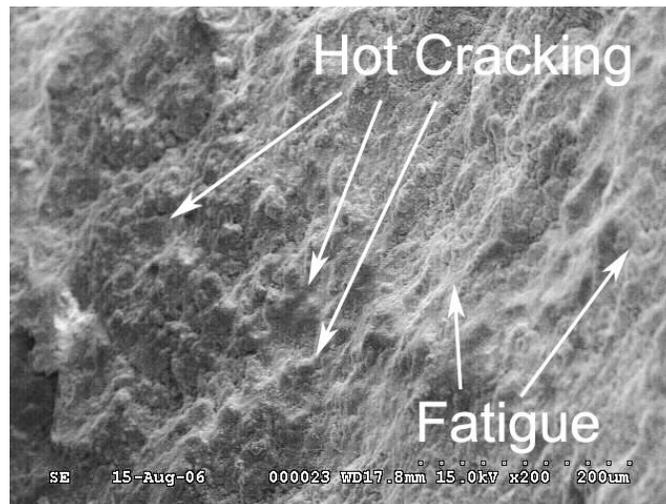
Figure 8 – 200X Hot Cracking and Fatigue - Axle Housing Segment

The fracture mode nearest the fracture origin, Figure 8, appears to have been hot cracking, which was indicated by apparent intergranular fracture and melting. Again, the amount of corrosion was significant enough that a definite evaluation was not possible. The extent of the corrosion is a clear indication that the crack had been open for a considerable amount of time.

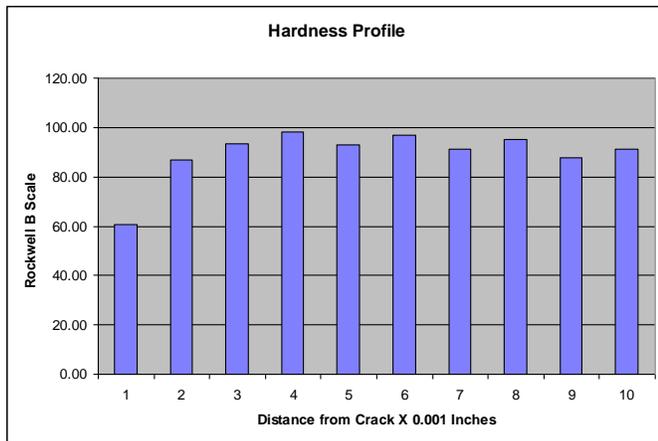
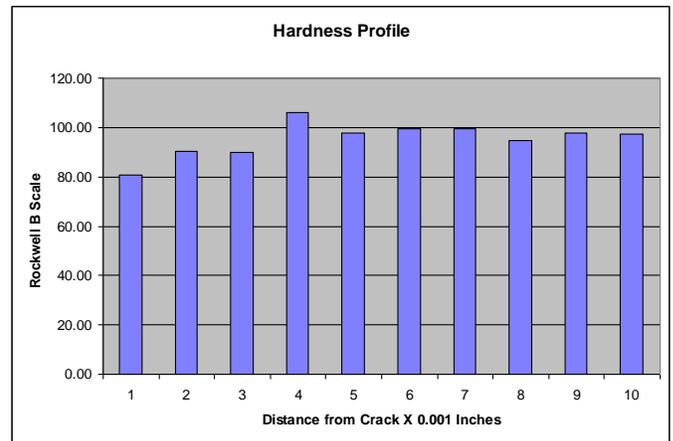
Figure 9 – Hardness Profile Starting at Fatigue Crack - Axle Housing Segment

Figure 10 – Hardness Profile Starting near Hot Crack End - Axle Housing Segment

The two hardness profiles starting on either side of the fracture origin have characteristics similar to those produced by fatigue cracks, Figures 9 and 10. The two profiles indicate plastic strain to about 0.004 inches of the crack. The size of the plastic radius can be used to estimate the cyclic fatigue stress associated with the fracture. Using the plastic radius is not as accurate as using the fatigue striation spacing.

The plastic radius as determined by micro-hardness testing was 0.004 inches. This yields a cyclic stress of 6700 psi. AWS D1.1 limits the cyclic stress load for similar designs to 7000 psi. Without other contributing factors, namely, stress risers caused by poor quality welding resulting from an improper welding procedure and a weld operator not qualified to the procedure, this connection should not have failed.

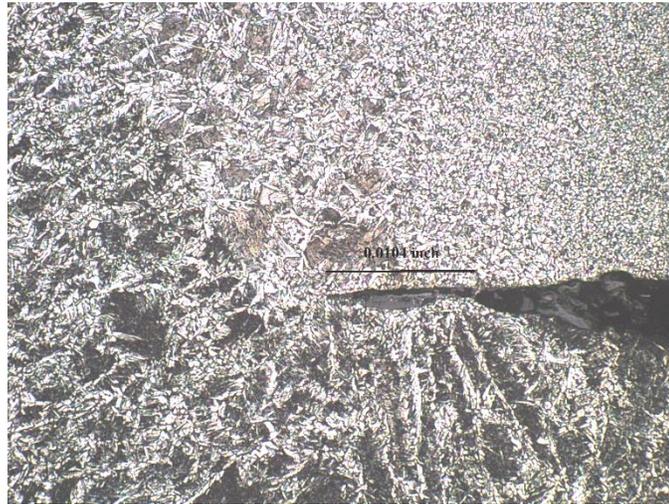
Figure 11 – 100X Lack of Fusion in Root of Circumferential Fillet Weld - Axle Housing Segment

The common characteristic of the circumferential fillet weld associated with the axle housing segment was lack of fusion in the root. **The weld would not have been acceptable to any welding code that I am aware of**, because of the lack of weld fusion shown in Figure 11. Tubular branch connections such as the ones that failed are some of the most difficult welds to properly design and weld. They require very highly qualified welder operators, and often very elaborate weld procedures to produce defect free welds. This particular branch connection does not meet AWS D1.1:2000 criteria for a pre-qualified structural weld subject to fatigue loading. The manufacturer would need to develop and qualify a welding procedure for this branch connection to produce a weld that meets all of the requirements for a fatigue loaded branch connection. Any personnel welding this connection would need to be qualified to that procedure. These records should be supplied with each axle housing assembly.

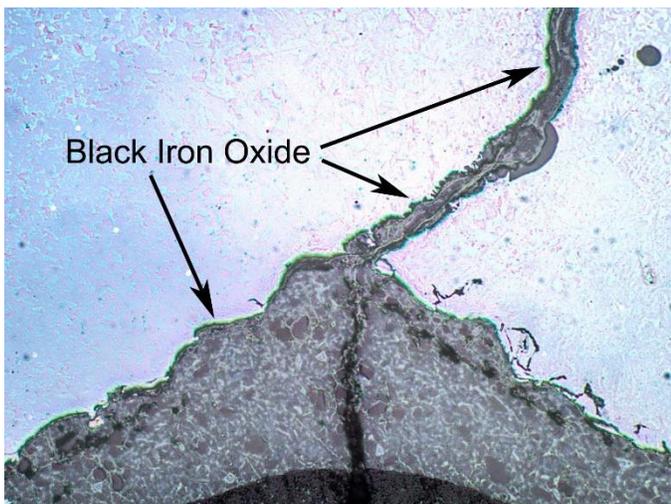
Figure 12 – 200X Hot Crack in Root of Axle Housing

The side of the crack in the axle housing segment that was designated as a hot crack had two types of oxide scale present, Figure 12. A black, high temperature oxide was caused by heat from the weld process. This assembly had failed prior to leaving the weld shop, and shows that there was no quality control, or likely even inspection of finished welded assemblies. Figure 13 shows extension of the hot crack. The end of the crack was likely the result of fatigue.

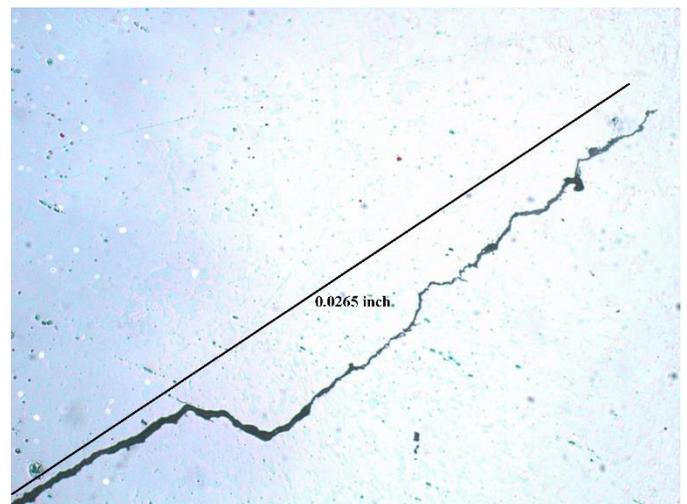
Figure 13 – 200X Hot Crack Extension from Root of Axle Housing

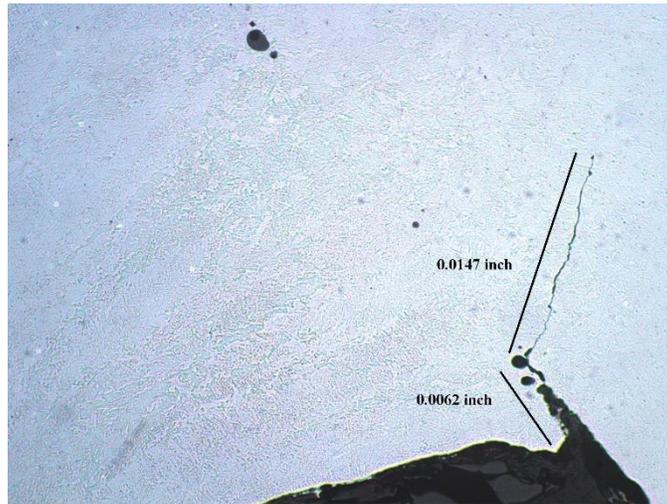
Figure 14 – 100X Crack in Weld Toe - Axle Housing Segment

Figure 14 shows the crack at the weld toe of the start-stop location. There is lack of fusion at the weld toe that was the result of the weld puddle running ahead of the arc, which is an operator error. The crack extends into the rectangular tubing material along the weld base metal interface. The quality of this weld was extremely poor.

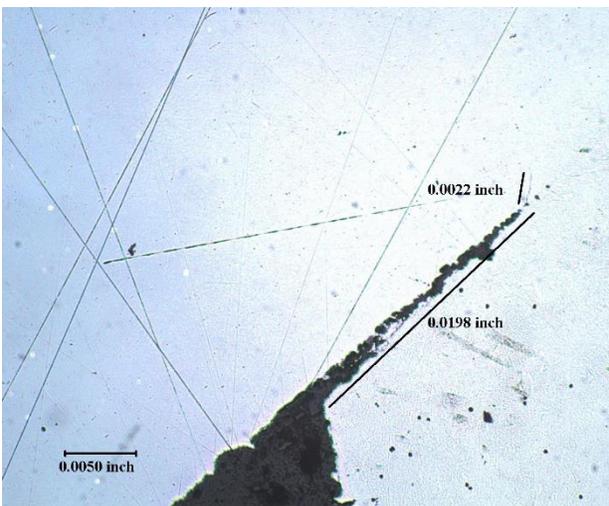
Figure 15 – 100X Lack of Fusion and Crack at Weld Toe - Axle Housing Segment

The weld start-stop location on the axle housing segment had lack of fusion at the weld toe, Figure 15. At the root of the lack of fusion was an extension crack penetrating about 0.030 inch into the tube wall, Figure 16. This was another very poor quality weld.

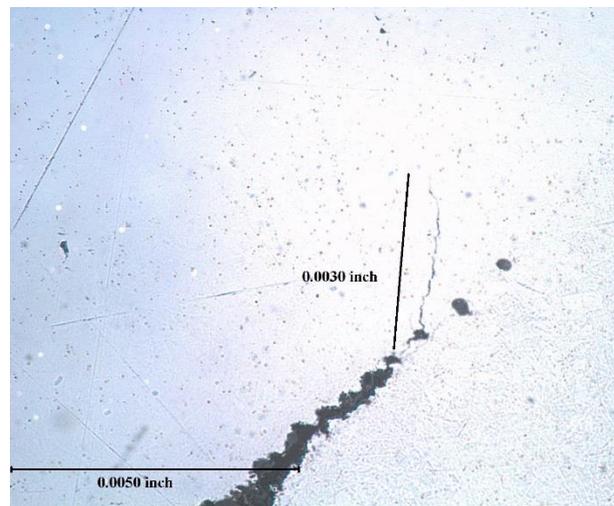
Figure 16 – 400X Crack Extension - Axle Housing Segment
