M. E. Williams and Associates, Inc.

Report Number: 16-4686

Failure analysis of two steam coil sections used in a steam heating system, and analysis of two water samples removed from the system containing the failed coils. The water samples were examined by visual examination, scanning electron microscopic examination, energy dispersive x-ray analysis, and anion analysis. The copper tubing in the failed coil samples was examined by visual examination, scanning electron microscopic examination, energy dispersive x-ray analysis, and metallographic examination.

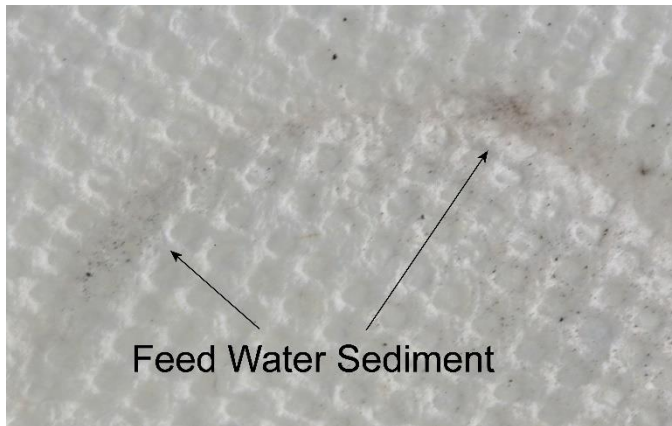
Figure 1 – Feed Water Sediment from Front by Dock Water Sample

There was a small amount of sediment in the feed water sample labeled Front by Dock. Some of the sediment is shown in Figure 1.

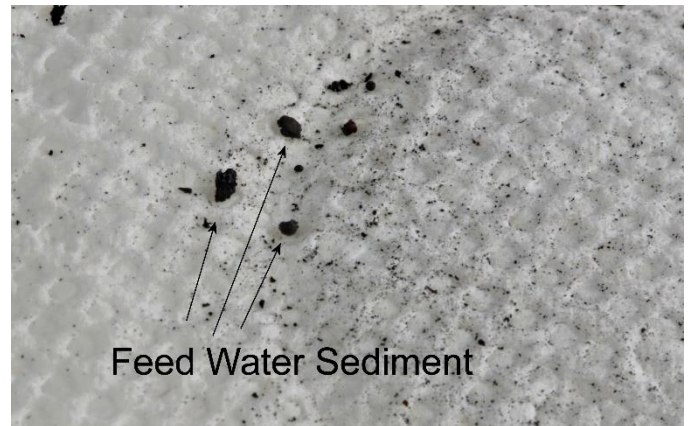
Figure 2 – Feed Water Sediment from CIP Water Sample

There was considerably more sediment in the CIP Water Sample. Some of that sediment is shown in Figure 2. Figure 3 shows some of the sediment sticking to a magnet, indicating that the black material in

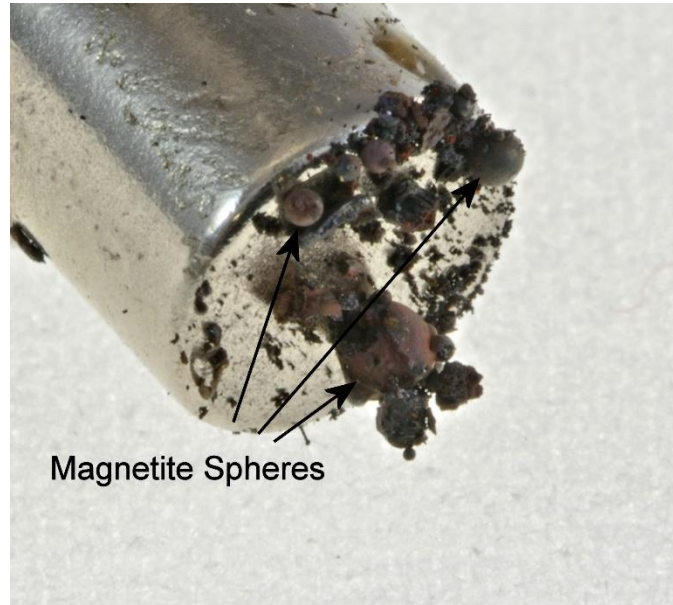
the sediment was magnetite, magnetic iron oxide (Fe_3O_4). Some of the magnetic iron oxide is in the form of spheres.

Figure 3 – Sediment from CIP Water Sample

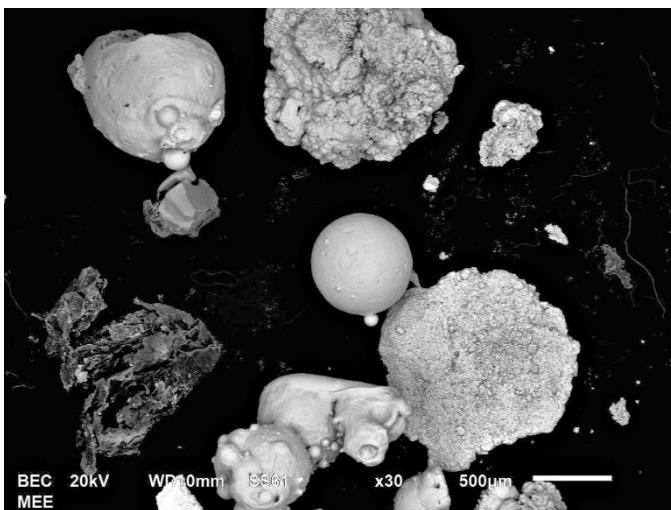
Figure 10 – 30X Feed Water Sediment CIP, Area 1

The sediment from the CIP location was somewhat different than that from the Dock location. Figure 10 shows the variety of structures that were found. Figure 11 shows the locations of the analysis. The spectra are shown in Figures 12 through 16, and the semi-quantitative analysis is given in the table that follows.

Location 1 appears to be a piece of carbon steel. Aluminum and titanium are often used as grain refiners in steel. Locations 2 and 3 are iron oxide nodules. Location 4 is a piece of copper oxide scale. Location 5 is an iron rich organic material. Each of these particles were formed as a result of corrosion in the system. A likely source of the aluminum is the steel piping and tubing in the system.

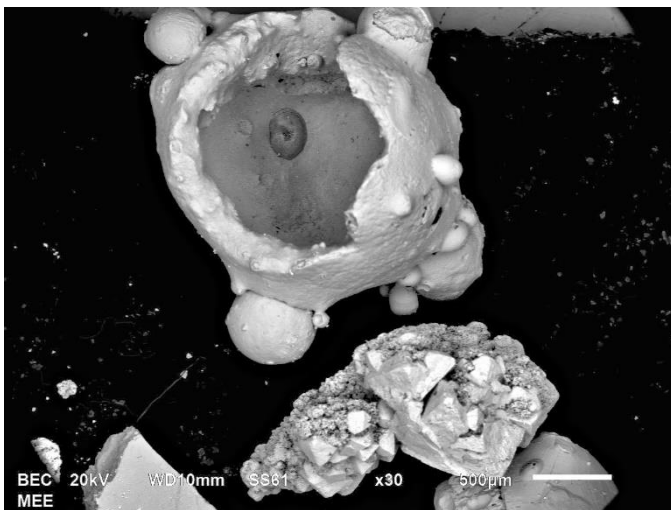
Figure 17 – 30X Feed Water Sediment CIP, Area 2

The hollow nodule shown in Figure 17 indicates there may be bacteria in the feed water. The pH of the feed water may be high enough to prevent bacteria growth, but localized pH may allow bacterial growth. Location 3, Figure 18, had to be reanalyzed to obtain a good spectrum, because the x-rays were blocked by the hollow nodule. The reanalysis is reported as Location 4 in the table and spectra that follow. The semi-quantitative analysis is given in the table that follows.

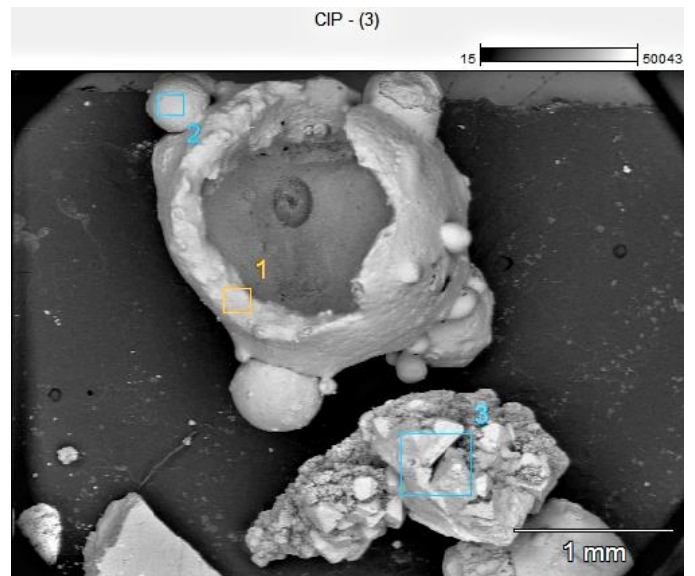
Figure 18 – 30X Feed Water Sediment CIP, Area 2, Analysis Locations

The hollow nodule, Location 1, appears to be oxidized steel. Location 2 is iron oxide, and Location 4 is a group of copper oxide crystals. Aluminum was present in all three locations.

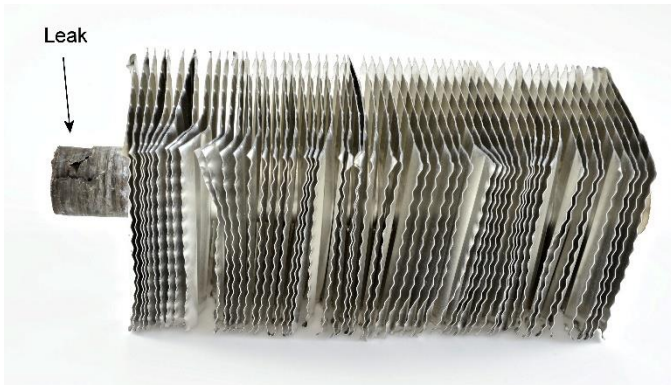
Figure 22 – Coil Sample 1

Figure 22 shows Coil Sample 1. The leak was on the top side of the tube, and the tube was located on the top of the coil. It was the last tube that the steam would pass through in the coil. There was considerable thinning of the copper tubing associated with the leak, Figures 23 and 24. Thinning of the tubing is usually the result of fine water droplets in the steam that impinge on the surface and cause erosion. Figure 25 shows cracks on the inside diameter of the tube. This sample was from the tube on the right in Figure 24. Cracking was likely the result of embrittlement of the copper tube and had nothing to do with erosion.

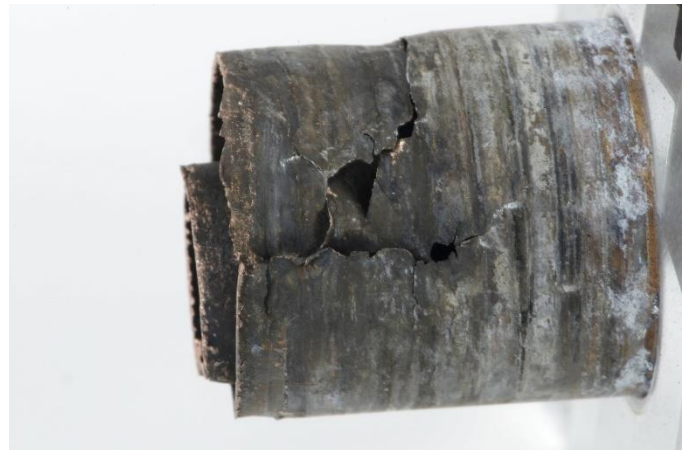
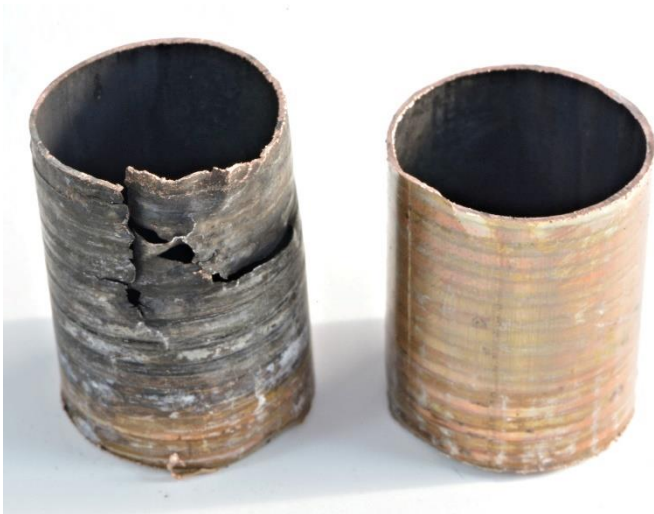
Figure 23 – Leak, Coil Sample 1

Figure 24 – Tube Sections, Sample 1

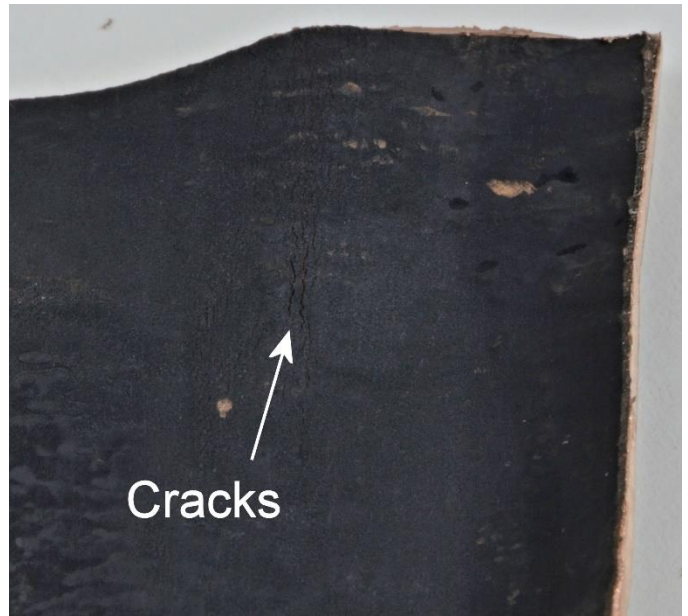
Figure 25 – Crack in I.D. Tube Sample 1

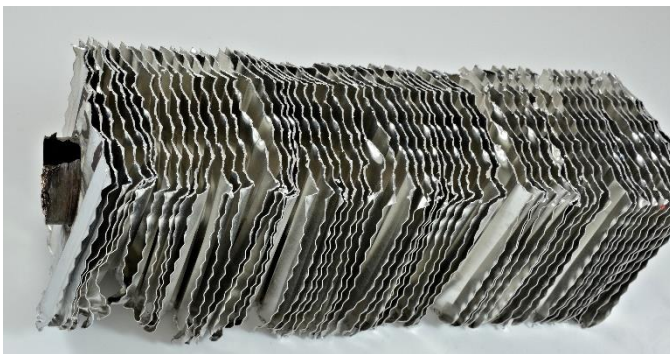
Figure 26 – Coil Sample 2

Coil Sample 2, Figure 26, was also taken from the top row of the coil. The leak on the top side of the tubing appeared to be the result of thinning. Figures 27 and 28 show the leak, which was on the top side of the tube. The apparent cause of leakage was erosion due to condensate in the steam. The tube did not crack when it was opened for examination, Figure 29. What appears to be cracks was the result of the oxide scale flaking off.

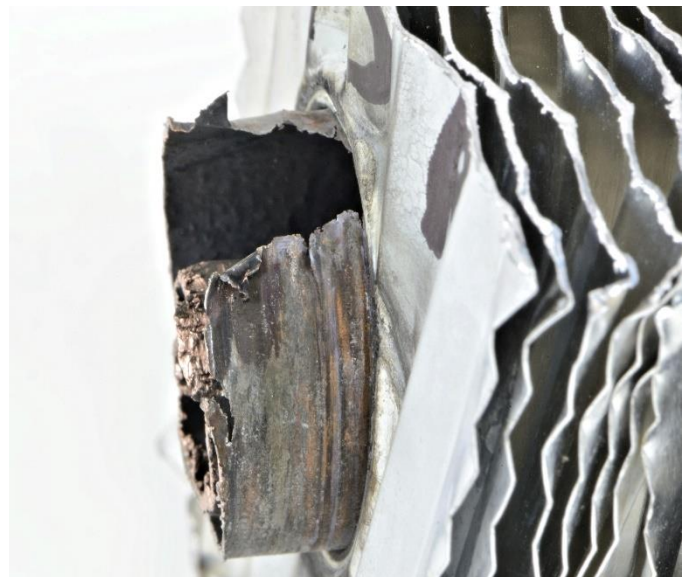
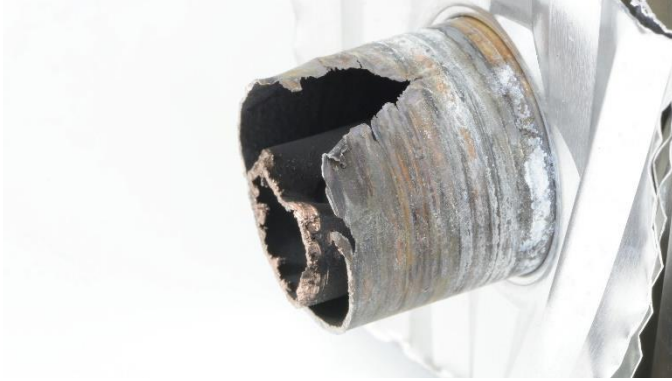
Figure 27 – Leak in Coil Sample 2

Figure 28 – Leak in Coil Sample 2

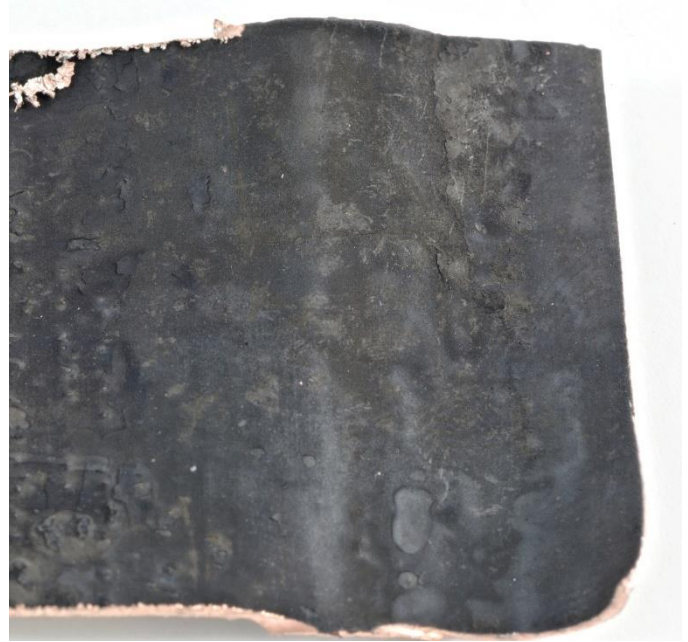
Figure 29 – Inside Diameter of Coil Sample 2

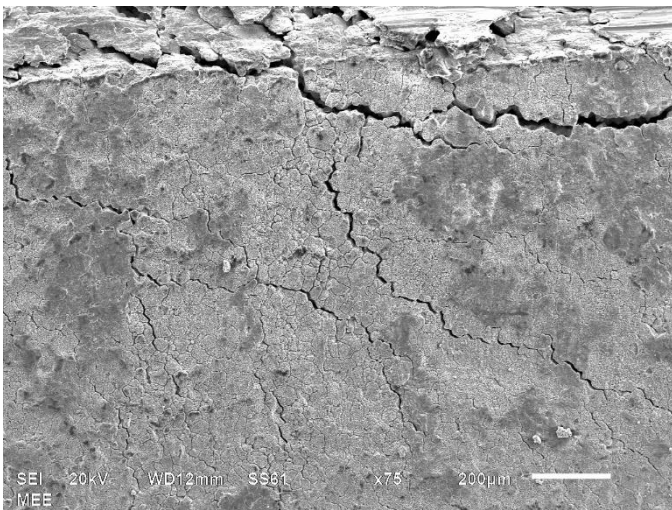
Figure 30 – 75X Intergranular Cracking I.D. Coil Sample 1

The cracking on the inside diameter of Coil Sample 1 is shown in Figure 30. The cracking mode is intergranular, which is a brittle fracture mode. The most common cause of intergranular cracking in copper

tubing is ammonia. Figure 31 is the spectrum of the surface shown in Figure 30. Only three elements are present: carbon, oxygen, and copper. Ammonia and other nitrogen compounds are very hard to detect by energy dispersive x-ray analysis, but the intergranular cracking is a key indicator that they were present.

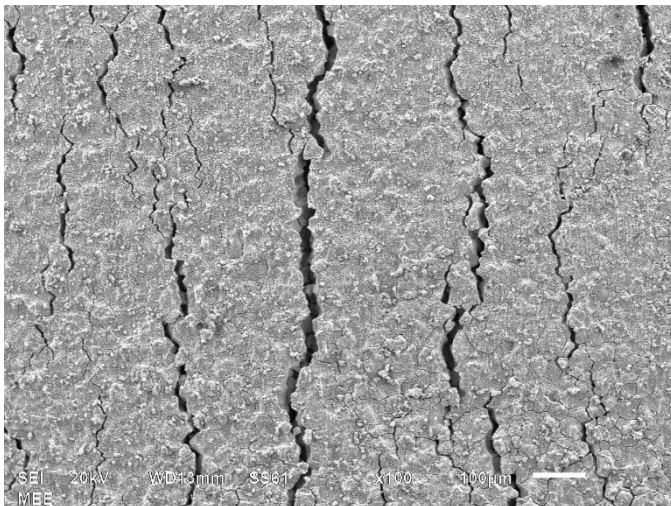
Figure 32 – 37X Intergranular Cracking on I.D. of Coil Sample 1

The intergranular cracking on the inside diameter of Coil Sample 1 is clearly shown in Figure 32. Figure 33 shows the nature of the oxide formation on the inside diameter of Coil Sample 1. Figure 34 is the energy dispersive x-ray spectrum of the surface area shown in Figure 32. This was the only location where aluminum was detected on the inside diameter of the copper tubing. The other elements were carbon, oxygen, and copper.

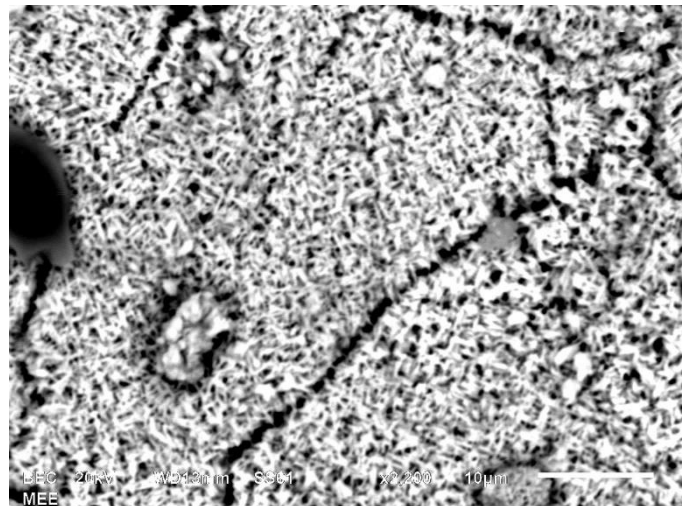
Figure 33 – 2200X I.D. Surface of Coil Sample 1

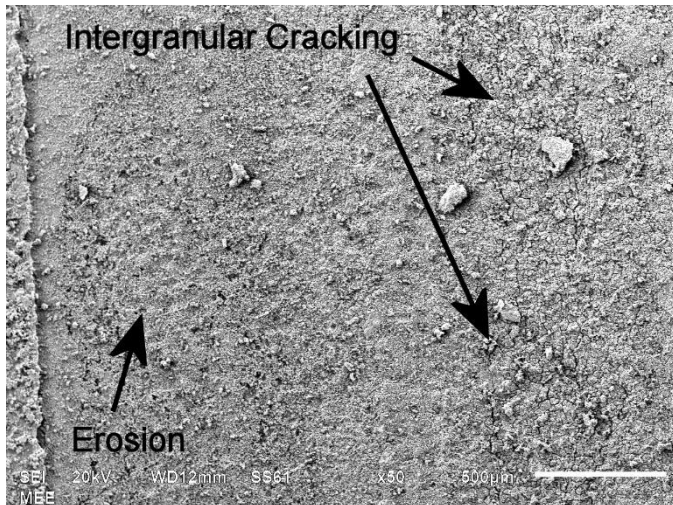
Figure 35 – 50X I.D. of Coil Sample 2

Figure 35 shows a location on the inside diameter of Coil Sample 2. The thick oxide scale had flaked off the copper at this location. There was evidence of erosion and evidence of intergranular cracking present. Figure 36 shows the spectrum of the area shown in Figure 35. The elements present were carbon, oxygen, and copper.

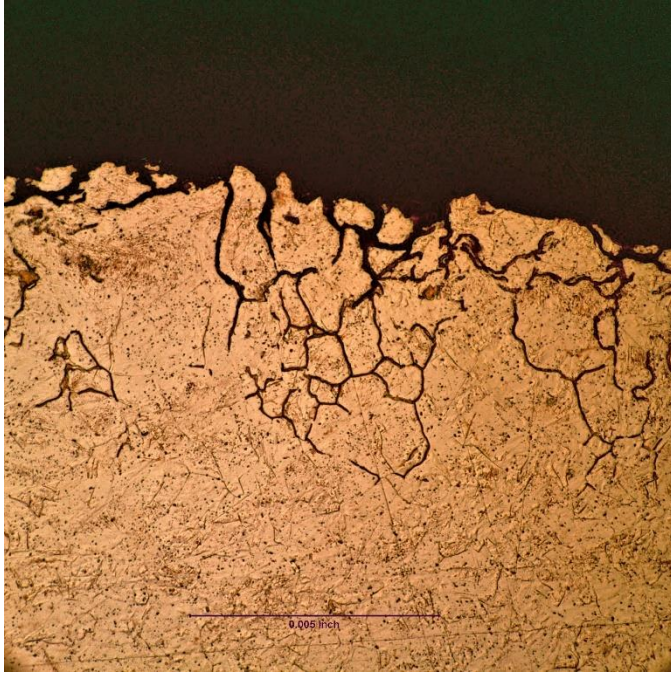
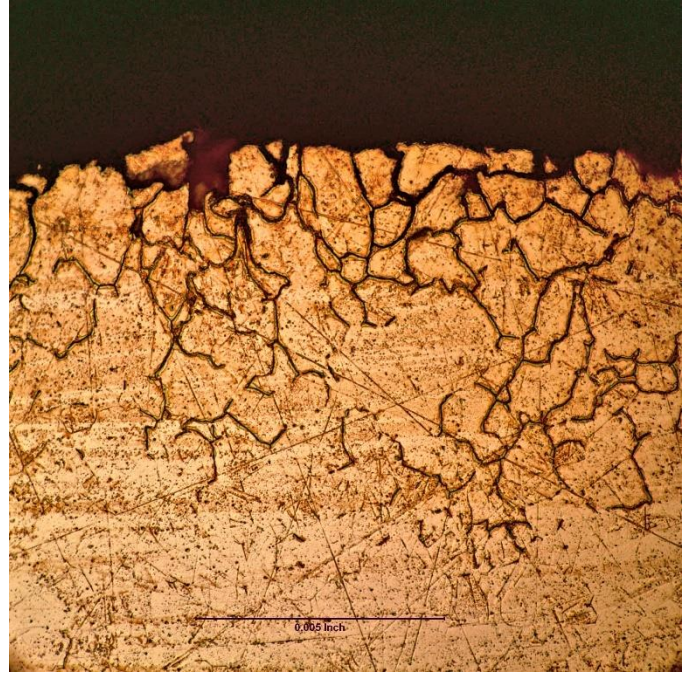
Figures 37 and 38 show intergranular stress corrosion cracking in the copper from Coil Sample 1. The intergranular stress corrosion cracking occurred in most locations on the inside diameter of the tube. There was thinning at the top of the tube. The bottom of the tube did not show thinning. Intergranular stress corrosion cracking destroys the metallic bonds at the grain boundaries, as shown in the photos. Any force to the grains will likely cause them to break free from the tube surface. The combination of erosion and intergranular stress corrosion cracking would result in rapid thinning of the copper tubing.

Figure 37 – 400X Intergranular Stress Corrosion Cracking of Top Side of Copper Tube from Coil Sample 1

Figure 38 – 400X Intergranular Stress Corrosion Cracking of Bottom Side of Copper Tube from Coil Sample 1

1. Replace the heat exchangers with heat exchangers fabricated from 304L stainless steel.
2. Check the steel tubing in the system by ultrasonic testing to determine the thickness of the steel tubing and piping, if they are accessible.

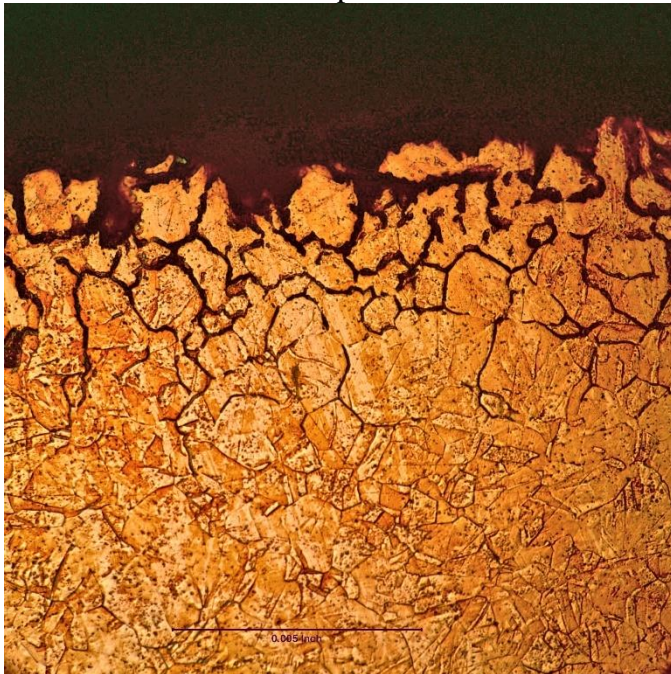
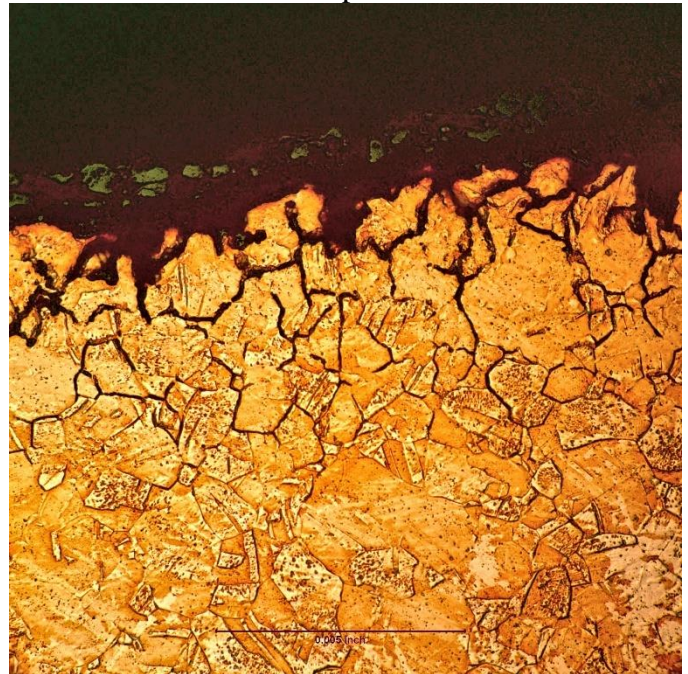
Figure 39 – 400X Intergranular Stress Corrosion Cracking of Top Side of Copper Tube from Coil Sample 2

Figure 40 – 400X Intergranular Stress Corrosion Cracking of Bottom Side of Copper Tube from Coil Sample 2

The copper tube from Coil Sample 2 showed the same conditions found in the sample from Coil Sample 1. The most common cause of intergranular stress corrosion cracking in copper is ammonia. Even at room temperature, moist ammonia will cause stress corrosion cracking in copper tubing.
