## Extension Spring Failure

Merlin E. Williams, P.E.

This music wire extension spring failed after being in service for a short period of time. This investigation was to determine the cause of the spring failure. The spring was examined by visual examination, hardness testing, scanning electron microscopic examination, fracture mechanics, and metallographic examination.

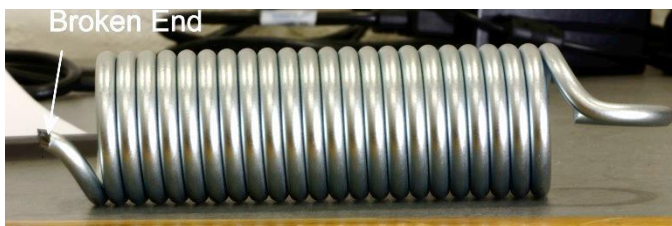
Figure 1 – Broken Spring

The broken Extension Spring is shown in Figure 1. The broken end is on the left hand side of the photo. The location of the fracture origin is shown in Figure 2. Figure 3 shows a tool mark caused during forming of the spring. The tool mark was only on the broken end of the spring where the failure initiation occurred. The tool mark is a common manufacturing defect associated with springs.

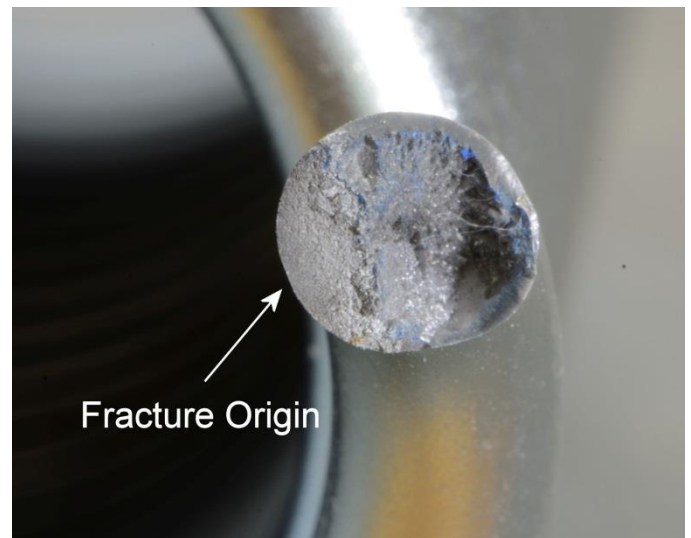
Figure 2 – Fractured End

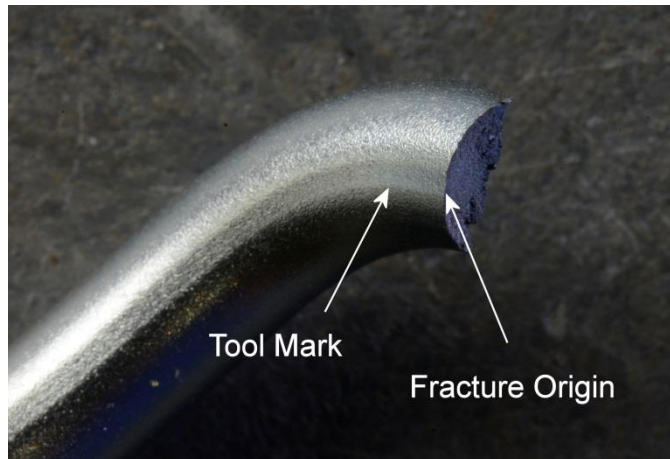
Figure 3 – Tool Mark Associated with Fracture Origin

The visual examination revealed a manufacturing defect associated with the fracture origin of the spring.

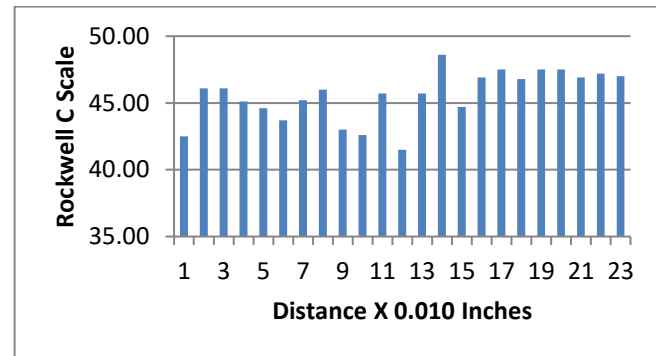
Figure 4 – Hardness Profile

The average hardness across the spring wire was 45.48 Rockwell C Scale. The hardness is in the correct range for spring wire of this diameter. The hardness profile, Figure 4, looks very good for formed music wire.

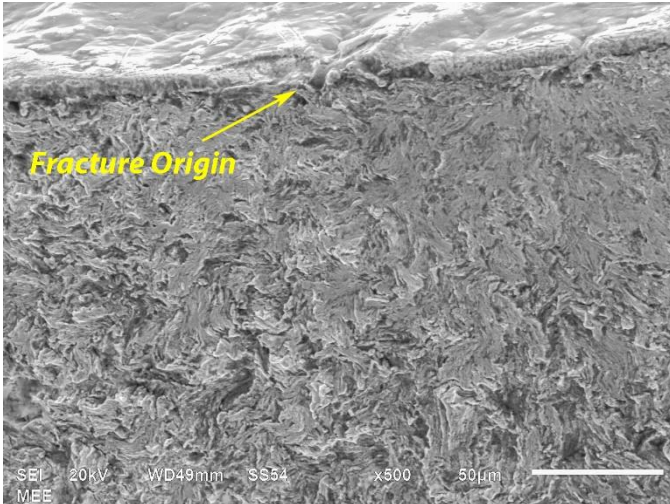
The fracture origin is shown in Figure 5. There is a depression in the wire surface that is noticeable at this location. An error in the forming of the wire caused the tool mark which indicated that the steel was highly cold worked. There was cracking and flaking of the music wire at the fracture origin.

Figure 5 – 500X Fracture Origin

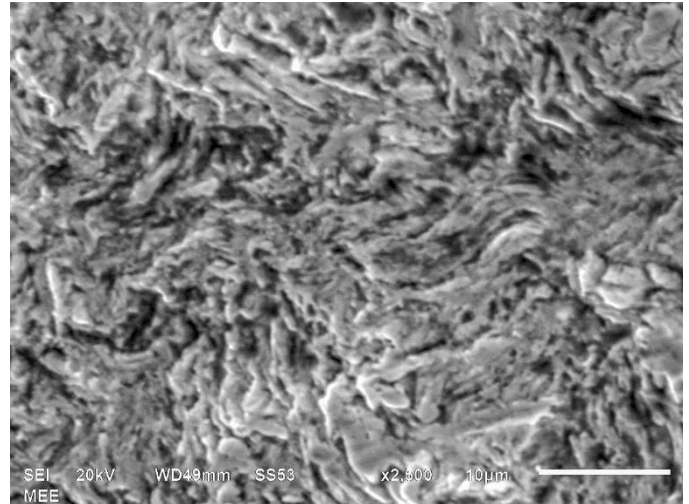
Figure 6 shows fatigue striations near the fracture origin. There was some indication that triaxial stress may have been involved in the spring failure. The striation spacing was found to be  $18.43 \times 10^{-6}$  inches.

Figure 6 – 2000X Fatigue Striations near Fracture Origin

The measured value for “a”, for the broken Extension Spring was 0.099 inches. Based on the measured “a” value and the fatigue striation spacing, the cyclic stress on the spring was estimated to be 80 ksi, which is typically considered to be the endurance limit for steels that have yield strengths higher than 160 ksi.

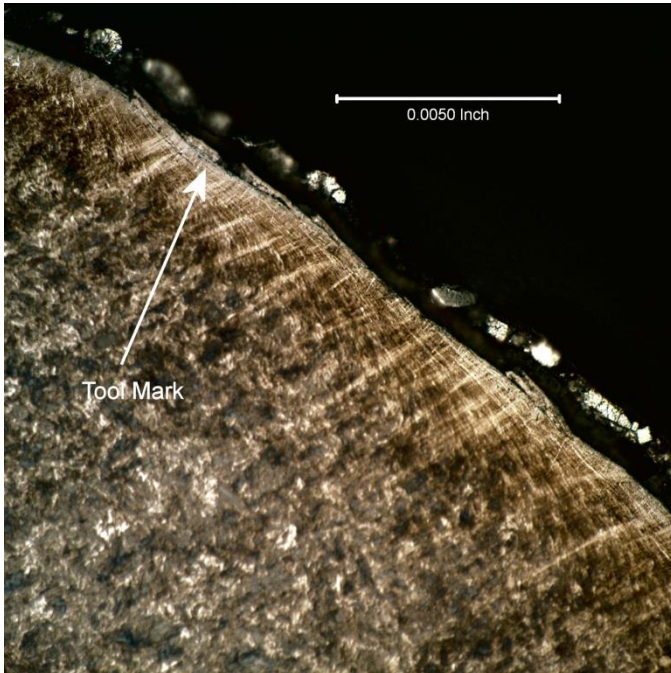
Figure 7 – 400X Tool Mark

Figure 7 shows the highly cold worked steel that resulted from the tool mark on the spring wire. There was also some cracking and flaking of the music wire resulting from the excessive cold working caused by the tool mark. There was also a small amount of surface decarburization present on the spring wire, Figure 8. The surface decarburization did not appear to have contributed to the spring failure.

Based on the findings given in this report, the spring failure was the result of cold working caused by the tool mark. Tool marks are common manufacturing defects that occur during the forming of a spring. Tool marks are also a common cause of premature spring failure.

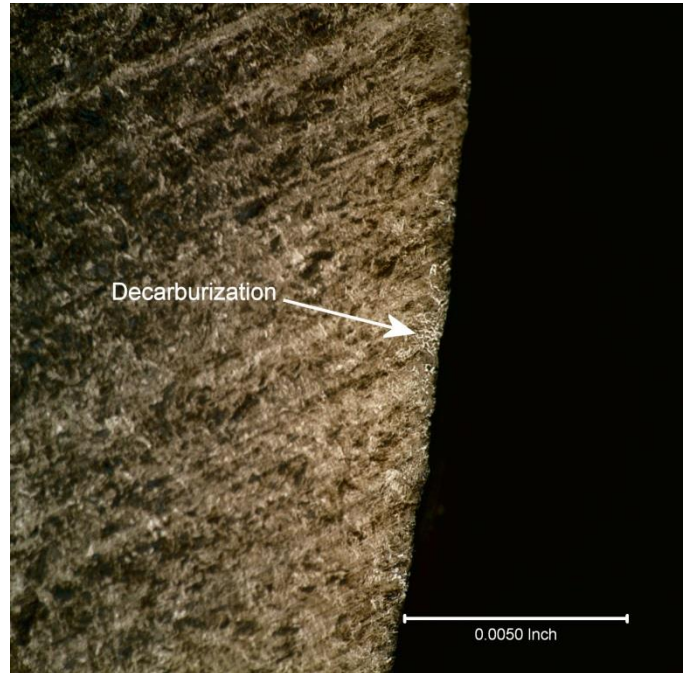
Figure 8 – 400X Surface Decarburization
