Case Study: Grain Auger Failure

Inspection of a Westfield MK 130-71 Plus Auger in 2021. The damage to the auger was supposedly caused by a tornado in 2018, but not reported to the insurance company until 2020.

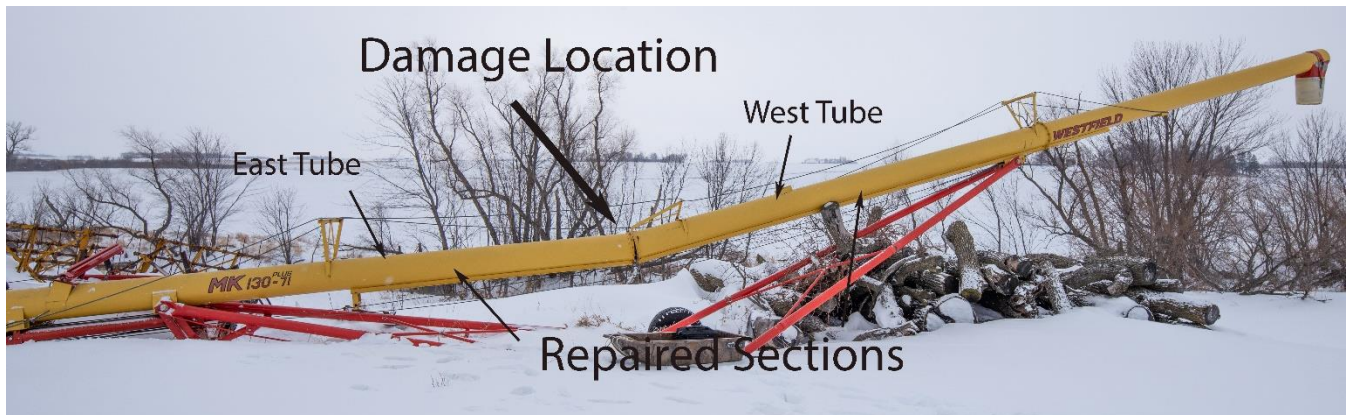
Figure 1 – Auger and Tube Descriptions

Figure 1 shows the Westfield auger when it was inspected in February of 2021. The damage location was in the center of the auger and was primarily to the flange joint between the two center tubes. Figure 1 gives the descriptions used in this report for the damaged auger tubes.

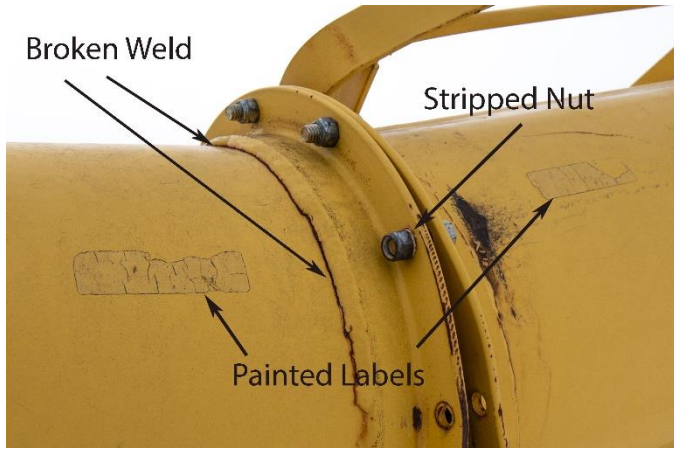
Figure 2 – Damage to East Flange

The damage associated with the east tube flange joint is shown in Figure 2. The significant damage is the broken weld holding the flange to the auger tube. The flange joint had been repaired by welding and was repainted at some time prior to the inspection, and prior to the damage to the flange joint. The two tubes connected at this joint were repainted after the weld repairs. This is indicated by the painted-over labels shown in Figure 2.

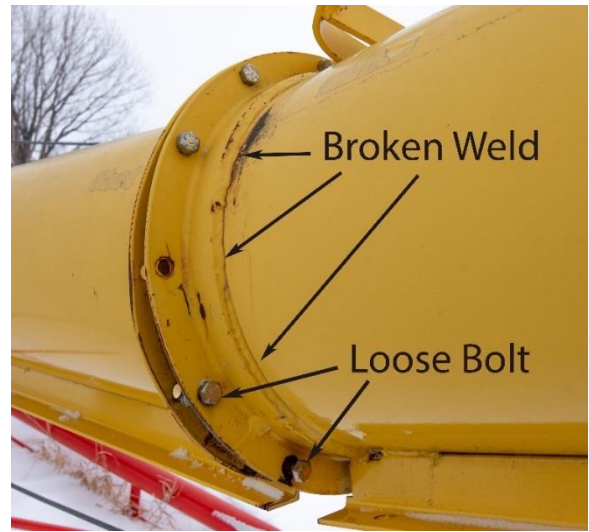
Figure 3 – Damage to West Flange

The damage on the west side of the flange joint is shown in Figure 3. The flange weld on the west tube was broken. This weld had been repaired. There was a corrosion spot where the paint did not adhere after repainting. The corrosion of the steel has been going on for at least several years.

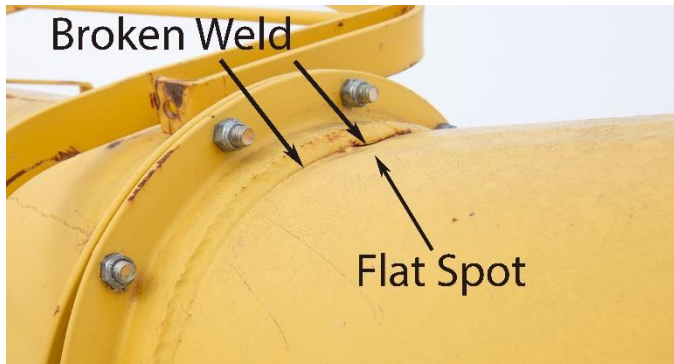
Figure 4 – Damage to East Flange

Broken welds and a flat spot or dent in the east tube is shown in Figures 4 and 5. The broken weld indicated in Figure 4 follows the profile of the flat spot, indicating that the spot was there when the weld was repaired. The dent on the east auger tube was present prior to the weld repairs to the two flanges in the center of the auger. Figure 5 shows the dent better. The dent runs along the tube for 12 to 18 inches.

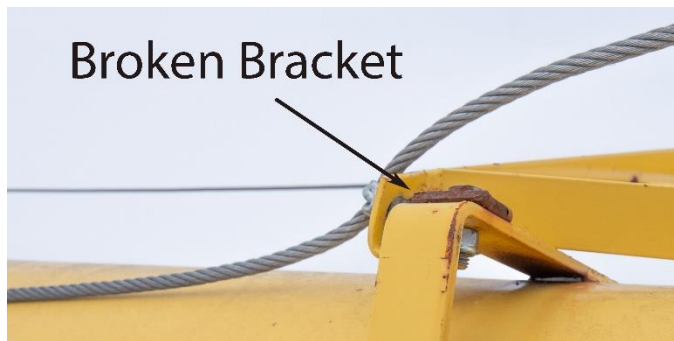
Figure 6 – Broken Support Bracket for Cable Gantry

There is a cable gantry that runs seventy five percent of the length of the auger. The broken support bracket was west of the damaged flanges. The portion of the bracket bolted to the auger is shown in Figure 6. This section of the bracket was heavily rusted. Figure 7 shows another section of the bracket frame. There is a defective weld present, indicating that the bracket had been repaired prior to the current damage to the auger. The weld-remains show a high percentage of lack of fusion, which is sufficient to reject any weld. The failure of this weld was likely caused by a one-time event that precipitated the current damage and failure of the auger. The purpose of the cable gantry was to provide tension to support the end section of the auger tubing, and to prevent excessive bending moments in the joint at the center of the auger.

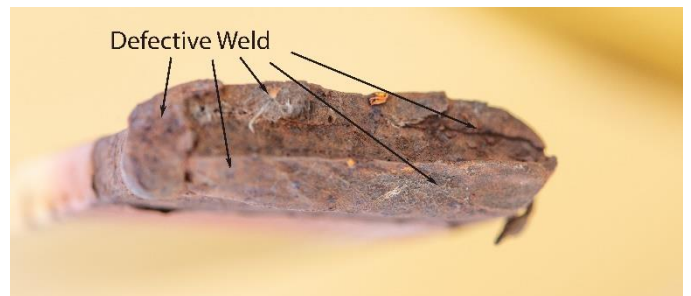
Figure 7 – Broken Bracket Defective Weld

It is quite clear that the Westfield MK 130-71 Plus Auger had been damaged and repaired prior to the damage claimed in the current claim. It is also quite clear that the repair of the damage was not up to typical industrial standards. This is illustrated by the broken bracket weld, Figure 7, and the broken flange-to-tube welds shown in Figures 2, 3, 4, and 5. The characteristics of these broken welds indicate lack of fusion. In the case shown in Figure 7, it was lack of fusion between bracket segments. In the case shown in Figures 2, 3, 4, and 5, it was lack of fusion between the weld and the auger tubes. Both of these cases are examples of poor workmanship.

The poor weld quality of the bracket, Figure 7, was definitely a major contributing factor to the auger damage that was currently being investigated. The breakage of the bracket weld could have been caused by moving the auger from one location to another, or by a tree or branch falling on the gantry during the 2018 tornado.

- 1) Poor weld quality bracket, Figure 7. This weld showed a considerable amount of lack of fusion and was not acceptable by any known industrial standard. Failure of this weld was the most likely cause of damage to the grain auger.
- 2) The auger tube-to-flange repair welds were defective, showing lack of fusion between the welds and auger tubes.
- 3) Indications were that the locking nuts used on the flange bolts were not Grade 8 to match the characteristics of the bolts, and therefore failed by stripping of the threads of both bolts and nuts.
- 4) The current damage to the auger was most likely the result of a one-time event, which is not determinable.

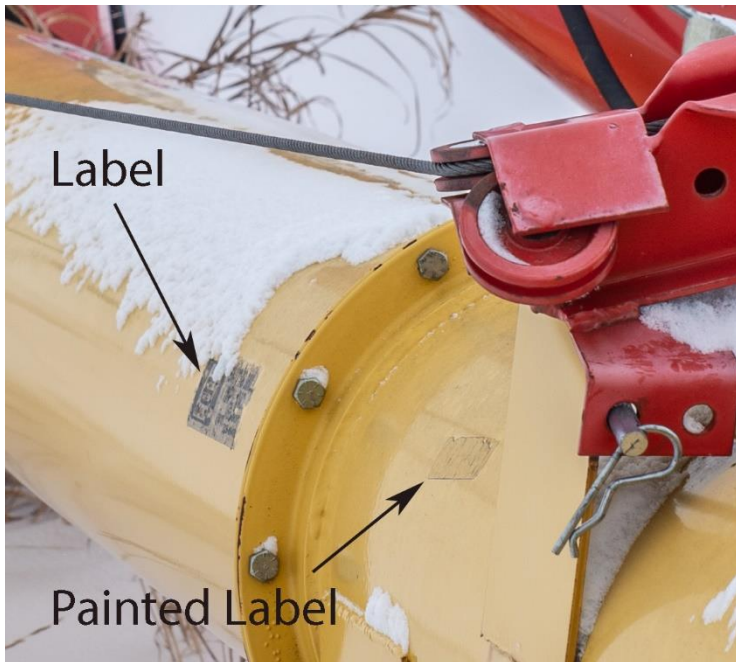
Figure 8 – Labels on Two Eastern Auger Tubes

The flange joint between the two eastern tube sections is shown in Figure 8. The eastern most tube has a label that is free of paint. The other tube has a painted label, indicating that the entire tube was painted after the weld repairs were made.

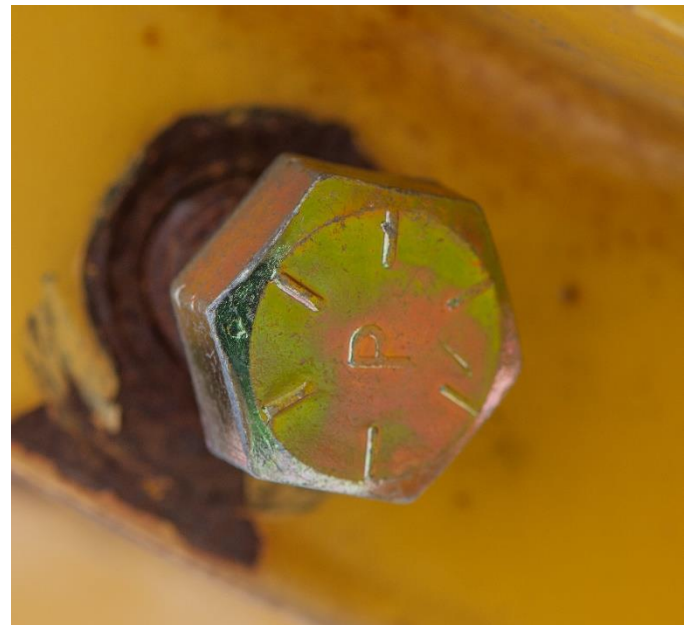
Figure 9 – Grade 8 Bolt Head

Figure 9 shows the head of a Grade 8 bolt, indicated by six marks on the bolt head. All of the bolts used to hold the tube flanges together were Grade 8.

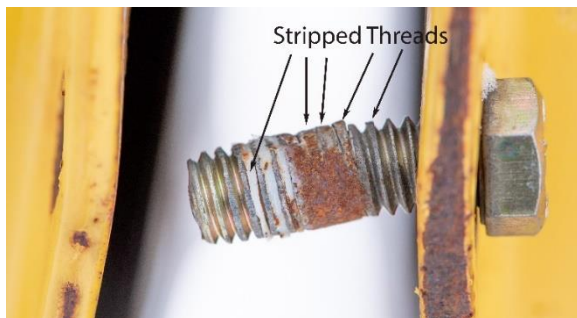
Figure 10 – Stripped Threads on Flange Bolt

Figures 10 and 11 show stripped threads on two flange bolts. Both the bolt threads and nut threads were stripped, the nut threads were imbedded between the bolt threads.

Stripping of the bolt and nut threads requires a considerable amount of force. The broken threads failed by shear fracture during a onetime overload event that broke the bolt threads, and sheared off the nut threads. No nuts were recovered or removed. The nuts used may not have been Grade 8 nuts, and could, therefore, have caused failing at a lower load than expected for Grade 8 nuts and bolts. When the auger was repaired, the bolts and nuts were likely replaced.

The most likely reason the flange bolts failed is that the lock nuts were not Grade 8. This can be tested for, but samples are needed for destructive testing and verification of the combined nut/bolt strength.
