Case Study: Shaft Failure

Examination of carburized coupling shaft to determine cause of failure. The shaft failed within a few minutes after being put into service on a piece of off-road equipment. The shaft was examined by visual examination, hardness testing, and metallographic examination.

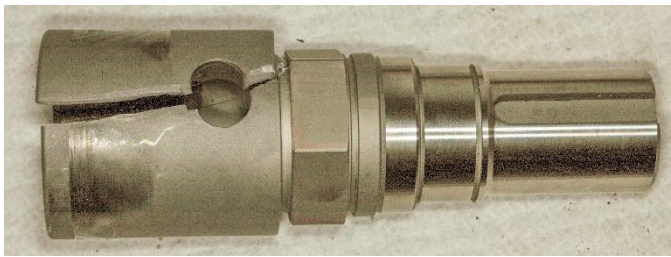
Figure 1 – Crack in Shaft

Figures 1 through 4 show the large cracks in the shaft. Figure 2 shows the fracture origin at the outer end of the keyway. Figure 3 shows additional cracking at the base end of the keyway. The coloration of the fracture surface and the outer surface of the shaft were identical, indicating that the fracturing likely occurred prior to tempering.

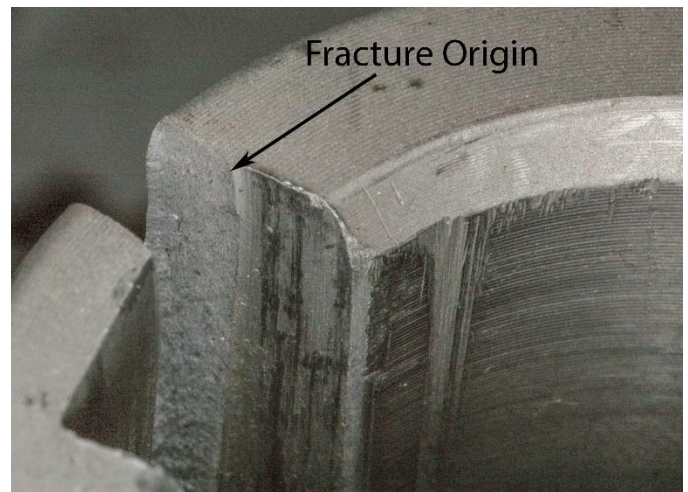
Figure 2 – Fracture Origin in Keyway

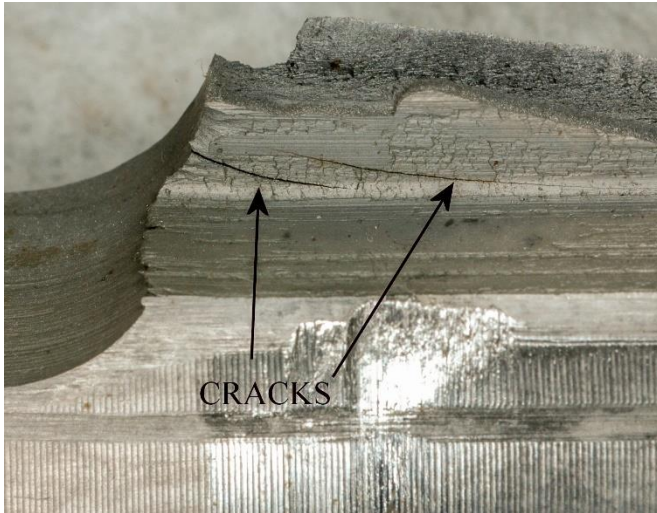
Figure 3 – Cracks at Base End of Keyway

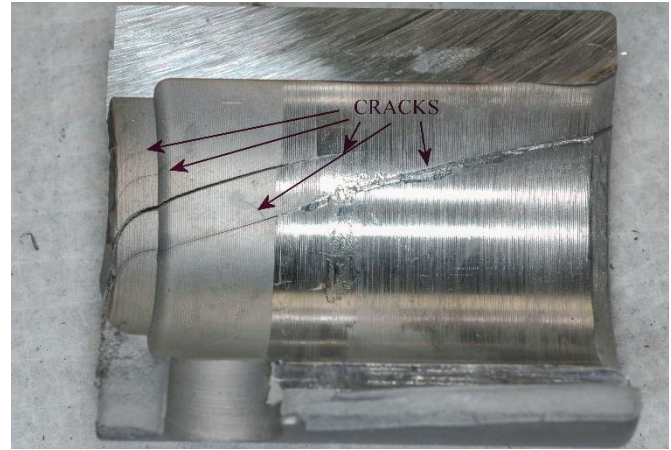
Figure 4 – Cracks Inside Diameter

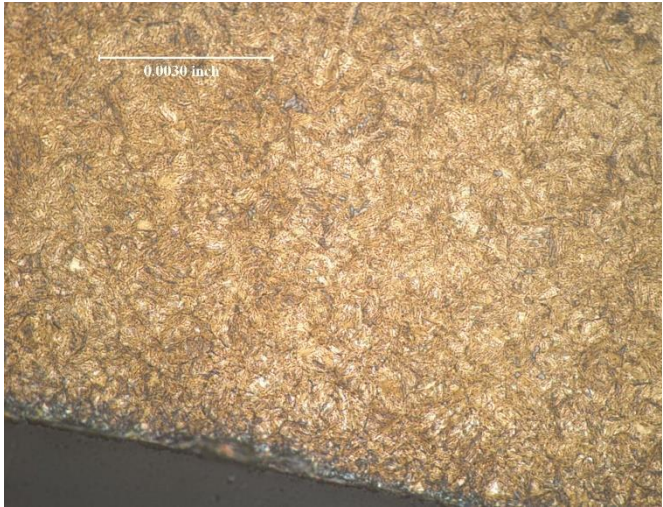
Figure 5 – 400X Tempered Martensite Case Sample 1

The microstructure of the carburized case shown in Figure 5 was tempered martensite. There was no visible evidence of retained austenite or undissolved carbides. Figure 6 shows the small crack on the inside diameter. The fracture is intergranular, and is typical of delayed quench cracking.

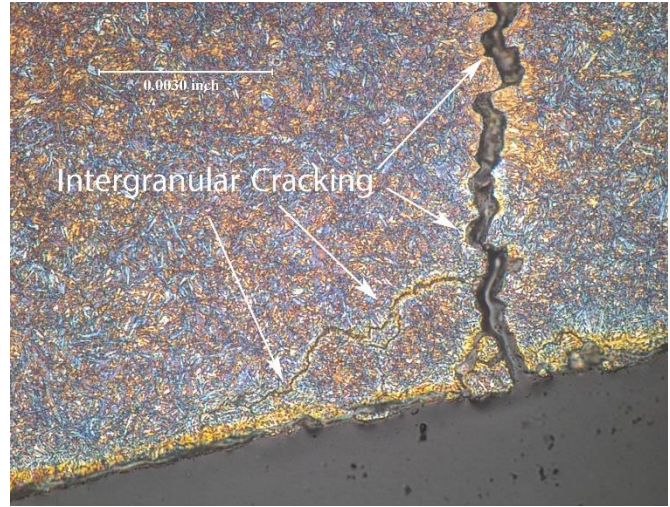
Figure 6 – 400X Intergranular Cracking in Case Sample 1

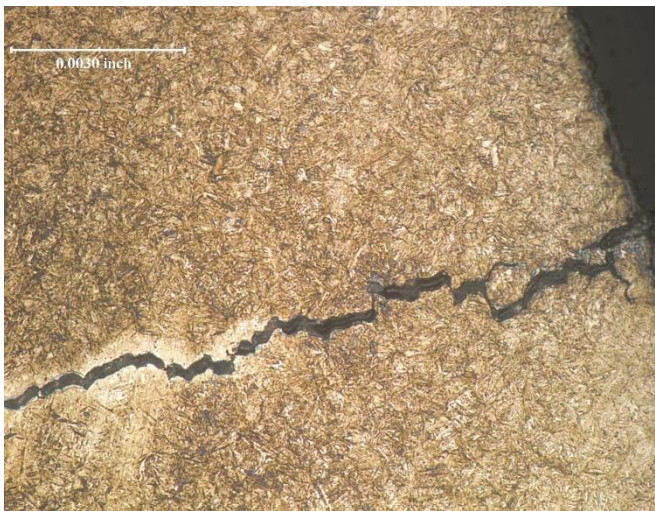
Figure 7 – 400X Intergranular Fracture and Case Microstructure

Figure 7 shows the intergranular fracture in the carburized case. This crack is also typical of delayed quench cracking. There was no evidence of retained austenite or carbides at this location. Figure 8 shows the oxide scale in the intergranular crack. The presence of oxide scale indicates that the crack was there prior to tempering, which indicates a significant time delay between quenching and tempering.

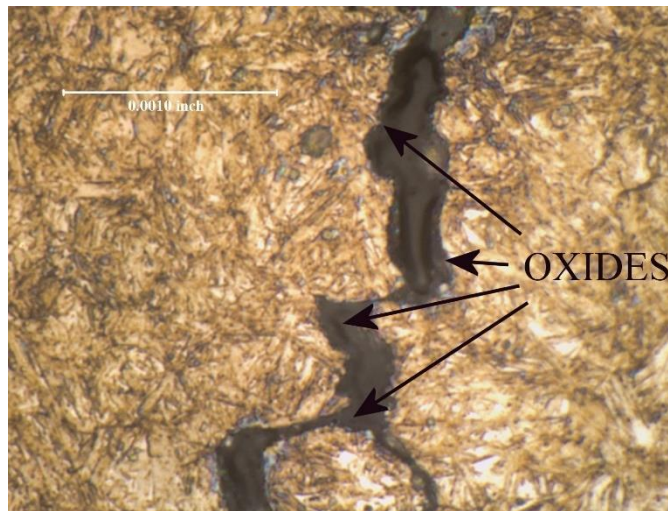
Figure 8 – 1500X Oxide Scale in Intergranular Crack
