25 HP Hydraulic Pump Shaft Failure – Case Study

Merlin E. Williams, P.E.
M. E. Williams and Associates, Inc.
merlin@mewai.com
507-835-2344

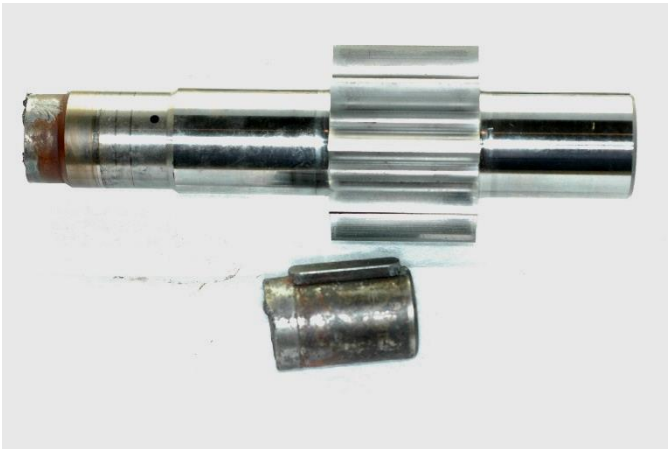
Figure 1 – Complete Shaft

Figure 1 shows the broken hydraulic pump shaft. Based on the visual examination, the shaft appears to have failed by torsional fatigue, Figure 2. This is indicated by a number of fracture origins and ratchet marks located around the shaft circumference.

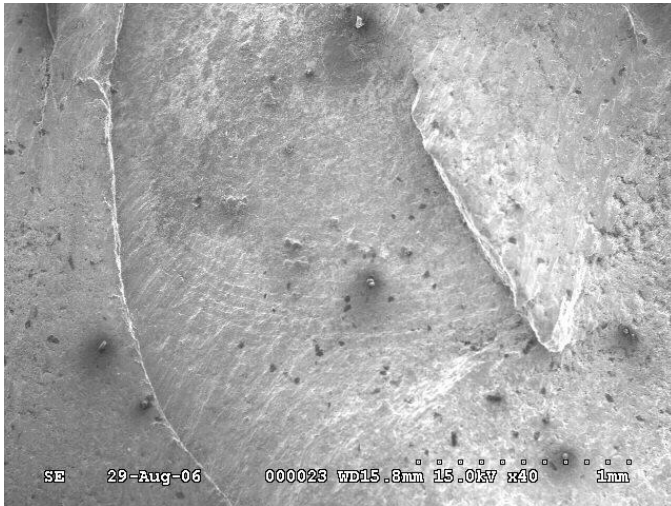
Figure 3 – 40X Beach Marks Near Center of the Shaft

There was a small area near the center of the shaft that was not heavily corroded, and/or Brinelled during the shaft failure. Figure 3 shows beach marks at that location, which are a characteristic of fatigue.

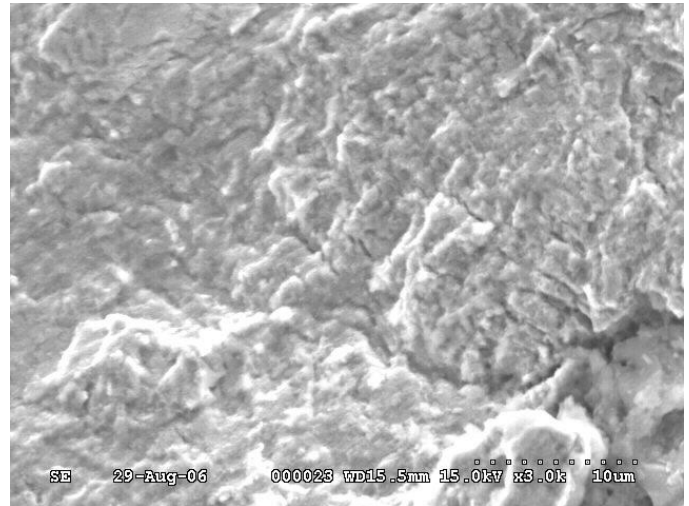
Figure 4 – 3000X Fatigue Striations

Figure 4 shows the fatigue striations. The spacing of the striations was determined to be 1.85×10^{-5} inches. Figures 4 and 5 show striations that were approximately perpendicular to each other, which is a common characteristic of torsional fatigue. Both locations show fissile fracture which results when the cyclic stress exceeds the tensile strength of the steel. The striation spacing shown in Figure 5 was determined to be 1.66×10^{-5} inches. The striation spacing at both locations indicates high cycle fatigue.

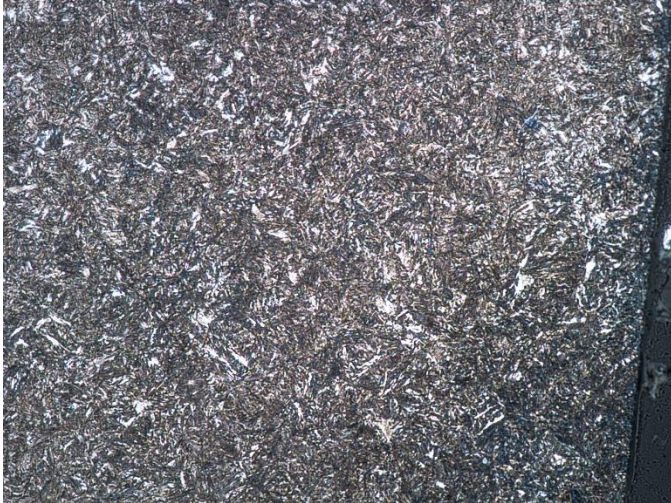
Figure 6 – 400X Case of Shaft

The shaft had neither the effective case depth, or the surface hardness specified by the manufacturer. The most likely cause of this was slack quenching during the heat treating process. Higher surface hardness’s resulting from the carburized case are intended to increase the resistance to fatigue in shafts. That did not happen with this shaft.

There was ferrite in the carburized case of the shaft. The ferrite is the white areas in Figures 6. The presence of ferrite explains the low hardness and is a positive indicator of slack quenching, which increases the vulnerability of the shaft to fatigue failure. Ferrite is essentially pure iron and, being much weaker than the martensitic matrix, will act as fracture initiation sites.

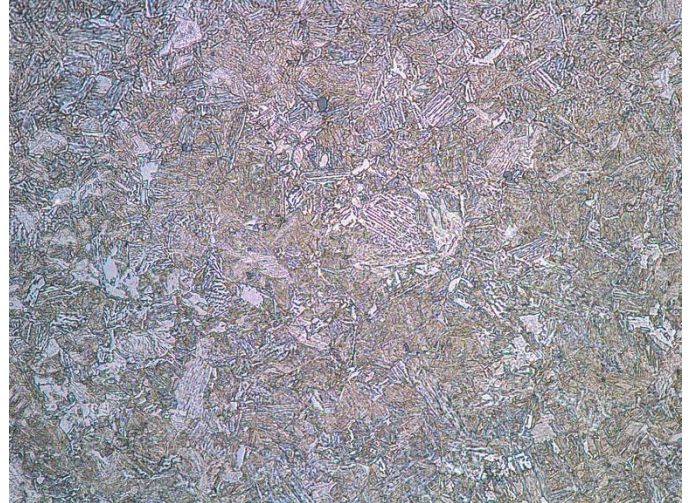
Figure 7 – 400X Microstructure Core of Shaft

The microstructure in the core of the shaft consisted of tempered low carbon martensite, Bainite, and acicular ferrite, Figure 7. The presence of acicular ferrite is a clear indicator of slack quenching.
