## Case Study: Communication Tower Inspection

### Subject

Inspection of a 300 foot communications tower located in Minnesota. The tower was inspected prior to purchase by a new owner. The tower inspection was not a full inspection and only included conditions readily observed from the ground to identify structural and electrical defects that could have detrimental effects on the operation of the radio stations using the tower. The relative engineering standards and specifications for communications towers and equipment are referenced.

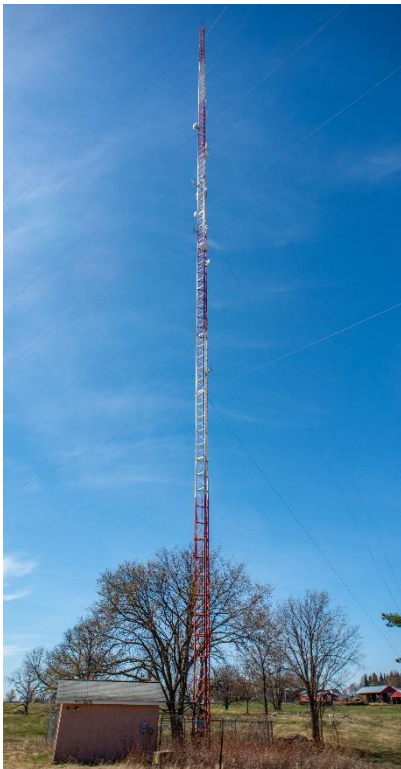
Figure 1 – Tower and Communications House

Figure 1 shows the tower and site. The view shown in this photo was from the east.

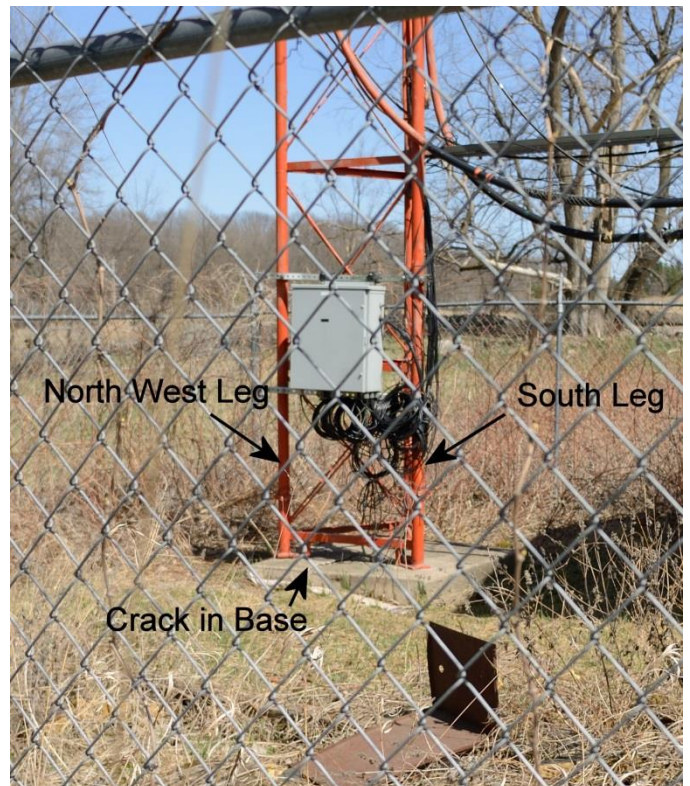
Figure 2 – Tower Base

Figure 2 shows the tower base as seen from the southwest. The two visible legs are labeled on the photo to aid in further discussion.

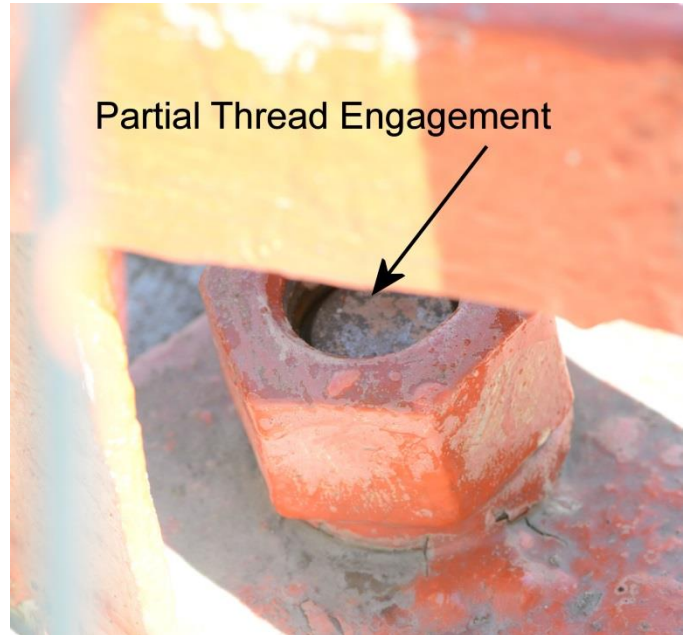
Figure 4 – Partial Thread Engagement, Anchor Point, South Tower Leg

American National Standard for Specification for Structural Steel Buildings, page 118, Section J3.1. states that, “Bolts are permitted to be installed to the snug-tight condition when used in: (a) bearing-type connections and (b) tension or combined shear and tension applications, for Group A bolts only, where loosening or fatigue due to vibration or load fluctuations are not design considerations.” The loading at the guyed tower base should only be compression; therefore, a snug-tight connection is acceptable. The snug-tight condition is defined as the tightness required to bring the connected plies into firm contact. The connection shown in Figure 3 does not meet this requirement. There is a gap between the plate and concrete, and the lock washer has not been compressed. Figure 4 shows incomplete engagement of the nut and anchor bolt. This is not acceptable by any standard.

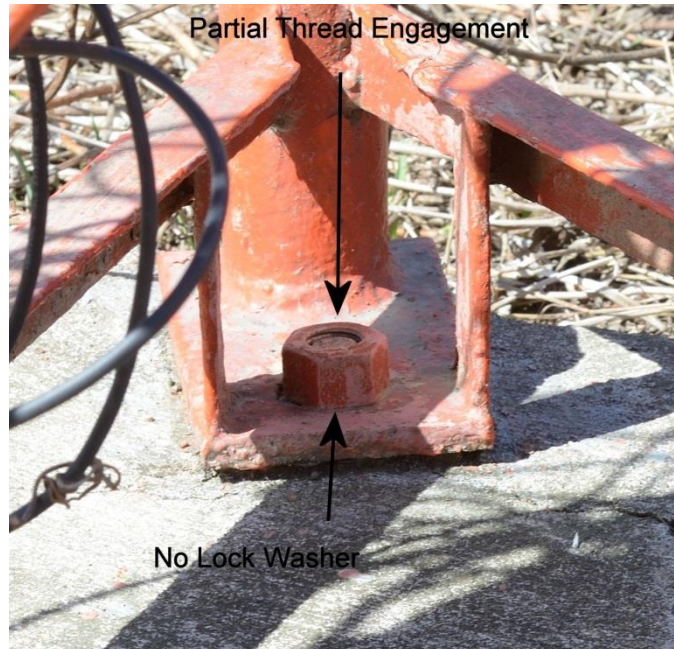
Figure 5 – Tower Base Connection, North Tower Leg

The nut is not fully engaged with the anchor bolt. Figure 5 shows the connection at the tower base at the north tower leg. There is a plate under the tower leg filling the gap. The nut is not fully engaged and there was no lock washer at this location.

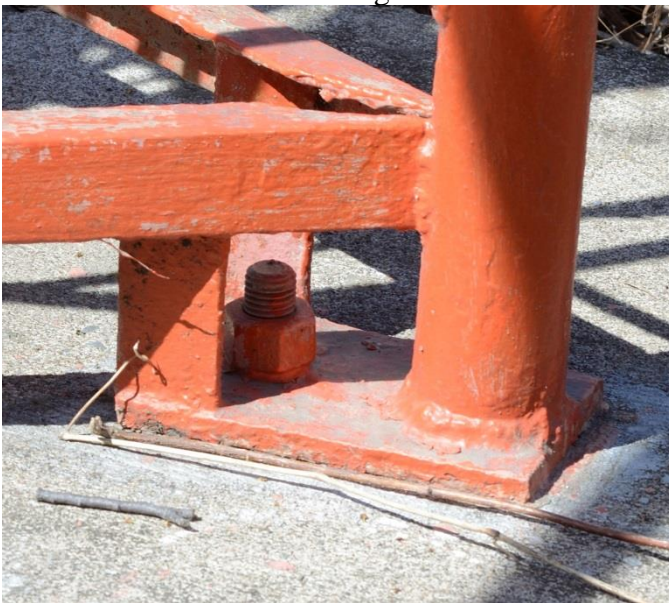
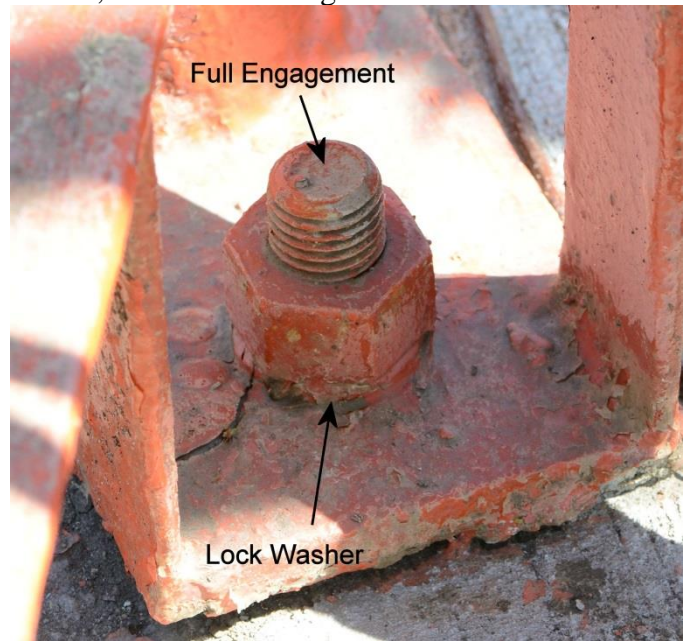
Figure 6 – East Tower Leg Connection

Figure 7 East Tower Leg Connection

The connection between the concrete base and the east tower leg looks to be very good when viewed from the south, Figure 6. The view from the west, Figure 7, is much different. The east tower leg is only contacting the concrete along the south side of the bottom plate. This connection is also not acceptable.

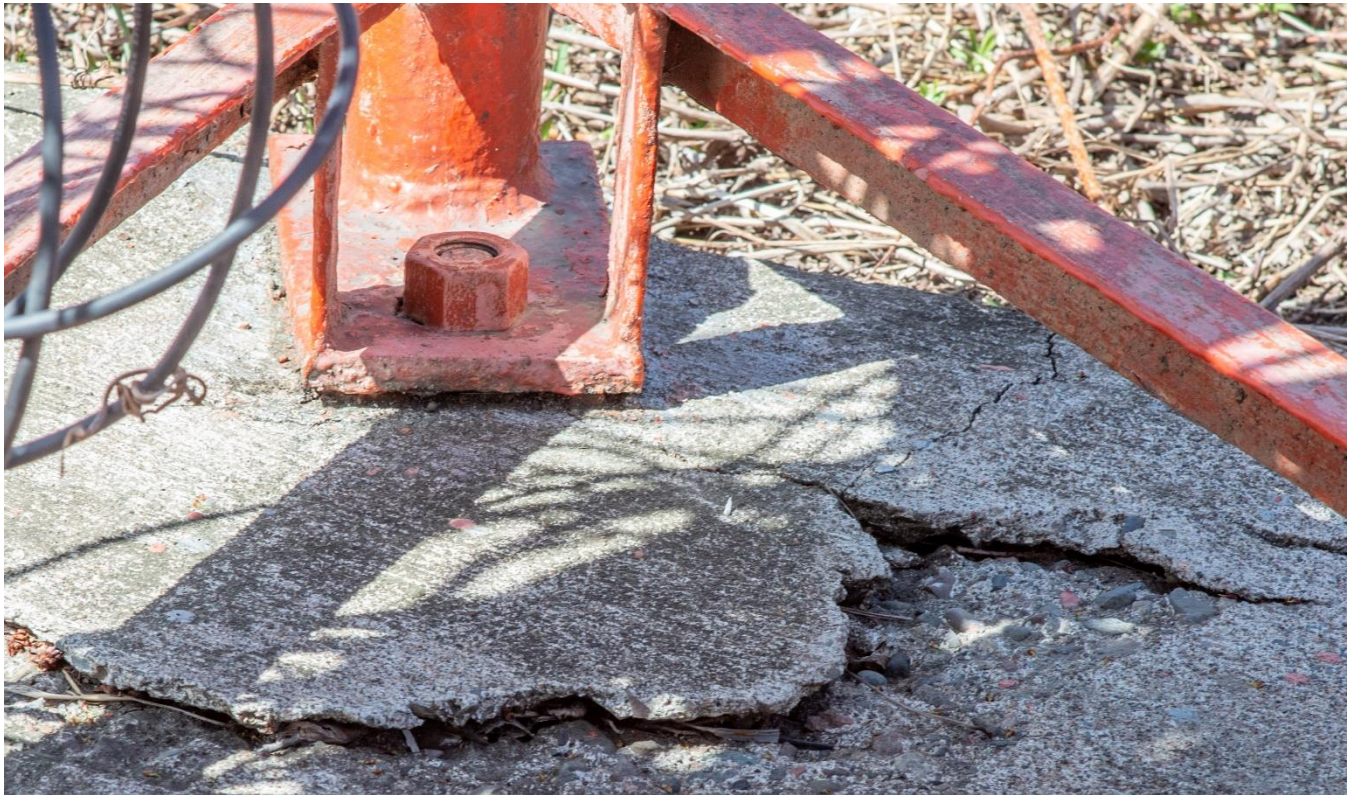
Figure 8 – Cracked Concrete Base North Leg

Figure 8 shows the cracked concrete base associated with the north tower leg. The cracking could be from the tower having been forced to the south, resulting in tensile force in the top layer of concrete. It may also be from settling of the north side of the concrete base, meaning that the base and footing are not deep enough to be below frost line. The cracking could have been the result of a lightning strike, because of a

poor grounding system. The concrete base supporting the tower will likely need to be replaced. The nut and anchor bolt are not fully engaged, and the plate is not flat on the concrete.

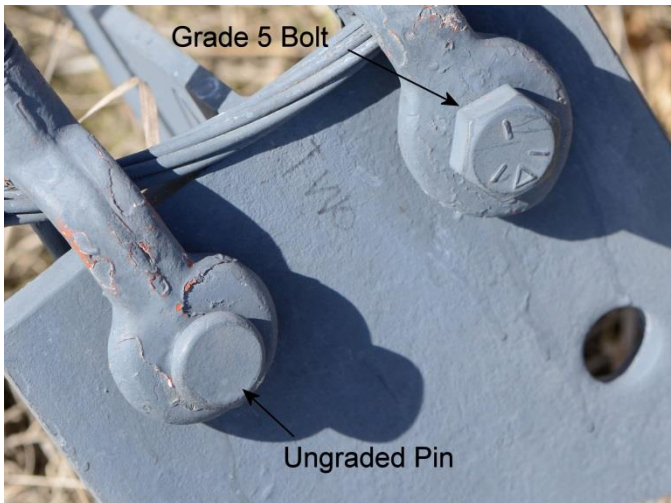
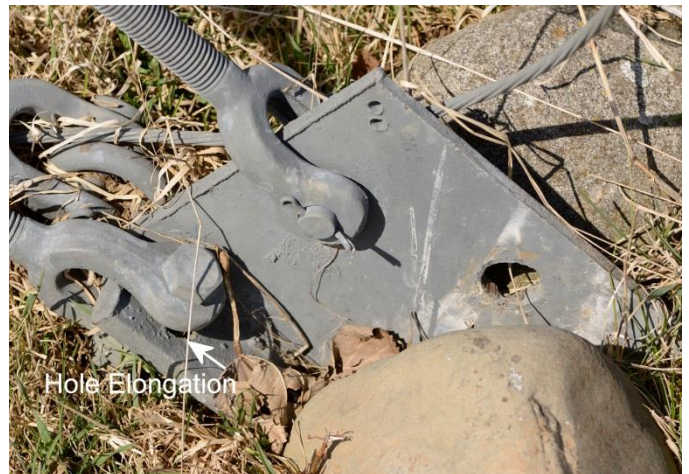
Figure 9 – East Guy Wire Anchor #1

Figure 10 – East Guy Wire Anchor #2

Figures 9 and 10 show the two guy wire anchors east of the tower. It is very likely that the conditions at these two anchors are typical of the other four anchors. Figure 9 shows one clevis held in place with a Grade 5 bolt, and the other clevis held in place with an ungraded pin. Figure 10 shows two of the clevises held in place with pins, and the third one with a Grade 5 bolt. The hole in the anchor where the Grade 5

bolt is used was elongated. It appears that the original clevis pins may have been Grade 5. Any repairs need to be done using Grade 5, or ASTM A325 fasteners.

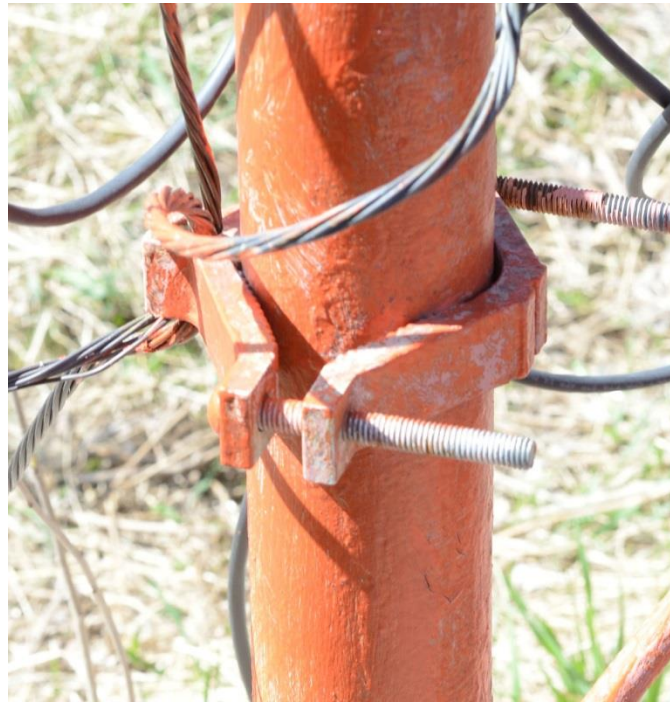
Figure 11 – Tower Ground Connection

Mil-STD-124B Grounding, Bonding and Shielding for...Communication... and many industrial standards are available guidelines for lightning protection. These guidelines far exceed the requirements of the Electrical Code. The ground connection shown in Figure 11 meets the Electrical Code, but does not come close to the standards used by the communications industry. The following is a list of some of the issues involved in grounding of communication equipment and towers.

The ground wire at the tower location was number 6 copper, and the ground rods were flush with the surface of the ground. There was no evidence of bonding, and the guy wires were not grounded. A new grounding system is needed for this tower.
