M. E. Williams and Associates, Inc.

Defective Carburized Shafts

Merlin E. Williams, P.E.

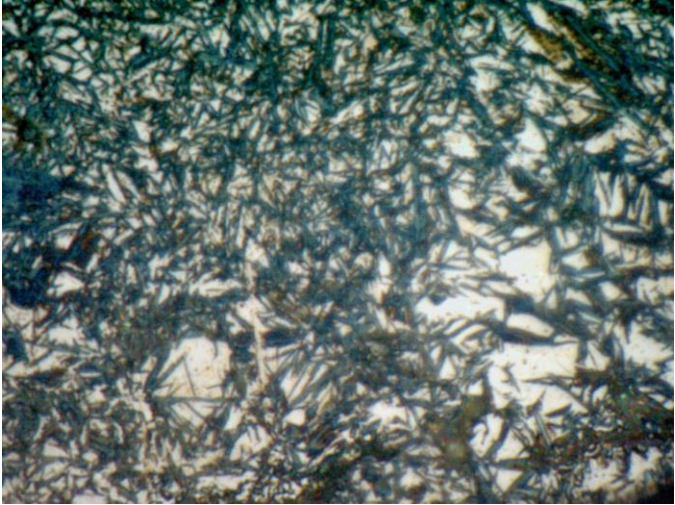
Figure 1 shows the retained austenite, white areas, of the carburized case of the broken axle. The amount of retained austenite is at least 14.5 percent, and the balance of the microstructure is plate martensite. This is a very brittle microstructure, and indicates that the surface carbon content is >1%.

Figure 1 – 1500X Retained Austenite Keyway, Broken Axle

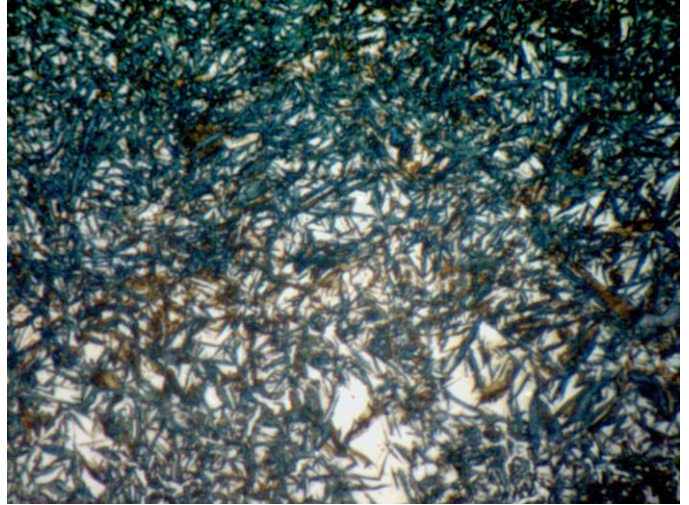
Figure 2 – 1500X Retained Austenite Keyway, Good Axle

The Good axle that did not break during torque testing had 11.3% retained austenite in the keyway. The balance of the microstructure was plate martensite, Figure 2. This microstructure is also very brittle, and indicates a surface carbon content higher than 1%.

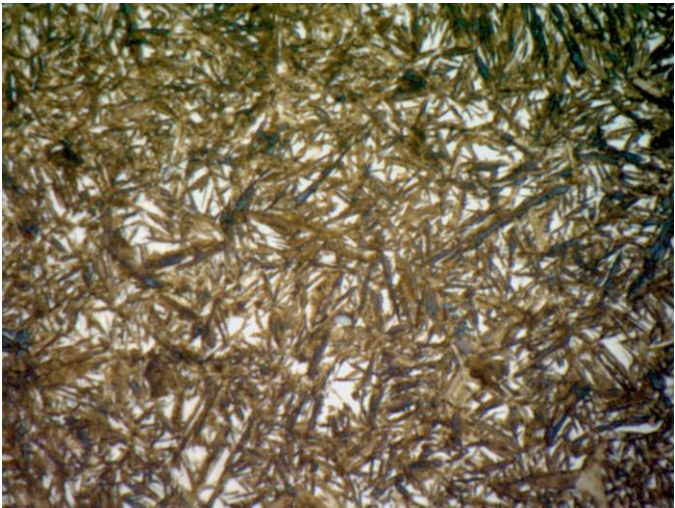
Figure 3 – 1500X Retained Austenite, Good Axle Bearing Surface

The percentage of retained austenite in the case on the ground bearing surface was 8.1. The microstructure was plate martensite, Figure 3.

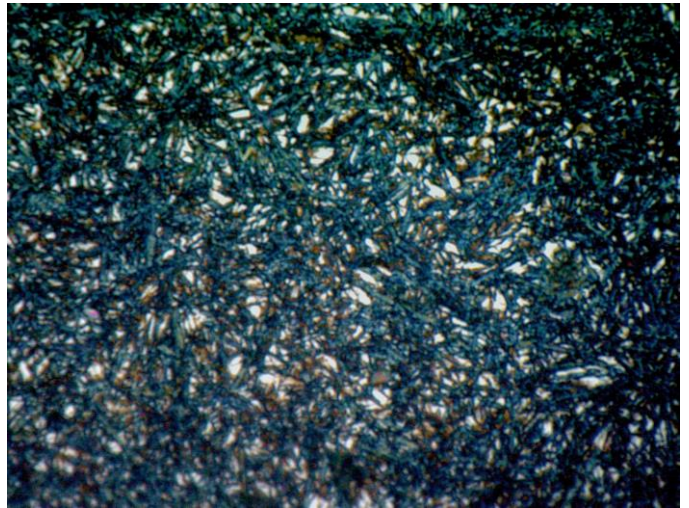
Figure 4 – 1500X Retained Austenite, Axle Lot I Bearing Area

Figure 4 shows the microstructure at the surface of the axle from Lot I. The amount of retained austenite is less than that found in the Good and the Broken axles.

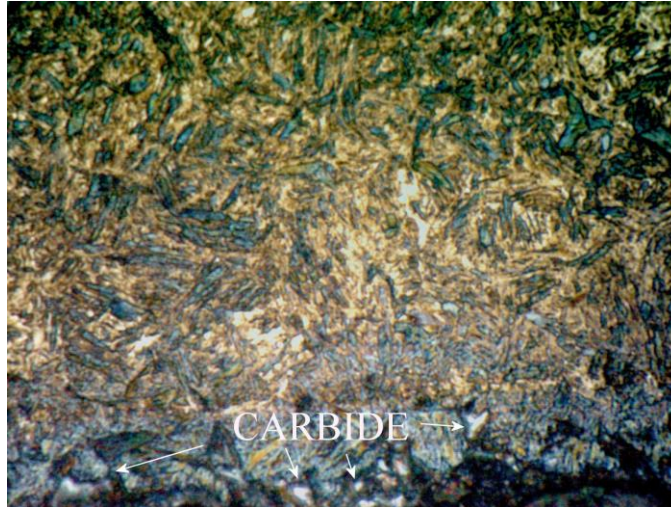
Figure 5 – 1500X Tempered Martensite and Carbides, Lot K-1

The carburized case on the axle from Lot K-1 had a microstructure of lathe martensite with a few carbides at the surface, Figure 5. Lathe martensite is formed during quenching if the carbon level is 0.80 percent or less. Lathe martensite has a higher fracture toughness than plate martensite. The microstructure explains the lower hardness readings on the hardness profile shown in Table 2.

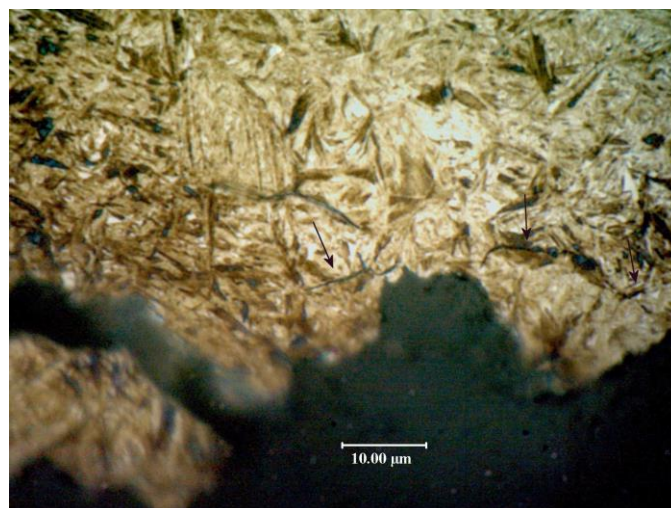
Plate martensite is a very brittle microstructure and is very likely to crack under normal loading conditions. This is exactly what happened in the case of the axle that broke during torque testing. Figure 6 shows cracks in the plate martensite, indicated by arrows. The bulk of the fractures appear to have been along the interface between plate and lathe martensite. Even without the presence of the retained austenite, the microstructure present in this carburized case would have been problematic. The interface between the plate and lathe martensite was between 0.008 and 0.016 inch depth. It is possible that, under load, the plate martensite layer could separate from the underlying lathe martensite. This is a possible occurrence even if the retained austenite were not present.

Figure 6 – 1500X Micro-Cracking in Plate Martensite

Heavy equipment manufacturers do not like to have carburized parts cold treated to remove retained austenite because of micro-cracks that form in the case. They control the retained austenite by controlling the carbon level in the case. The lower carbon level also insures that the case is free of plate martensite. Plate martensite can spontaneously produce micro-cracking, as shown in Figure 6.

The microstructures indicate that the Broken axle, the Good axle, and the Lot I axle, were heat treated with very high carbon potentials of over one percent. These axles did not receive cold treating, were likely only snap-tempered, and bearing races were ground to size. The maximum as-quenched hardness in steel is obtained at a carbon level of 0.80 percent, which was located at a depth of 0.004 to 0.008 inches below the finished surface. As the carbon level increased near the surface, the as-quenched hardness dropped off. To achieve the desired carburizing carbon level of 0.80% on the surface and a 99.9 percent lath martensitic structure, the heat treating process needs to be tailored to this application. If this is not done, the manufacturing processes following heat treatment need to remove the objectionable surface microstructures. This is usually much more expensive to do. In the case of these axles, it would mean grinding all carburized surfaces, including spline and keyway, to remove the plate martensite layer.
