M. E. Williams and Associates, Inc.

Case Study: Corrosion Caused by Packaging Material

Merlin E. Williams, P.E.

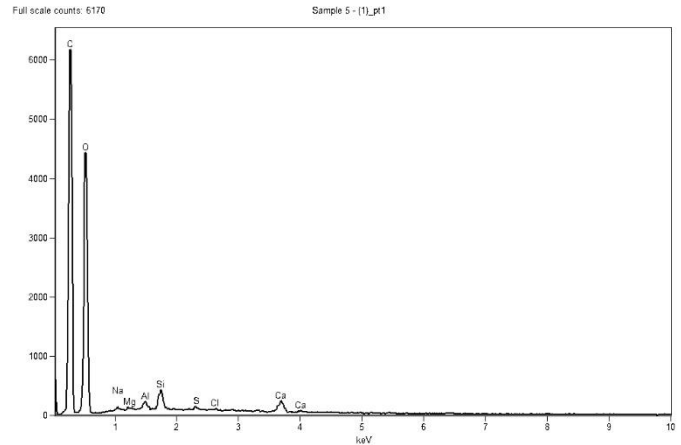
Figure 5 – Cardboard Surface that was Analyzed

The active elements found in the cardboard, Table 1, were sodium, sulfur, and chlorine. The sulfur and chlorine compounds used in the manufacturing of cardboard will form acids in the presence of water. Acid-sulfur compounds are corrosive to aluminum, copper, and zinc. Acid-chlorine compounds are corrosive to aluminum and zinc. Neutral salts of chlorine are soluble in water and are corrosive to aluminum. Soluble sodium, sulfur, and chlorine compounds are electrolytes, and will cause galvanic corrosion of dissimilar metals, such as aluminum, copper, and zinc. Wet cardboard and other paper products in contact with any active metal, such as aluminum, usually results in corrosion.

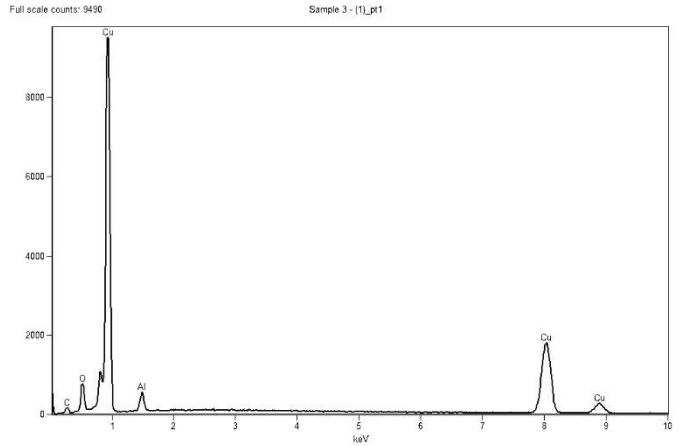
Figure 8 – Spectrum Location 1, Sheet Tube

Table 2 gives the semi-quantitative analysis of the sheet tube. The tube was wet when it was removed from the coil. Any dissolved ions present would have made the water conductive, resulting in corrosion of the aluminum fin material by galvanic corrosion. The energy dispersive x-ray analysis did not indicate any chlorine or sulfur. The white material on the surface of the copper sheet tube was aluminum oxide. Location 1, shown in Figure 7, was a clean spot.

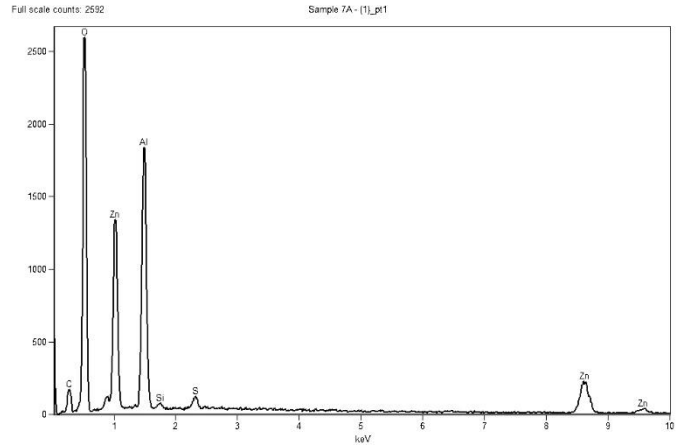
Figure 15 – Spectrum Location 1, Fin Material

The semi-quantitative analysis of the gray deposits on the edge of the fin material, Figure 3, is given in Table 3. The gray deposit on the material was zinc from the galvanized drip pan or galvanized frame. The active element present was sulfur, and again, the likely source of the sulfur was cardboard packing material.

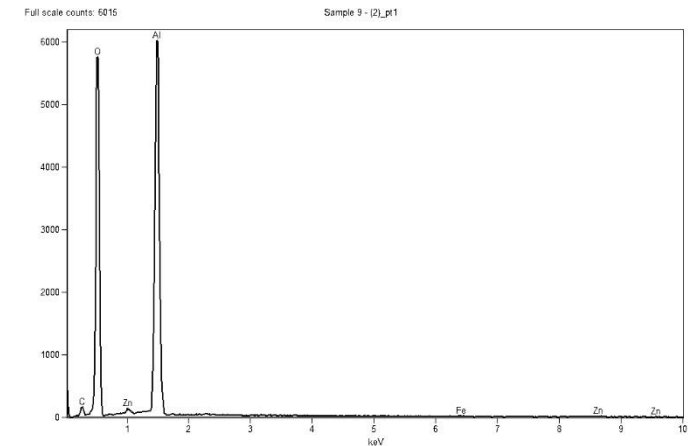
Figure 20 – Spectrum Location 1, Crystalline Material

The semi-quantitative analysis of the crystalline material, Table 4, indicates that the powder is a mixture of aluminum and zinc oxides, and that the corrosive agent was sulfur.
