# *M. E. Williams and Associates, Inc.*

## Case Study: Paint Failure

Examination of paint from a small town Minnesota Water Tower to determine the cause of paint failure. Paint chips that had fallen from the tower were collected for examination, and other samples were removed from the tower structure. The samples were examined by visual examination, microscopic examination, scanning electron microscopic and energy dispersive x-ray analysis, and chemical analysis.

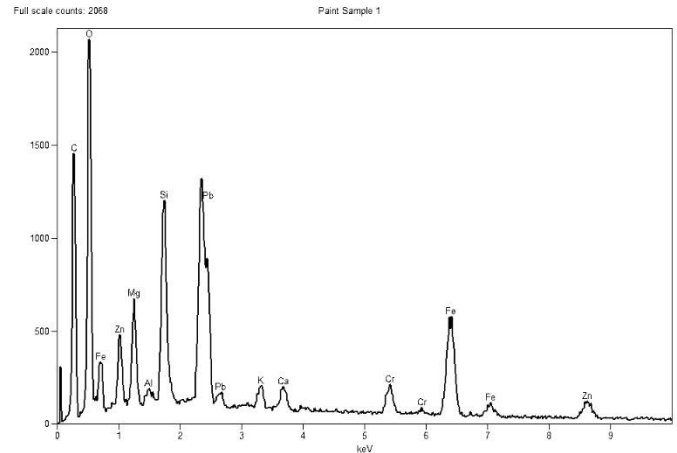
Paint Sample 1 was the paint material picked up from the ground around the east tower leg. The primer surface of the paint, Figure 12, was examined with a scanning electron microscope. The primer layer was cracked, indicating that the primer was brittle. The energy dispersive x-ray, EDX, spectrum of this surface is shown in Figure 13. The spectrum shows a significant quantity of lead present in the primer. Since the sale of lead based paints and primer has been banned since January 1, 1991, the presence of lead in the primer flakes means that the ground surrounding the water tower was contaminated with lead. The semi-quantitative analysis of the primer is given in the table that follows.

Figure 12 – 50X Primer Surface of Paint Sample 1

The cracking in the primer layer, shown in Figures 12 and 14, indicated that the primer had become brittle. All paints and primer continue to age and become brittle after many years.

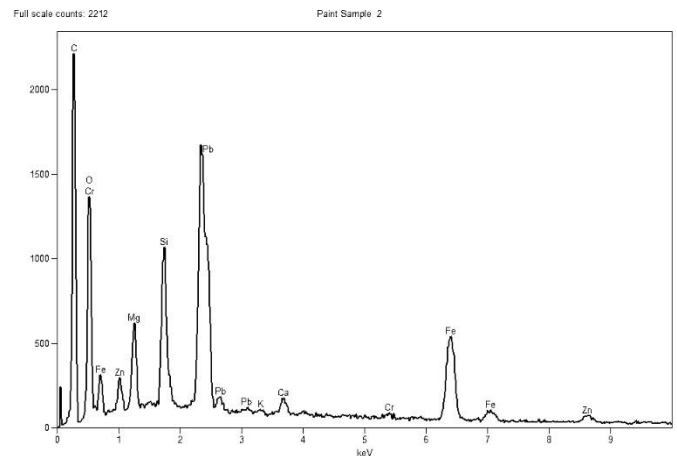
Figure 14 – 50X Primer Surface of Paint Sample 2

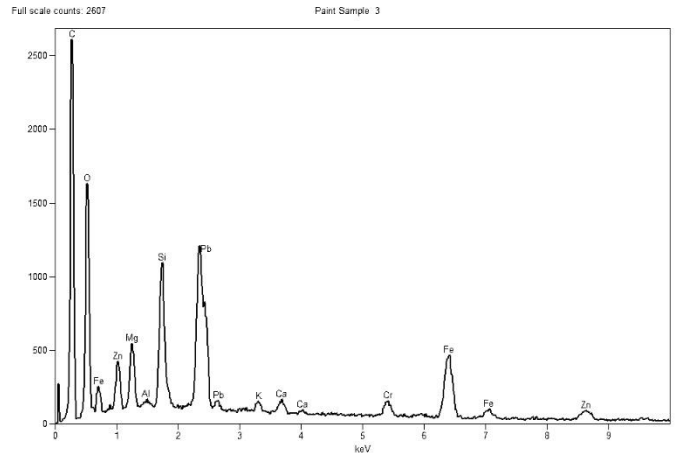
Figure 16 – 100X Primer Surface of Paint Sample 3

Paint Sample 3 was removed by the cross hatch test on a tower leg. The primer surface is shown in Figure 18. The EDX spectrum is shown in Figure 19. Lead was present at this location. The semi-quantitative analysis is given in the table that follows.
