Case Study: Stainless Steel Ammonia Evaporator Coil

Merlin E. Williams, P.E.

Scope of Examination

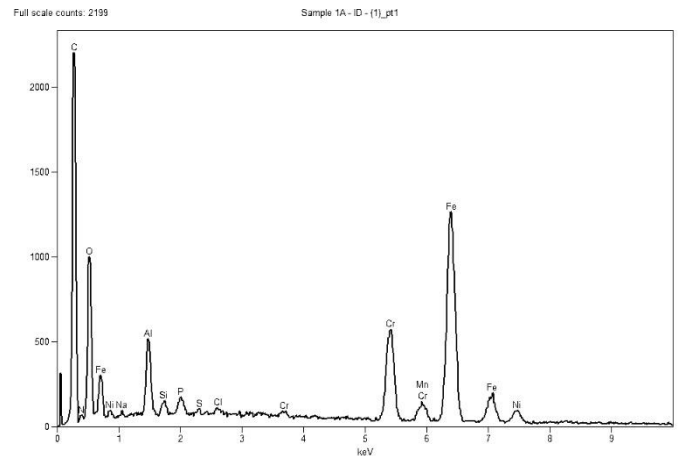
Figure 13 – Spectrum of Location 1 near Leak on I.D.

Figure 12 shows the locations where the debris was associated with the corrosion pit on the inside diameter of the tube. The SEM image was made in the back scatter mode; therefore, the darker material has the lowest atomic weight. Carbon based materials show up as black. The semi-quantitative analysis for the three locations is given in Table 1. The spectra shown in Figure 13 indicates the unusual presence of carbon, sodium, aluminum, phosphorous, sulfur, and chlorine. Chlorine in the form of chlorides is highly corrosive to 304 stainless steel. The spectra shown in Figure 14 indicates the presence of the same unexpected elements, plus calcium. Figure 15 is the spectra for an area of clean 304 stainless steel.

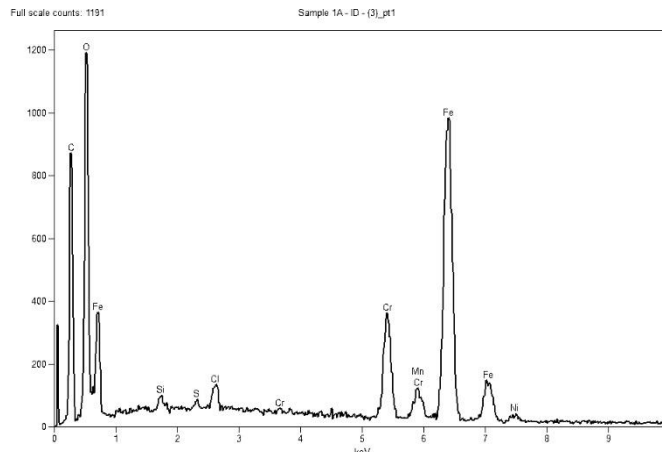
Figure 17 – Spectrum of Location 1 on Tube Wall

The three spots that were analyzed on the tube wall, Figure 16, were virtually identical. The three spectra, shown in Figures 17, 18, and 19, show the presence of iron oxide, organic material, sodium chloride, and stainless steel. The semi-quantitative analysis of these locations is given in Table 2.

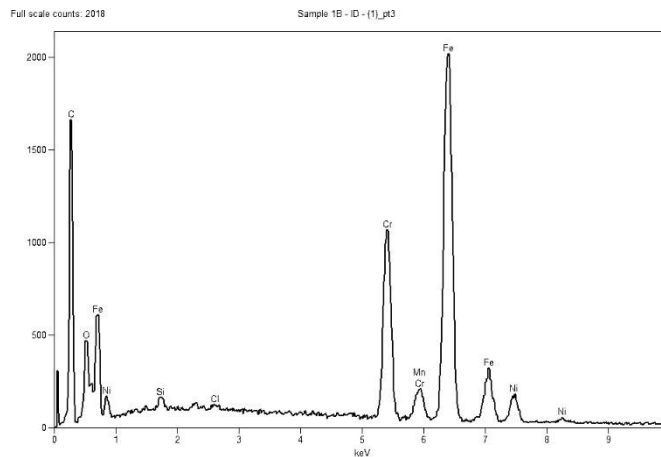
Figure 23 – Spectrum of Location 3 Deposit on Tube Wall

The spot analysis for Location 2, Figure 22, shows organic material, a chloride salt, and underlying stainless steel. Location 3 is similar, but the stainless steel is more prevalent. The semi-quantitative analysis is given in Table 3.
