M. E. Williams and Associates, Inc.

Report Number: 16-4686

Failure analysis of two steam coil sections used in a steam heating system, and analysis of two water samples removed from the system containing the failed coils. The water samples were examined by visual examination, scanning electron microscopic examination, energy dispersive x-ray analysis, and anion analysis. The copper tubing in the failed coil samples was examined by visual examination, scanning electron microscopic examination, energy dispersive x-ray analysis, and metallographic examination.

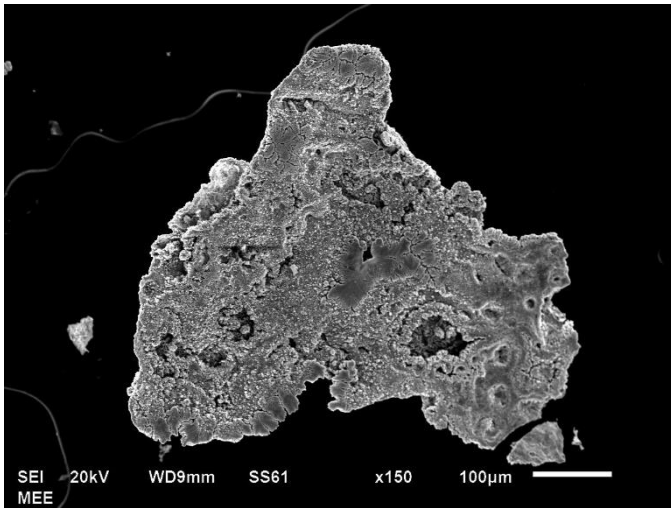
Figure 4 – 150X Feed Water Sediment, Front of Dock Sample

Front of Dock Sediment Analysis (Percent by Weight)			
Element/Location	Figure 4	Figure 7 - 1	Figure 7 – 2
Carbon	2.7	3.7	0.7
Oxygen	13.6	7.7	21.4
Aluminum	0.4	0.2	N/A
Silicon	N/A	N/A	0.3
Sulfur	Trace	N/A	N/A
Iron	82.2	1.6	73.2
Copper	1.1	86.8	4.4
Spectrum	Figure 5	Figure 8	Figure 9

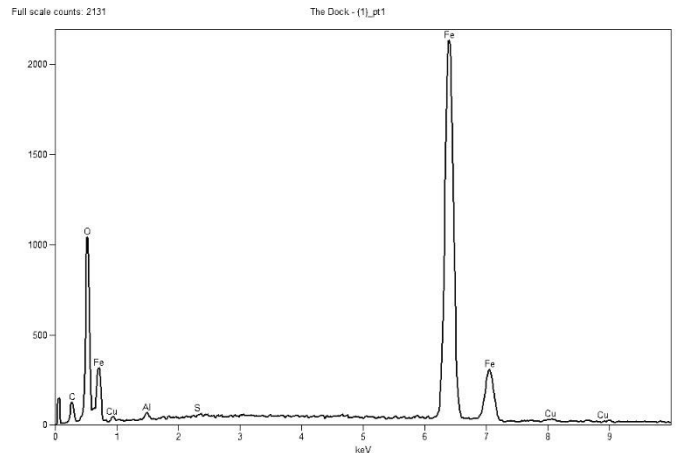
Figure 5 – Spectrum of Sediment shown in Figure 4 – Front of Dock Sample

The presence of aluminum is a potential problem with the feed water.

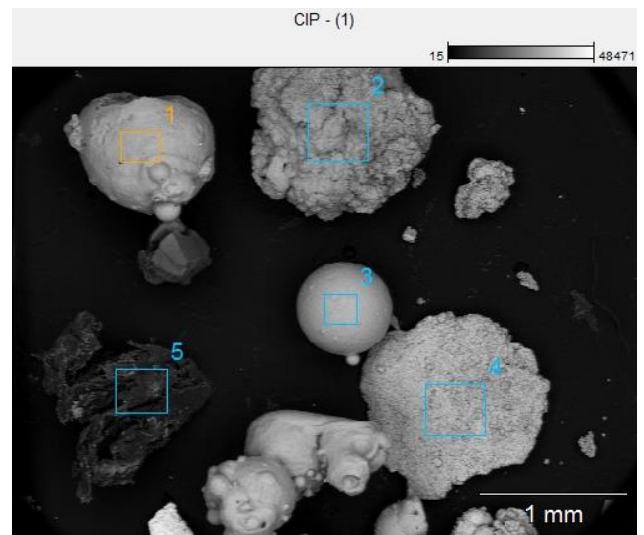
Figure 11 – 30X Analysis Locations, CIP Water Sediment, Area 1

The sediment from the CIP location was somewhat different than that from the Dock location. Figure 10 shows the variety of structures that were found. Figure 11 shows the locations of the analysis. The spectra are shown in Figures 12 through 16, and the semi-quantitative analysis is given in the table that follows.

Location 1 appears to be a piece of carbon steel. Aluminum and titanium are often used as grain refiners in steel. Locations 2 and 3 are iron oxide nodules. Location 4 is a piece of copper oxide scale. Location 5 is an iron rich organic material. Each of these particles were formed as a result of corrosion in the system. A likely source of the aluminum is the steel piping and tubing in the system.

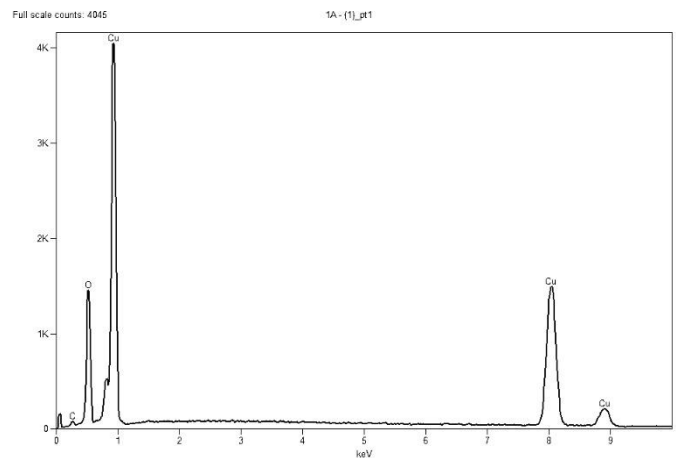
Figure 31 – Spectrum of Surface Shown in Figure 30 Coil Sample 1

tubing is ammonia. Figure 31 is the spectrum of the surface shown in Figure 30. Only three elements are present: carbon, oxygen, and copper. Ammonia and other nitrogen compounds are very hard to detect by energy dispersive x-ray analysis, but the intergranular cracking is a key indicator that they were present.

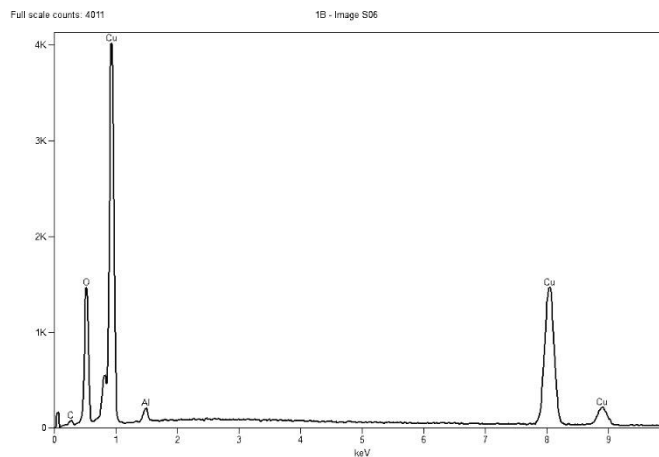
Figure 34 – Spectrum of the Surface Shown in Figure 32

The intergranular cracking on the inside diameter of Coil Sample 1 is clearly shown in Figure 32. Figure 33 shows the nature of the oxide formation on the inside diameter of Coil Sample 1. Figure 34 is the energy dispersive x-ray spectrum of the surface area shown in Figure 32. This was the only location where aluminum was detected on the inside diameter of the copper tubing. The other elements were carbon, oxygen, and copper.

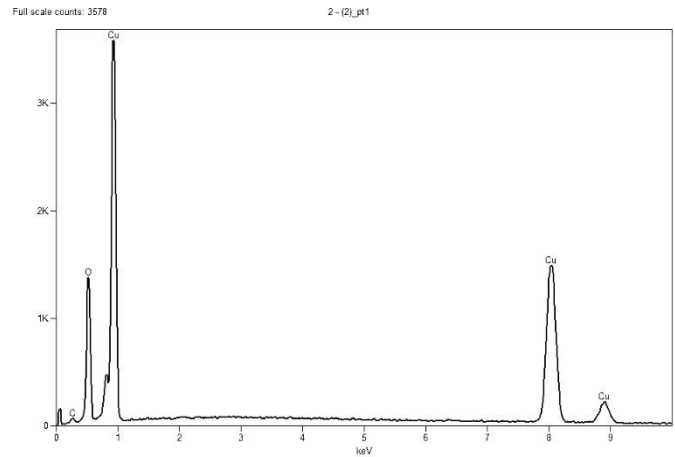
Figure 36 – Spectrum of Surface shown in Figure 35

Figure 35 shows a location on the inside diameter of Coil Sample 2. The thick oxide scale had flaked off the copper at this location. There was evidence of erosion and evidence of intergranular cracking present. Figure 36 shows the spectrum of the area shown in Figure 35. The elements present were carbon, oxygen, and copper.
